**ENDANGERED SPECIES ACT-LISTED  
AMPHIBIANS - CALIFORNIA  
RED-LEGGED FROG  
STUDY REPORT  
DON PEDRO PROJECT  
FERC NO. 2299**

**Prepared for:**  
**Turlock Irrigation District – Turlock, California**  
**Modesto Irrigation District – Modesto, California**

**Prepared by:**  
**HDR Engineering, Inc.**

**January 2013**

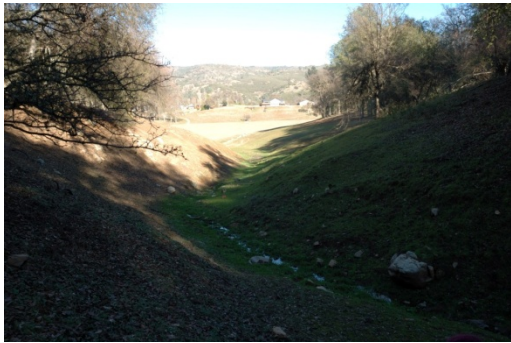
*F1*

F1 is a 58-m-long section of an unnamed tributary, a tributary to the Hatch Creek arm of Don Pedro Reservoir, located partially below the high water line of the reservoir within the FERC Project Boundary. F1 is 2.7 km from the nearest known CRLF occurrence. National Wetlands Inventory (NWI) data (USFWS 2012) depict a riverine, intermittent, streambed, temporarily flooded (R4SBA) wetland feature in the area of the site.

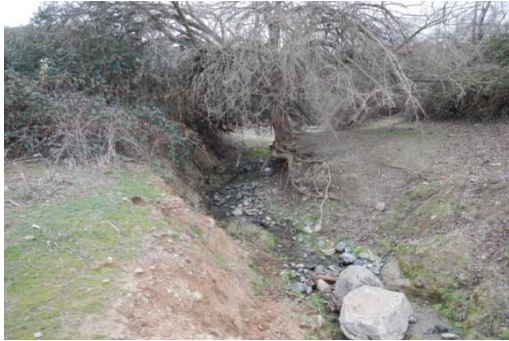
F2 is a 112-m-long section of an unnamed intermittent tributary to Don Pedro Reservoir, located approximately 65 m west of Marsh Flat Road, partially below the high water line of Don Pedro Reservoir, and within the FERC Project Boundary. F2 is 2.5 km from the nearest known CRLF occurrence. NWI data depict F2 as a riverine, intermittent, streambed, seasonally flooded (R4SBC) wetland feature.

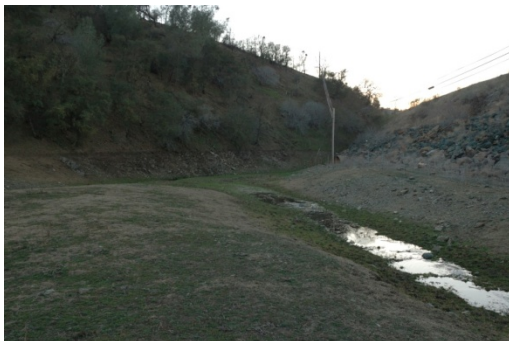
F3 is a freshwater pond formed at the confluence of three perennial tributaries to Don Pedro Reservoir, located east of SR 182, 65 m east of Don Pedro Reservoir, and within the FERC Project Boundary. F3 is 4 km from the nearest known CRLF occurrence. NWI data for the area depict a palustrine, unconsolidated bottom, permanently flooded, diked/impounded (PUBHh) wetland feature in the area of the site.

The site was assessed on February 8, 2012. The bank full width was estimated at 1.5 m with a maximum depth of 0.5 m. The stream gradient was approximately 3 percent. Pools measuring up to 5 m x 1.5 m and 0.1 m deep were present at the site. Non-pool habitat was made up of riffles. Substrate consisted of silt. Banks were gently sloping with an incised vegetated channel. The dominant emergent and margin vegetation was grass with no overhanging vegetation present. Surrounding upland habitat consisted of blue oak (*Quercus douglasii*) pastureland. A juvenile American bullfrog was observed during the survey.

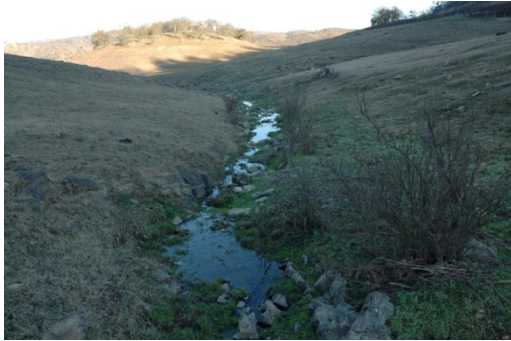
F5 is a 152-m-long section of an unnamed intermittent tributary to Don Pedro Reservoir, located approximately 75 m north of SR 132, partially below the high water line of Don Pedro Reservoir and within the FERC Project Boundary. F5 is 4 km from the nearest known CRLF occurrence. NWI data for the area depict a riverine, intermittent, streambed, temporarily flooded (R4SBA) wetland feature from the mouth of the reservoir to 350 m upstream, including Site F5, which becomes a freshwater emergent seasonal (PEMC) wetland feature further upstream.

The site was assessed on February 8, 2012. The bank full width was estimated at 1.5 m and depth was 0.5 m. The stream gradient was 3.5 percent. Pools measuring up to 3 m x 0.75 m and 0.1 m deep were present in the stream. Non-pool habitat was a mix of riffle, cascade, and run. The substrate consisted of angular cobbles and boulders. The banks of the channel were incised and consisted of soil with emergent vegetation. Willows (*Salix* sp.) and grasses were the dominant vegetation at the site, with willows overhanging the stream. No fish or amphibians were observed; however, fish are known to be present in Don Pedro Reservoir. Surrounding upland habitat was blue oak pastureland, with the canopy cover minimal below the high water line and increasing to 30 percent upstream of the assessment location.

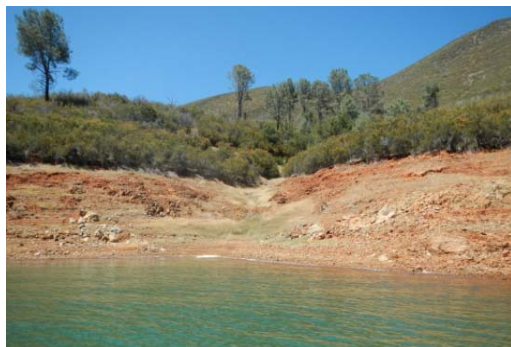
F7 is a 32-m-long section of an ephemeral tributary to Don Pedro Reservoir at Upper Bay, below the high water line and within the FERC Project Boundary. F7 is 10 km from the nearest known CRLF occurrence. NWI data for the area depict a riverine, intermittent, streambed, temporarily flooded (R4SBA) wetland feature.

The site was assessed on June 19, 2012. F7 is in the vicinity of seven other ephemeral tributaries to Don Pedro Reservoir at Upper Bay. The bank full width was 1 m with a depth of 0.25 m. The stream gradient was 4 percent. The stream was dry at the time of survey, but it was assumed that pools would be present during flow conditions. Non-pool habitat was assumed to be a mix of riffle and cascade. The substrate was made up of soil and

bedrock with some cobbles. The stream banks were very shallow and vegetated with grasses, sloping to steeper bedrock in places. Emergent vegetation consisted of grasses and forbs below the high water line. Buckthorn, oak, and foothill pine were overhanging the stream channel above the high water line and were the dominant vegetation in the uplands. No fish or amphibians were observed; however, fish are known to be present in Don Pedro Reservoir.

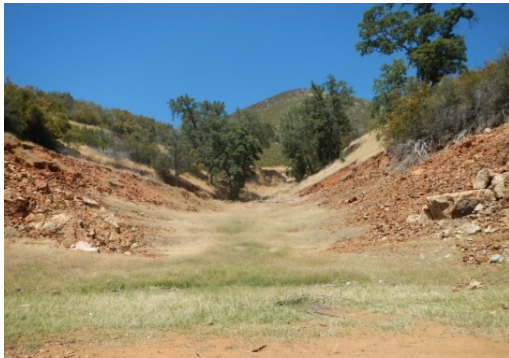
**F8**

F8 is a 45-m-long section of an ephemeral tributary to the upper bay of Don Pedro Reservoir, below the high water line of Don Pedro Reservoir within the FERC Project Boundary. F8 is 10 km from the nearest known CRLF occurrence. NWI data for the area depict a riverine, intermittent, streambed, temporarily flooded (R4SBA) wetland feature in the area of the site.

was 1 m with a depth of 0.25 m. The stream gradient was 4 percent. The stream was dry at the time of survey, but it was assumed that no pools were present. Non-pool habitat was assumed to be riffle during flow conditions. The substrate was made up of soil and bedrock with some cobbles. The stream bank varied from gently sloping to steep bedrock and cobbles with grass present in flat areas. Emergent and margin vegetation consisted of grasses and forbs below the high water line, with buckthorn and oak in the upland and overhanging the stream channel in some areas. No fish or amphibians were observed; however, fish are known to be present in Don Pedro Reservoir.

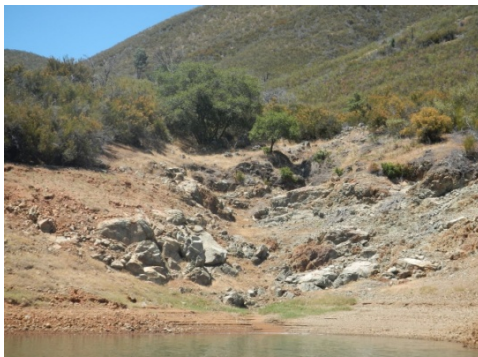
**F9**

F9 is a 37-m-long section of an ephemeral tributary to the upper bay of Don Pedro Reservoir, below the high water line of Don Pedro Reservoir within the FERC Project Boundary. F9 is 9.8 km from the nearest known CRLF occurrence. NWI data for the area depict a riverine, intermittent, streambed, temporarily flooded (R4SBA) wetland feature in the area of the site.

was 2 m with a depth of 1 m. The stream gradient was 6 percent. The stream was dry at the time of survey, but it was assumed that pools would be present during flow conditions. Non-pool habitat was assumed to be a mix of cascade, riffle, and step-pool. The substrate was made up of soil and grasses that were present throughout the stream channel. Stream banks consisted of somewhat steep bedrock. Emergent and margin vegetation consisted of grasses, with one oak overhanging the stream channel. Upland habitat was dominated by buckthorn (*Ceanothus* sp.). No fish or amphibians were observed; however, fish are known to be present in Don Pedro Reservoir.

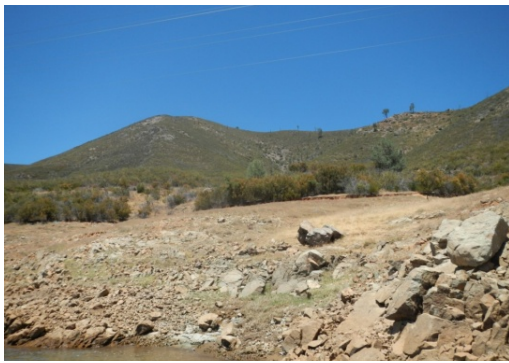
**F10**

F10 is a 53-m-long section of an ephemeral tributary to the upper bay of Don Pedro Reservoir, below the high water line of Don Pedro Reservoir within the FERC Project Boundary. F10 is 9.7 km from the nearest known CRLF occurrence. NWI data for the area depict a riverine, intermittent, streambed, temporarily flooded (R4SBA) wetland feature in the area of the site.

The site was assessed on June 19, 2012. F10 is in the vicinity of seven other ephemeral tributaries to the upper bay of Don Pedro Reservoir. There was no defined stream channel, so bank full width and depth could not be estimated. The stream was dry at the time of survey, but it was assumed that no pools would be present. Non-pool habitat was assumed to be riffle during flow conditions. The substrate was made up of soil and grasses that were present throughout the stream channel. Emergent and margin vegetation consisted of desiccated grasses, with buckthorn and Manzanita in the upland and overhanging the stream channel in some areas. No fish or amphibians were observed; however, fish are known to be present in Don Pedro Reservoir.

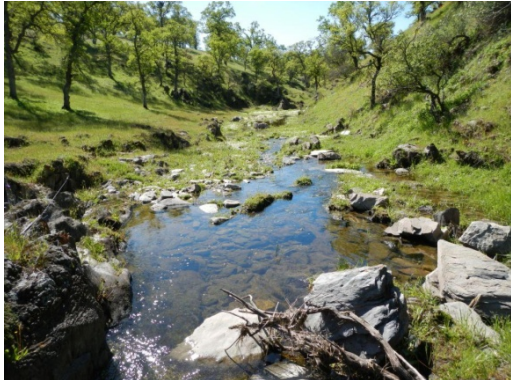
F11 is a 591-m-long section of West Fork Big Creek, a perennial tributary to Don Pedro Reservoir, located partially below the high water line of Don Pedro Reservoir within the FERC Project Boundary. F11 is 17 km from the nearest known CRLF occurrence. NWI data for the area depict a riverine, intermittent, streambed, seasonally flooded (R4SBC) wetland feature in the area of the site.

Pools measuring up to 2 m x 5 m and 0.75 m deep were present in the stream. Non-pool habitat consisted of riffle, run, and step-pool. The substrate was made up of bedrock and cobbles. Stream banks varied from low gradient to steeper areas of vegetated soil with some bedrock outcroppings. Emergent vegetation was a mix of grasses and forbs, with willow overhanging the site. Upland habitat was made up of oak, a few pines, and shrubs. American bullfrogs and small fish were observed at the site during the survey.

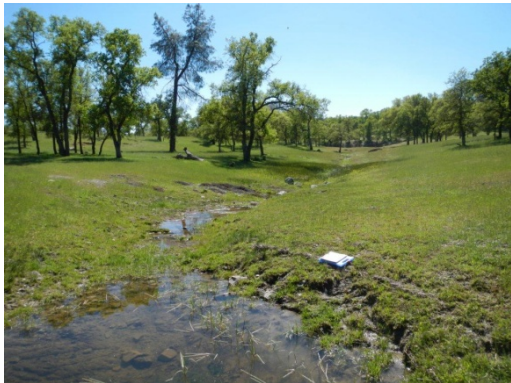
F12 is a 58-m-long section of an unnamed perennial tributary to the Big Creek arm of Don Pedro Reservoir, located 40 m northeast of Don Pedro Reservoir within the FERC Project Boundary. F12 is 8.7 km from the nearest known CRLF occurrence. NWI data for the area depict a riverine, intermittent, streambed, seasonally flooded (R4SBC) wetland feature in the area of the site.

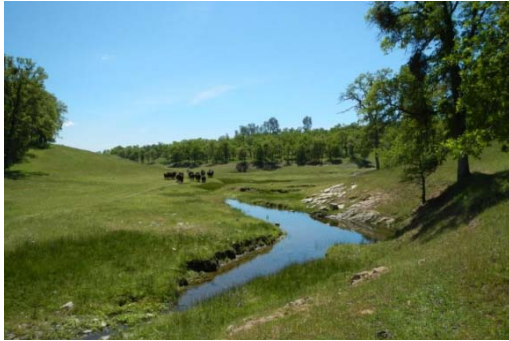
F13 is a 736-m-long section of an unnamed perennial tributary to 49er Bay, located 15 m south of Old Don Pedro Road, partially below the high water line of Don Pedro Reservoir and within the FERC Project Boundary. F13 is 7.3 km from the nearest known CRLF occurrence. NWI data for the area depict a riverine, intermittent, streambed, seasonally flooded (R4SBC) wetland feature in the area of the site.

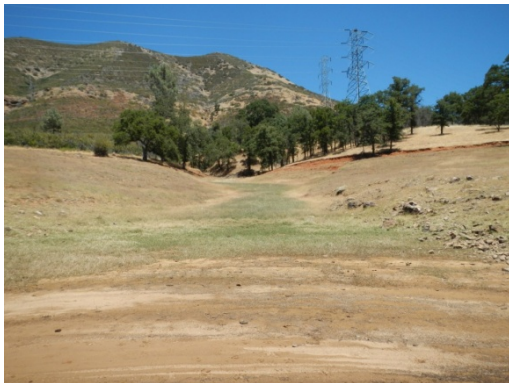
F14 is a 45-m-long section of an ephemeral tributary to the upper bay of Don Pedro Reservoir, below the high water line of Don Pedro Reservoir within the FERC Project Boundary. F14 is 9.5 km from the nearest known CRLF occurrence. NWI data for the area depict a riverine, intermittent, streambed, temporarily flooded (R4SBA) wetland feature in the area of the site.

but it was assumed that no pools would be present. Non-pool habitat was assumed to be riffle during flow conditions. The substrate was made up of soil and grasses that were present throughout the stream channel. Stream banks were gently sloping and covered with grass with some rocks where the stream approached the reservoir. Emergent and margin vegetation consisted of grasses, with oak in the upland and overhanging the stream channel in the upstream portion of the site. Manzanita and buckthorn were also present in the upland habitat. No fish or amphibians were observed; however, fish are known to be present in Don Pedro Reservoir.

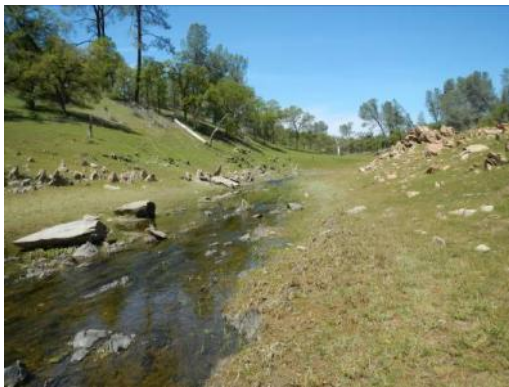
F15 is a 1,218-m-long section of Big Creek and associated tributaries, located partially below the high water line of Don Pedro Reservoir within the FERC Project Boundary. F15 is 12.2 km from the nearest known CRLF occurrence. NWI data for the area depict a riverine, intermittent, streambed, seasonally flooded (R4SBC) wetland feature from the mouth at the reservoir upstream.

bank full width of the stream was observed to be 7 - 8 m with a depth of 0.5 m. The stream gradient was 2 - 4 percent. Pools measuring up to 1 m x 3 m and 1.5 m deep were present in the stream. Non-pool habitat consisted of riffle, run, and cascade. The substrate was made up of bedrock, gravel, cobble, and boulder. Stream banks were low gradient near the stream, turning to steeper rolling hills. Emergent and margin vegetation were a combination of grasses and forbs with no vegetation overhanging the site. Upland habitat was a mixed oak and foothill pine savannah with approximately 45 percent canopy cover. Juvenile and larval American bullfrogs were present throughout the site, and 3 western toads were observed in amplexus during the survey. A bald eagle was observed feeding on a bass near the stream with a juvenile or subadult nearby. Horses were observed grazing near the stream.

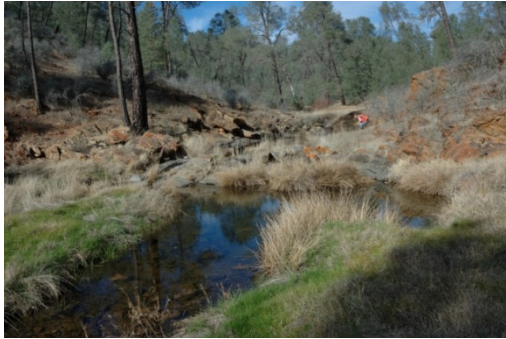
F17 is a 187-m-long section of Poor Man's Gulch, below the high water line of Don Pedro Reservoir within the FERC Project Boundary. F17 is 12.8 km from the nearest known CRLF occurrence. NWI data for the area depict a riverine, intermittent, streambed, seasonally flooded (R4SBC) wetland feature in the area of the site.

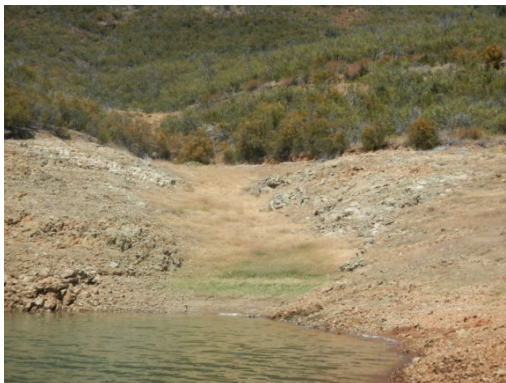
F19 is a 26-m-long section of an ephemeral tributary to the upper bay of Don Pedro Reservoir, below the high water line of Don Pedro Reservoir within the FERC Project Boundary. F19 is 9.8 km from the nearest known CRLF occurrence. NWI data for the area depict a riverine, intermittent, streambed, temporarily flooded (R4SBA) wetland feature in the area of the site.

The site was assessed on June 19, 2012. F19 is in the vicinity of seven other ephemeral tributaries to the upper bay of Don Pedro Reservoir. The bank full width was 7 m with a depth of 1 m, but the channel was not well defined. The stream gradient was 6 percent. The stream was dry at the time of survey, but it was assumed that no pools would be present. Non-pool habitat was assumed to be riffle during flow conditions. The substrate was made up of soil and grasses that were present throughout the stream channel. Stream banks were gently sloping bedrock and gravel. Emergent and margin vegetation consisted of grasses, with buckthorn and other scrub/shrubs in the upland and overhanging the stream channel in the upstream portion of the site. No fish or amphibians were observed; however, fish are known to be present in Don Pedro Reservoir.

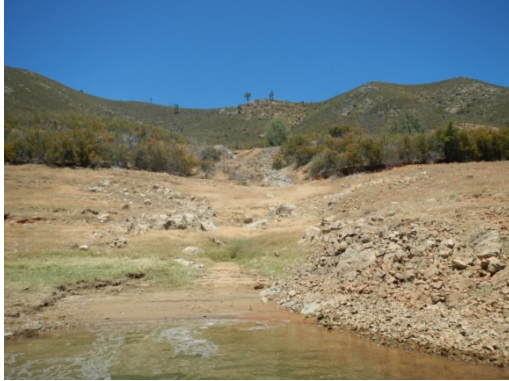
*F20*

F20 is a 33-m-long section of an ephemeral tributary to the upper bay of Don Pedro Reservoir, below the high water line of Don Pedro Reservoir within the FERC Project Boundary. F20 is 9.7 km from the nearest known CRLF occurrence. NWI data for the area depict a riverine, intermittent, streambed, temporarily flooded (R4SBA) wetland feature in the area of the site.

The site was assessed on June 19, 2012. F20 is in the vicinity of seven other ephemeral tributaries to the upper bay of Don Pedro Reservoir. There was no defined stream channel, so bank full width and depth could not be estimated. The stream gradient was 6 percent. The stream was dry at the time of survey, but it was assumed that no pools would be present. Non-pool habitat was assumed to be a mix of riffle and cascade during flow conditions. The substrate was made up of soil and grasses that were present throughout the stream channel and bedrock with some cobbles in the upstream section. Emergent and margin vegetation consisted of grasses, with buckthorn in the upland and overhanging the stream channel in the upstream portion of the site. The upland habitat was a combination of pine and scrub/shrub. No fish or amphibians were observed; however, fish are known to be present in Don Pedro Reservoir.

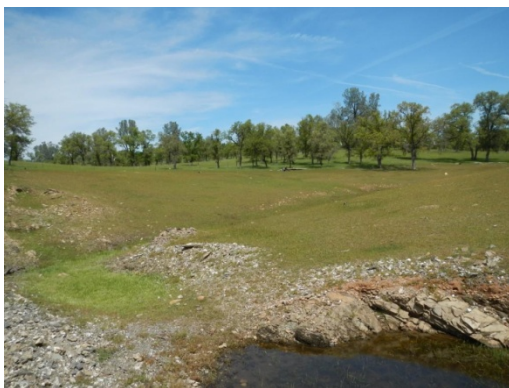
*F22*

F22 is a 145-m-long section of an unnamed perennial tributary to the Big Creek arm of Don Pedro Reservoir, located 10 m north of Don Pedro Reservoir within the FERC Project Boundary. F22 is 9.1 km from the nearest known CRLF occurrence. NWI data for the area depict a riverine, intermittent, streambed, seasonally flooded (R4SBC) wetland feature in the area of the site.

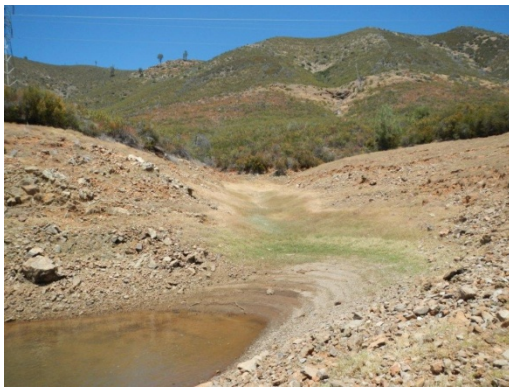
F23 is a 48-m-long section of an ephemeral tributary to the upper bay of Don Pedro Reservoir, below the high water line of Don Pedro Reservoir within the FERC Project Boundary. F23 is 9.6 km from the nearest known CRLF occurrence. NWI data for the area depict a riverine, intermittent, streambed, temporarily flooded (R4SBA) wetland feature in the area of the site.

The site was assessed on June 19, 2012. F23 is in the vicinity of seven other ephemeral tributaries to the upper bay of Don Pedro Reservoir. The bank full width was 7 - 10 m with a depth of 2 - 3 m. The stream gradient was 4 percent. The stream was dry at the time of survey, but it was assumed that no pools would be present. Non-pool habitat was assumed to be riffle during flow conditions. The substrate was made up of soil and grasses that were present throughout the stream channel. Stream banks were gently sloping and vegetated, and become increasingly rocky towards the top of the slope. Emergent and margin vegetation consisted of grasses, with Manzanita and buckthorn in the upland and overhanging the stream channel in some areas. No fish or amphibians were observed; however, fish are known to be present in Don Pedro Reservoir.

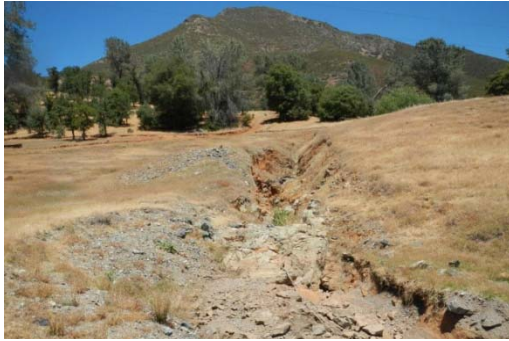
**F24**

F24 is a 77-m-long section of an ephemeral tributary to the upper bay of Don Pedro Reservoir, below the high water line of Don Pedro Reservoir within the FERC Project Boundary. F24 is 9.1 km from the nearest known CRLF occurrence. NWI data for the area depict a riverine, intermittent, streambed, seasonally flooded (R4SBC) wetland feature in the area of the site.

The site was assessed on June 19, 2012. F24 is in east of the group of seven other ephemeral tributaries to the upper bay of Don Pedro Reservoir. The site is adjacent to a large constructed gravel slope and beneath power lines. The bank full width was 3 m with a depth of 1.25 m. The stream gradient was 6 percent. The stream was dry at the time of survey, but it was assumed that pools up to 5m x 2m would be present during flow conditions. Non-pool habitat was assumed to be a mix of cascade and riffle. The substrate was made up of soil and gravel with bedrock in the upstream portion. Stream banks were steeply incised and made up of a combination of soil and gravel with bedrock upstream. Emergent and margin vegetation consisted of desiccated grasses and forbs, with no overhanging vegetation. Upland habitat was a mix of pine and oak with 60 percent canopy cover. No fish or amphibians were observed; however, fish are known to be present in Don Pedro Reservoir.

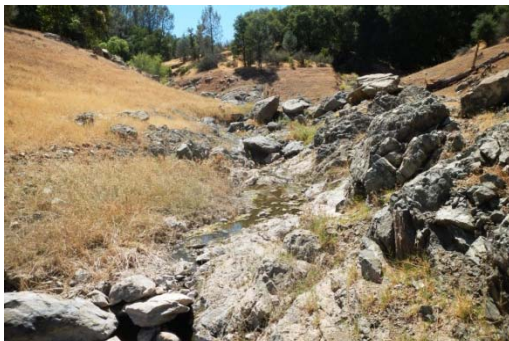
**F25**

F25 is a 54 -m-long section of an unnamed perennial tributary to Don Pedro Reservoir, located below the high water line of Don Pedro Reservoir and within the FERC Project Boundary in Wreck Bay. F25 is 11.7 km from the nearest known CRLF occurrence. NWI data for the area depict a riverine, intermittent, streambed, temporarily flooded (R4SBA) wetland feature in the area.

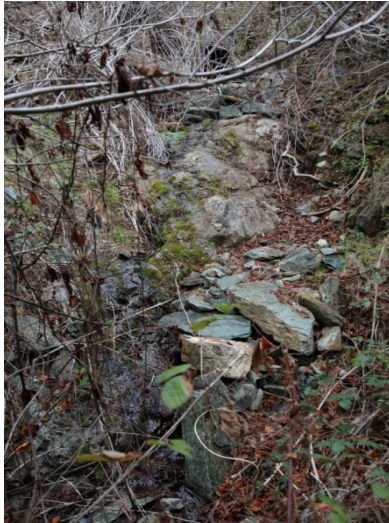
F26 is a 70 m-long section of an unnamed intermittent tributary to Don Pedro Reservoir, located perpendicular to Grizzly Road, partially below the high water line of Don Pedro Reservoir and within the FERC Project Boundary. F26 is 12.1 km from the nearest known CRLF occurrence. NWI data for the area depict a riverine, intermittent, streambed, temporarily flooded (R4SBA) wetland feature from the mouth at the reservoir upstream, including Site F26.

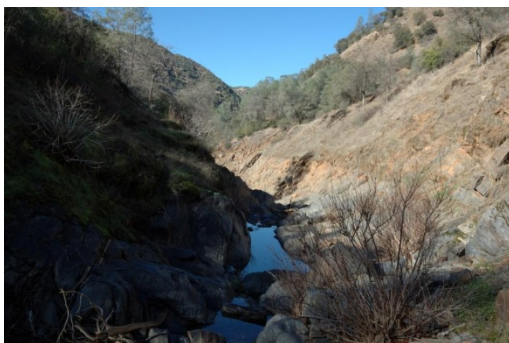
F27 is a 278-m-long section of Deer Creek, a perennial tributary to Don Pedro Reservoir, located south of Wards Ferry Road, partially below the high water line of Don Pedro Reservoir, and within the FERC Project Boundary. F27 is 17 km from the nearest known CRLF occurrence. NWI data for the area depict a riverine, intermittent, streambed, seasonally flooded (R4SBC) in the area of the site.

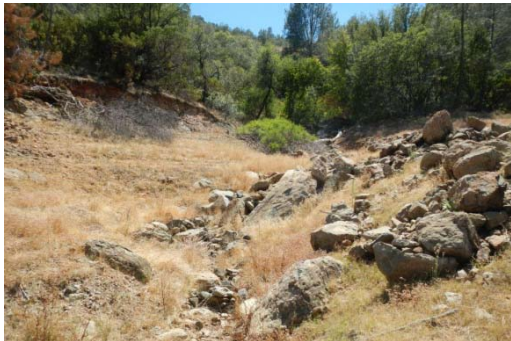
F29 is a 167-m-long section of an unnamed seasonal tributary to Don Pedro Reservoir that crosses SR 49, located below the high water line of Don Pedro Reservoir and within the FERC Project Boundary. F29 is 12.6 km from the nearest known CRLF occurrence. NWI data for the area depict a riverine, intermittent, streambed, temporarily flooded (R4SBA) wetland feature in the area.

The site was assessed on June 18, 2012. F25 is located northwest of sites F51 and F52 on SR 49. The bank full width was estimated at 2 m. The bank full width was estimated at 2 m with a maximum depth of 0.75 m. The stream gradient was 5 percent. The stream was dry at the time of survey, but it was assumed that pools measuring up to 1 m x 1 m during flow conditions. Non-pool habitat was assumed to be a mix of riffle and cascade. The substrate consisted of boulders and cobbles. The banks of the channel had a slightly steep grade with no abrupt drop off or incision and were vegetated to the stream. Emergent and margin vegetation consisted of grasses and forbs with willows overhanging. No amphibian or fish species were observed during the survey. Surrounding upland habitat included mixed oak and pine woodland with 90 percent canopy cover upstream, but no cover downstream.

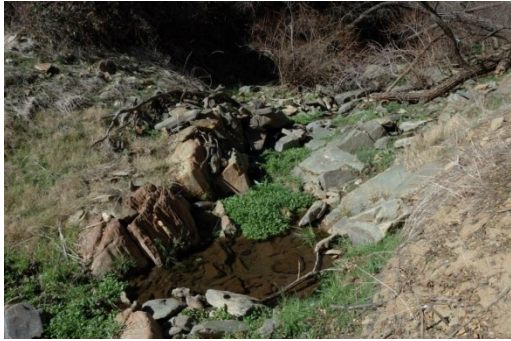
F30 is a 321-m-long section of a perennial tributary to Don Pedro Reservoir, Kanaka Creek, located south of Jacksonville Road, partially below the high water line of Don Pedro Reservoir, and within the FERC Project Boundary. F30 is 14.3 km from the nearest known CRLF occurrence. NWI data for the area depict a riverine, intermittent, streambed, seasonally flooded (R4SBC) wetland feature from the mouth at the reservoir upstream including Site F30.

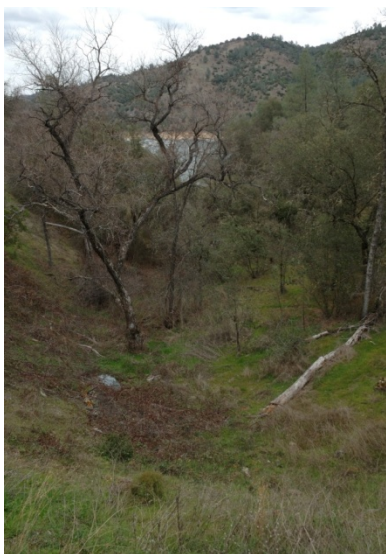
F31 is a 238-m-long section of an unnamed seasonal tributary to Don Pedro Reservoir, located northeast of US Hwy 120/49 near Moccasin Point Marina, partially below the high water line of Don Pedro Reservoir, and within the FERC Project Boundary. F31 is 11.7 km from the nearest known CRLF occurrence. NWI data for the area depict a riverine intermittent, streambed, temporarily flooded (R4SBA) wetland feature upstream of the where the stream joins the river, including Site F31.

consisted of riffle, but the stream was mostly dry at the time of the survey with some seepage at the culvert. Substrate was made up of angular cobble. The stream was channelized with incised banks, especially upstream of the culvert. Downstream of the culvert, no channel was visible at the time of the survey. No emergent vegetation was present, but the margins were vegetated with blackberry and upland grasses. Blackberry was overhanging the stream. Surrounding upland habitat included foothill pine, oak, and Manzanita (*Arctostaphylos* sp.). No fish or amphibians were observed; however, fish are known to be present in Don Pedro Reservoir.

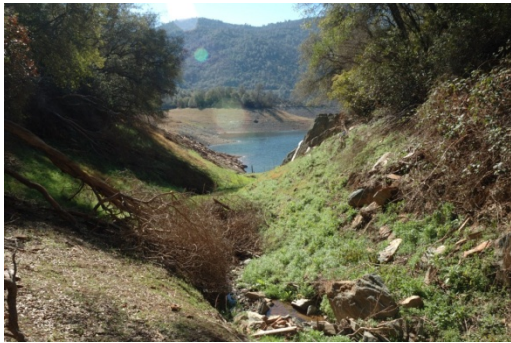
F32 is a 114-m-long section of an unnamed perennial tributary to Don Pedro Reservoir, located southwest of Jacksonville Road, 5 m north of Don Pedro Reservoir, and within the FERC Project Boundary. F32 is 13.7 km from the nearest known CRLF occurrence. NWI data for the area depict a riverine, intermittent, streambed, temporarily flooded (R4SBA) wetland feature upstream of the where the stream joins the river, including Site F32.

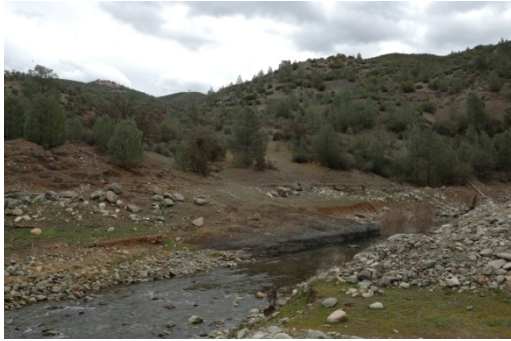
F33 is an 88-m-long section of an unnamed seasonal tributary to Don Pedro Reservoir, located south of Grizzly Road, partially below the high water line of Don Pedro Reservoir, and within the FERC Project Boundary. F33 is 11 km from the nearest known CRLF occurrence. NWI data for the area depict a riverine, intermittent, streambed, temporarily flooded (R4SBA) wetland feature upstream of the where the stream joins the river, including Site F33.

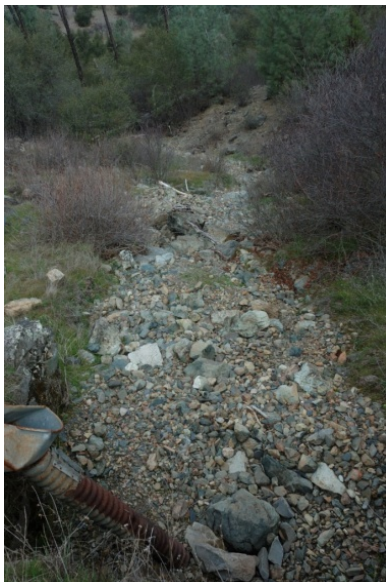
F34 is a 353-m-long section of an unnamed seasonal tributary to Don Pedro Reservoir, located south of Moccasin Creed D Road, partially below the high water line of Don Pedro Reservoir, and within the FERC Project Boundary. F34 is 10.7 km from the nearest known CRLF occurrence. NWI data for the area depict a riverine, intermittent, streambed, temporarily flooded (R4SBA) wetland feature from the mouth at the reservoir upstream including Site F34.

mainly consisted of cobble, but boulders, gravel and large woody debris were also present. Banks were sloping and made up of incised soil. The dominant bank and margin vegetation was a mix of upland grasses and willow, with emergent upland aster present and willows overhanging the stream. Surrounding upland habitat included a mix of foothill pine and oak woodland with willow along the banks of the stream. No fish or amphibians were observed; however, fish are known to be present in Don Pedro Reservoir.

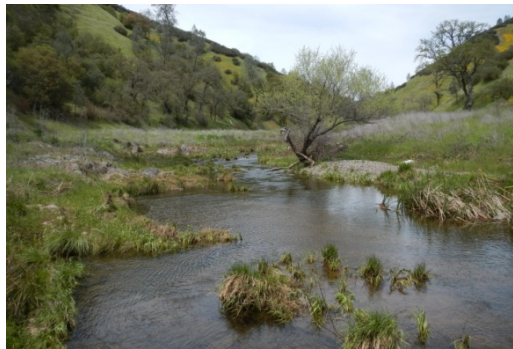
F35 is a 173-m-long section of Woods Creek, located below the high water line of Don Pedro Reservoir within the FERC Project Boundary. F35 is 13.6 km from the nearest known CRLF occurrence. NWI data for the area depict a lacustrine, littoral, unconsolidated shore, seasonally flooded, diked/impounded (L2USCh) wetland feature in the area of the site.

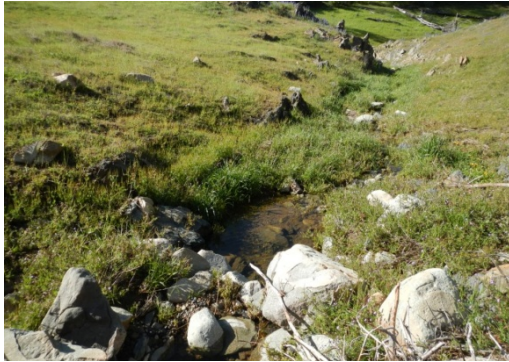
F36 is a 78-m-long section of a seasonal unnamed tributary to Don Pedro Reservoir, located below the high water line of Don Pedro Reservoir within the FERC Project Boundary. F36 is 1.9 km from the nearest known CRLF occurrence. NWI data for the area depict a lacustrine, limnetic, unconsolidated bottom, permanently flooded, diked/impounded (L1UBHh) wetland feature in the area of the site.

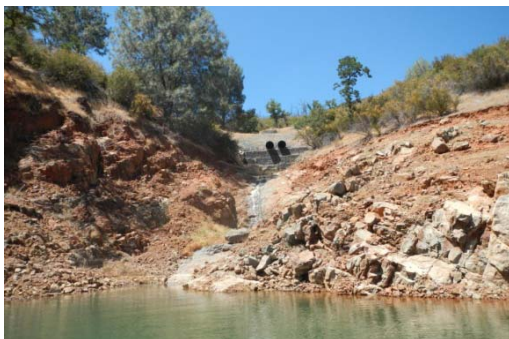
F38 is a 43-m-long section of an ephemeral tributary to the upper bay of Don Pedro Reservoir, below the high water line of Don Pedro Reservoir within the FERC Project Boundary. F38 is 10.1 km from the nearest known CRLF occurrence. NWI data for the area depict a riverine, intermittent, streambed, temporarily flooded (R4SBA) wetland feature in the area of the site.

in some areas. A few scattered oak and pine were also present in the upland. No fish or amphibians were observed; however, fish are known to be present in Don Pedro Reservoir.

F38 does not hold water for at least 20 weeks during the CRLF breeding season and therefore does not represent potential CRLF breeding habitat.

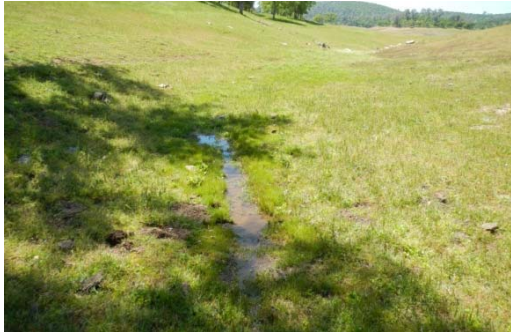
F39 is a 24-m-long section of a seasonal unnamed tributary to Don Pedro Reservoir's 49er Bay, 185 m northwest of Don Pedro Reservoir within the FERC Project Boundary. F39 is 6.4 km from the nearest known CRLF occurrence. NWI data for the area depict a riverine, intermittent, streambed, temporarily flooded (R4SBA) wetland feature in the area of the site.

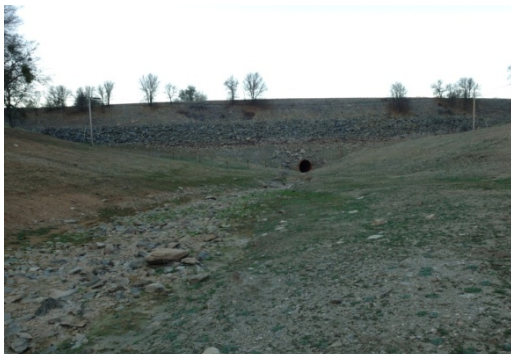
F40 is a palustrine freshwater pond, located south of US Hwy 132, below the high water line of Don Pedro Reservoir and within the FERC Project Boundary. F40 is 4.4 km from the nearest known CRLF occurrence. NWI data for the area depict a palustrine, unconsolidated shore, seasonally flooded, diked/impounded (PUSCh) wetland feature in the area of the site.

The site was assessed on February 8, 2012. F40 is a pond located above a culvert within a gently sloping drainage. The site covers approximately 14,300 m<sup>2</sup>; the maximum observed water depth was greater than 2 m; the bank full depth was greater than 2 m. The pond was dry at the time of assessment. Substrate consisted of soil, silt, bedrock, and boulders. Emergent vegetation consisted of sparse grass and forbs, the dominant vegetation in the area. No vegetation was

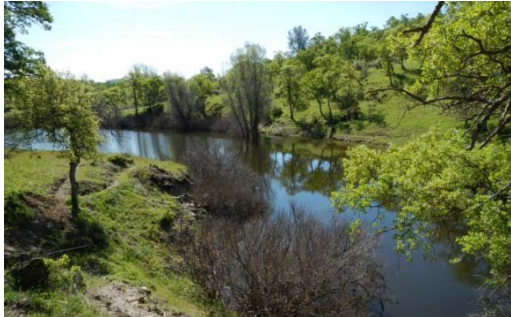
F43 is a palustrine, freshwater pond created by a natural impoundment within West Big Fork Creek, located below the high water line of Don Pedro Reservoir and within the FERC Project Boundary. F43 is 9.6 km from the nearest known CRLF occurrence. NWI data for the area depict a palustrine, unconsolidated bottom, permanently flooded, diked/impounded (PUBHh) wetland feature in the area of the site.

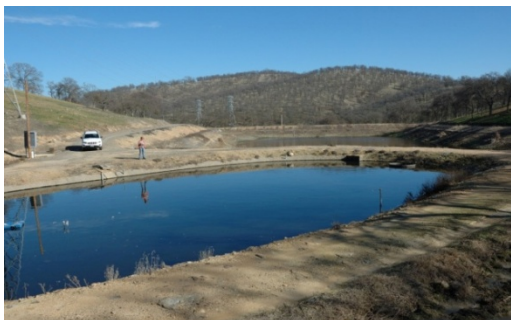
F45 is a perennial, freshwater pond, located southwest of Bond Flat Road, 790 m south of Don Pedro Reservoir, and within the FERC Project Boundary. F45 is 7.3 km from the nearest known CRLF occurrence. NWI data for the area depict a palustrine, unconsolidated bottom, permanently flooded, diked/impounded (PUBHh) wetland feature in the area of the site.

F45 holds water for at least 20 weeks during the CRLF breeding season and therefore represents potential CRLF breeding habitat. However, lack of overhanging and emergent or aquatic vegetation diminishes the potential suitability of this site.

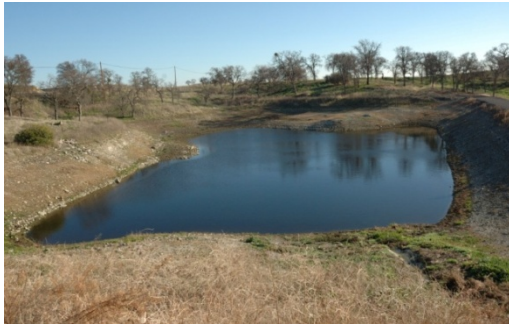
F46 is a perennial, freshwater pond, located southwest of Bonds Flat Road, 175 m west of Don Pedro Reservoir, and within the FERC Project Boundary. F45 is 8.9 km from the nearest known CRLF occurrence. NWI data for the area depict a palustrine, unconsolidated bottom, semipermanently flooded, excavated (PUBFx) wetland feature in the area of the site.

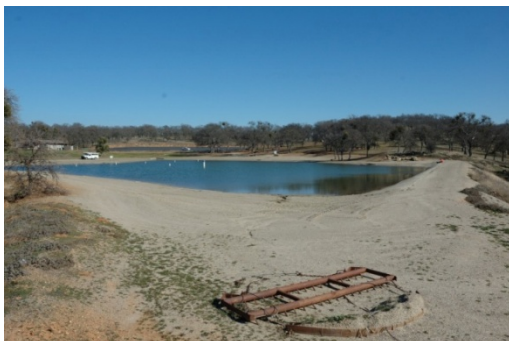
F47 is a perennial, freshwater pond, located north of Bonds Flat Road, 305 m south of Don Pedro Reservoir, and within the FERC Project Boundary. F46 is 6.7 km from the nearest known CRLF occurrence. NWI data for the area depict a palustrine, unconsolidated bottom, permanently flooded, diked/impounded (PUBHh) wetland feature in the area of the site.

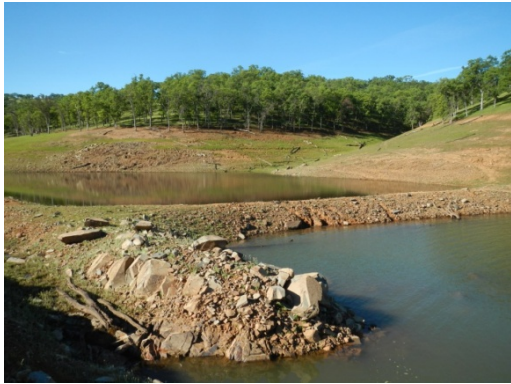
F48 is a perennial, freshwater pond created by an impoundment in Lucas Gulch, located below the high water line of Don Pedro Reservoir, within the FERC Project Boundary. F48 is 4.5 km from the nearest known CRLF occurrence. NWI data for the area depict a palustrine, unconsolidated bottom, permanently flooded, diked/impounded (PUBHh) wetland feature in the area of the site.

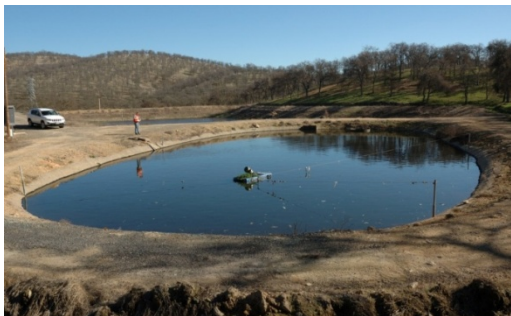
F49 is a perennial, freshwater pond, located southwest of Bond Flat Road, 710 m south of Don Pedro Reservoir, and within the FERC Project Boundary. F49 is 7.4 km from the nearest known CRLF occurrence. NWI data for the area depict a palustrine, unconsolidated bottom, permanently flooded, diked/impounded (PUBHh) wetland feature in the area of the site.

F49 holds water for at least 20 weeks during the CRLF breeding season and therefore represents potential CRLF breeding habitat. However, lack of overhanging and emergent or aquatic vegetation diminishes the potential suitability of this site.

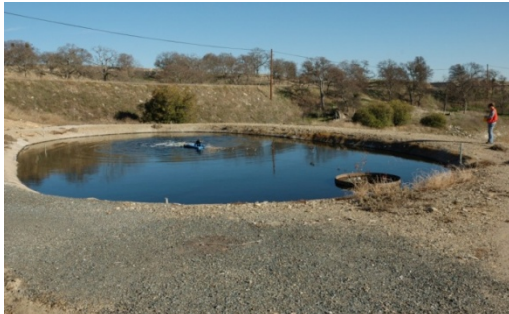
F50 is a perennial, freshwater pond, located west of Bond Flat Road, 200 m west of Don Pedro Reservoir, and within the FERC Project Boundary. F50 is 8.9 km from the nearest known CRLF occurrence. NWI data for the area depict a palustrine, unconsolidated bottom, semipermanently flooded, excavated (PUBFx) wetland feature in the area of the site.

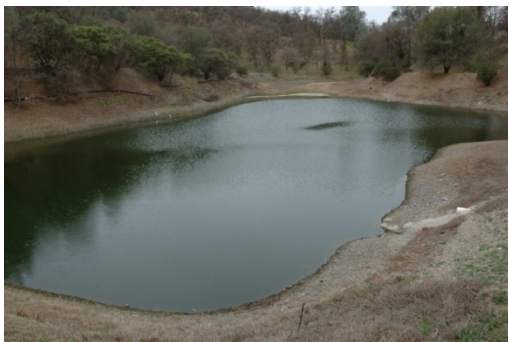
F51 is a perennial, freshwater pond, located north of SR49, 195 m southeast of Don Pedro Reservoir, and within the FERC Project Boundary. F51 is 12.1 km from the nearest known CRLF occurrence. NWI data for the area depict a palustrine, unconsolidated bottom, permanently flooded, diked/impounded (PUBHh) wetland feature in the area of the site.

some algae was observed at the inflow. Upland habitat was made up of oak woodland, foothill pine, and Manzanita.

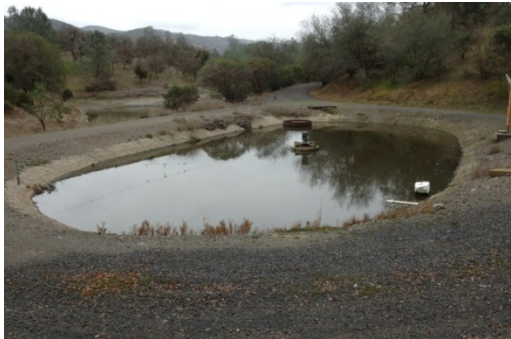
F52 is a perennial, freshwater pond, located north of SR49, 190 m southeast of Don Pedro Reservoir, and within the FERC Project Boundary. F52 is 12.2 km from the nearest known CRLF occurrence. NWI data for the area depict a palustrine, unconsolidated bottom, permanently flooded, diked/impounded (PUBHh) wetland feature in the area of the site.

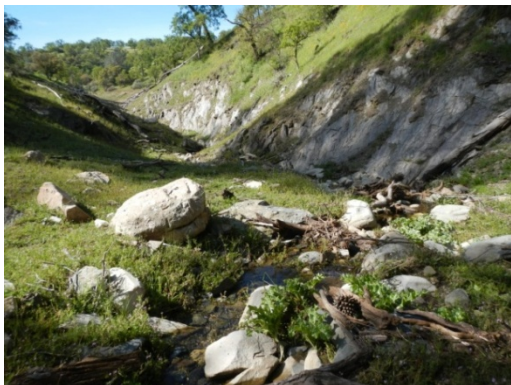
F53 is a 62-m-long section of a seasonal unnamed tributary to Don Pedro Reservoir, 8 m northwest of Don Pedro Reservoir and within the FERC Project Boundary. F53 is within 1.4 km from the nearest known CRLF occurrence. NWI data for the area depict a palustrine, scrub-shrub temporarily flooded (PSSA) wetland feature in the area of the site

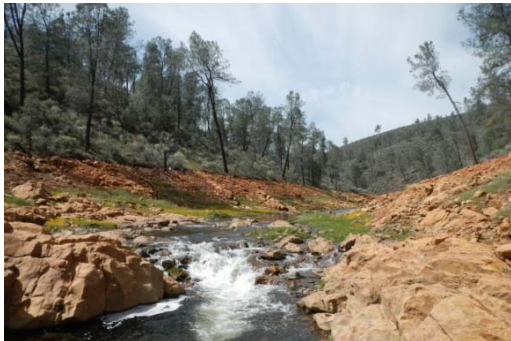
F54 is a 335-m-long section of Sixbit Gulch, a perennial tributary to Don Pedro Reservoir, located mostly below the high water line of Don Pedro Reservoir within the FERC Project Boundary. F54 is 14 km from the nearest known CRLF occurrence. NWI data for the area depict a palustrine, scrub-shrub temporarily flooded (PSSA) wetland feature in the area of the site.

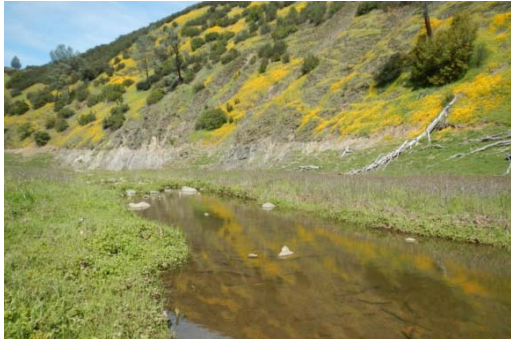
**F60**

F60 is a seasonal, freshwater pond, located below the high water line of Don Pedro Reservoir, within the FERC Project Boundary. F60 is 13.9 km from the nearest known CRLF occurrence. NWI data for the area depict a palustrine, emergent, temporarily flooded, diked/impounded (PEMAh) wetland feature in the area of the site.

F60 holds water for at least 20 weeks during the CRLF breeding season and therefore represents potential CRLF breeding habitat.

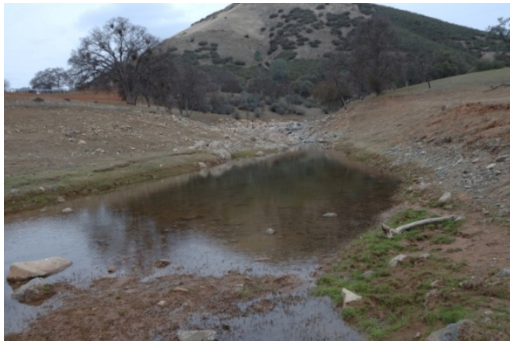
**F61**

F61 is a 47-m-long section of an unnamed perennial tributary to Don Pedro Reservoir, located west of Marshes Flat Road, partially below the high water line of Don Pedro Reservoir, and within the FERC Project Boundary. F61 is 2.8 km from the nearest known CRLF occurrence and is not within the USFWS Critical Habitat unit. NWI data for the area depict a palustrine, emergent, saturated (PEMB) wetland feature in the area of the site.

F61 holds water for at least 20 weeks during the CRLF breeding season and therefore represents potential CRLF breeding habitat. However, lack of overhanging vegetation diminishes the potential suitability of this site.

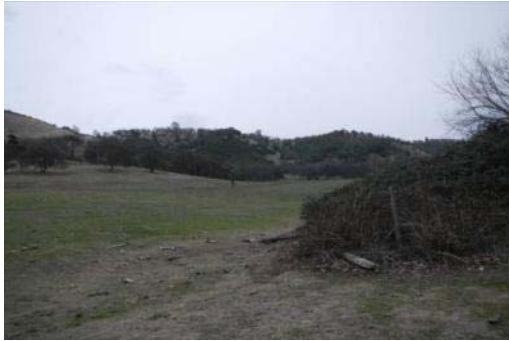
*F62, F63, and F64*

F62, F63, and F64 are all upland areas located west of Marshes Flat Road, adjacent to Don Pedro Reservoir, and south of Hatch Creek. The sites were labeled as emergent wetlands on the NWI map and were therefore included in the assessment; however, no aquatic feature currently occurs at the mapped location. Upland grassy slopes occurred along the shoreline in this location.

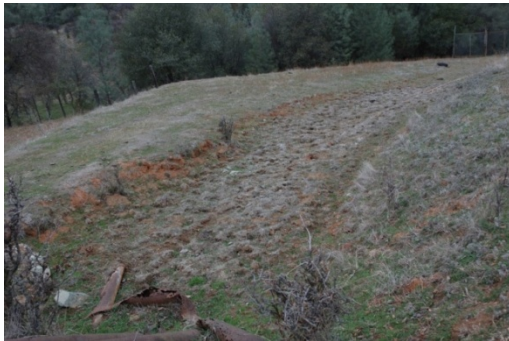
*F65*

F65 is an ephemeral, freshwater pond, located adjacent to Sunset Oaks Lane. F65 is 2.9 km from the nearest known CRLF occurrence. NWI data for the area depict a palustrine, emergent, saturated (PEMB) wetland feature in the area of the site.

F65 does not hold water for at least 20 weeks during the CRLF breeding season and therefore does not represent potential CRLF breeding habitat.

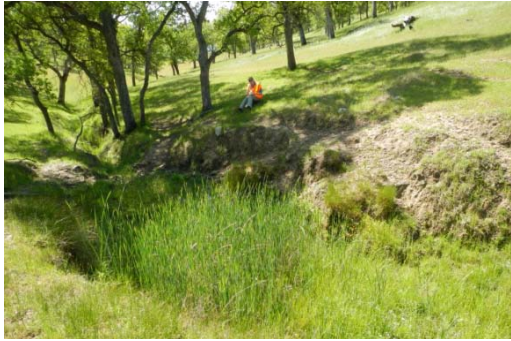
F66 is a 35-m-long section of a seasonal unnamed tributary to Don Pedro Reservoir, located 120 m from Don Pedro Reservoir within the FERC Project Boundary. F66 is 7.3 km from the nearest known CRLF occurrence. NWI data for the area depict a palustrine, emergent, saturated (PEMB) wetland feature in the area of the site.

F66 does not hold water for at least 20 weeks during the CRLF breeding season and therefore does not represent potential CRLF breeding habitat.

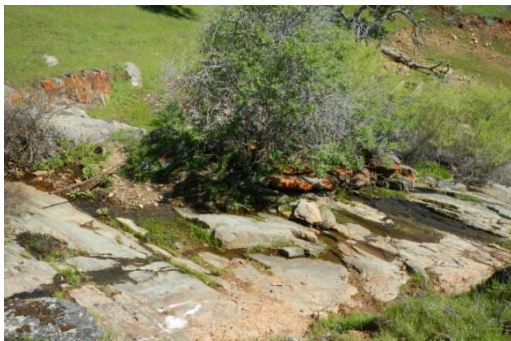
F68 is a 34-m-long section of a seasonal unnamed tributary to Don Pedro Reservoir, located partially below the high water line of Don Pedro Reservoir within the FERC Project Boundary. F68 is 7.1 km from the nearest known CRLF occurrence. NWI data for the area depict a palustrine, emergent, saturated (PEMB) wetland feature in the area of the site.

F68 does not hold water for at least 20 weeks during the CRLF breeding season and therefore does not represent potential CRLF breeding habitat.

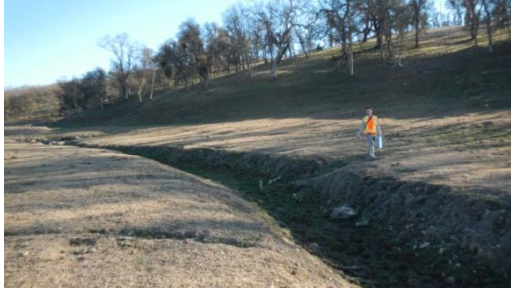
**F69**

F69 is a 658-m-long section of an unnamed perennial tributary to Don Pedro Reservoir, located north of Bonds Flat Road, partially below the high water line of Don Pedro Reservoir, and within the FERC Project Boundary. F69 is 5.1 km from the nearest known CRLF occurrence. NWI data for the area depict a palustrine, emergent, temporarily flooded, diked/impounded (PEMAh) wetland feature in the area of the site.

F69 holds water for at least 20 weeks during the CRLF breeding season and therefore represents potential CRLF breeding habitat

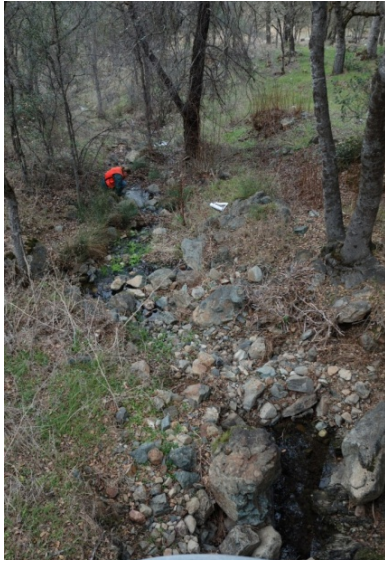
F73 is a 43-m-long section of an unnamed intermittent tributary to Don Pedro Reservoir, located north of Moccasin Creek D Road, partially below the high water line of Don Pedro Reservoir, and within the FERC Project Boundary. F73 is 11.5 km from the nearest known CRLF occurrence. NWI data for the area do not show a wetland feature in the area of the site.

F73 does not hold water for at least 20 weeks during the CRLF breeding season and therefore does not represent potential CRLF breeding habitat.

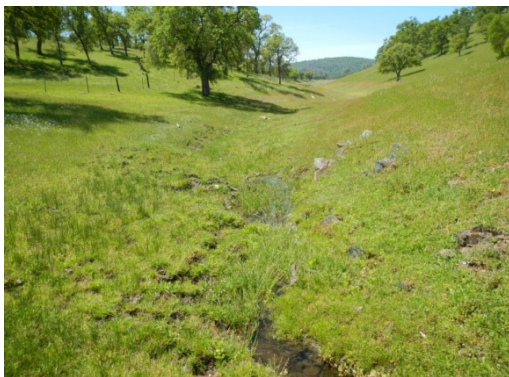
F75 is a 49-m-long section of a seasonal unnamed tributary to Don Pedro Reservoir, located 110 m northeast of Don Pedro Reservoir within the FERC Project Boundary. F75 is 6.7 km from the nearest known CRLF occurrence. NWI data for the area do not show a wetland feature at the site.

It is unknown if F75 holds water for at least 20 weeks during the CRLF breeding season and therefore may represent potential CRLF breeding habitat. However, lack of overhanging vegetation and the presence of American bullfrogs diminish the potential suitability of this site.

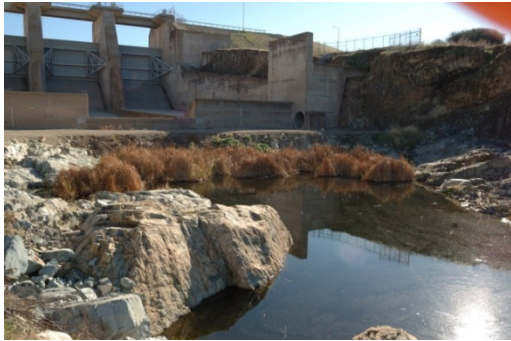
F77 is a series of perennial, freshwater ponds, located east of Bonds Flat Road, 110 m west of Don Pedro Reservoir, within the FERC Project Boundary. F77 is 8.7 km from the nearest known CRLF occurrence. NWI data for the area do not show a wetland feature in the area of the site.

F77 holds water for at least 20 weeks during the CRLF breeding season and therefore represents potential CRLF breeding habitat. However, lack of overhanging vegetation and the presence of American bullfrogs diminish the potential suitability of this site.

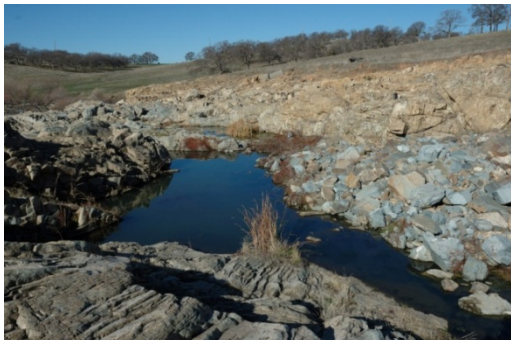
F78 is a perennial, freshwater pond, located west of Bonds Flat Road, 200 m west of Don Pedro Reservoir, within the FERC Project Boundary. F78 is 8.8 km from the nearest known CRLF occurrence. NWI data for the area do not show a wetland feature in the area of the site.

F78 holds water for at least 20 weeks during the CRLF breeding season and therefore represents potential CRLF breeding habitat. However, the presence of American bullfrogs diminishes the potential suitability of this site.

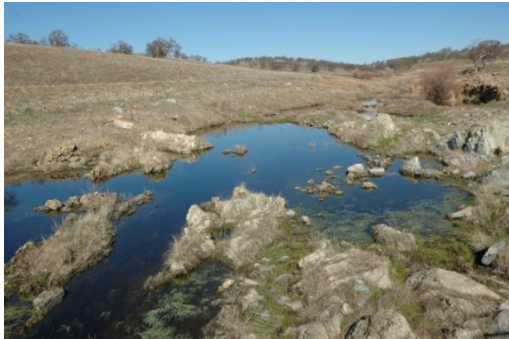
*F80*

F80 is a perennial, freshwater pond, located southwest of Bonds Flat Road, 480 m southwest of Don Pedro Reservoir, within the FERC Project Boundary. F80 is 9 km from the nearest known CRLF occurrence. NWI data for the area do not show a wetland feature in the area of the site.

F80 holds water for at least 20 weeks during the CRLF breeding season and therefore represents potential CRLF breeding habitat. However, the presence of American bullfrogs and the high potential of fish presence diminish the potential suitability of this site.

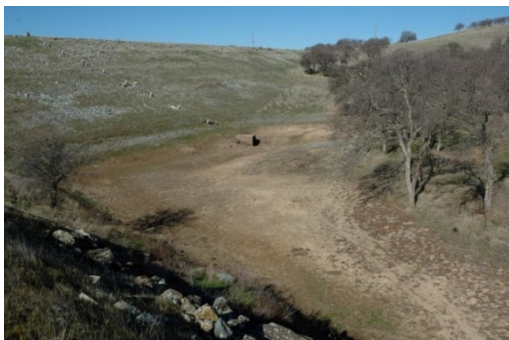
*F81*

F81 is a man-made, freshwater stock pond above a small dam, located southwest of Bonds Flat Road, 800 m southwest of Don Pedro Reservoir, within the FERC Project Boundary. F81 is 9.2 km from the nearest known CRLF occurrence. NWI data for the area do not show a wetland feature in the area of the site.

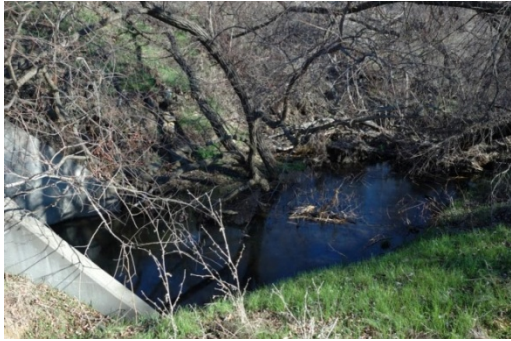
*F84*

F84 is a 357-m-long section of a Big Creek, a perennial tributary to Don Pedro Reservoir that crosses and is adjacent to La Grange Road, within the FERC Project Boundary. F84 is 7 km from the nearest known CRLF occurrence. NWI data for the area do not show a wetland feature in the area of the site.

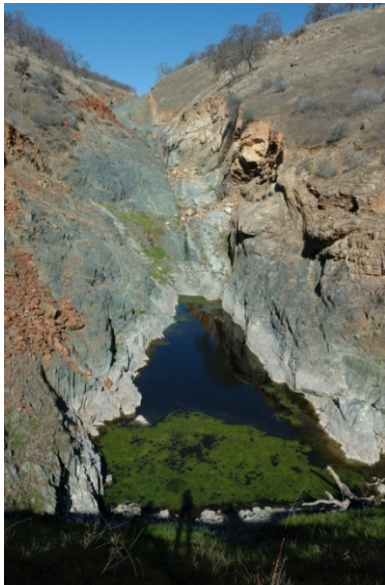
*F89*

F89 is a perennial, freshwater pond, located within a spillway, 1,800 m south of Don Pedro Reservoir, within the FERC Project Boundary. F89 is 9 km from the nearest known CRLF occurrence. NWI data for the area do not show a wetland feature in the area of the site.

The site was assessed on February 8, 2012, but could not be accessed by foot and was assessed from 50 ft. away on the fill dam. F89 is located southeast of site F88 in a deeply incised canyon, and is dammed by fill on the south end. The site covers approximately 235 m<sup>2</sup>; the maximum observed water depth was greater than 2 m; the bank full depth was greater than 3 m. The substrate consisted entirely of bedrock. No emergent or overhanging vegetation was present. Upland habitat was blue oak pastureland above a steep ravine and rock cliffs.

F89 holds water for at least 20 weeks during the CRLF breeding season and therefore represents potential CRLF breeding habitat. However, lack of overhanging and emergent or aquatic vegetation diminishes the potential suitability of this site.

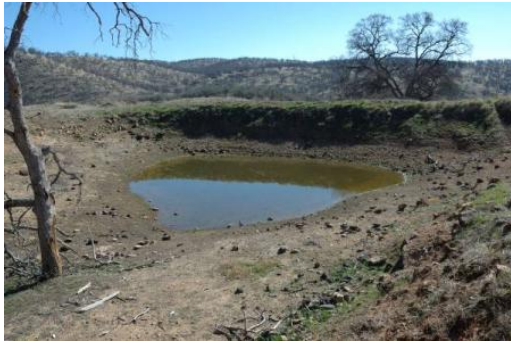
F90 is a perennial, freshwater stock pond, located 1,200 m south of Don Pedro Reservoir, within the FERC Project Boundary. F90 is 8.6 km from the nearest known CRLF occurrence. NWI data for the area do not show a wetland feature in the area of the site.

The site was assessed on February 8, 2012. F90 is not located near any other sites. The site covered approximately 100 m<sup>2</sup> at the time of the survey, but is assumed to cover approximately 570 m<sup>2</sup> when full. The maximum observed water depth was 0.75 m and the bank full depth was estimated to be 3 m. Substrate consisted of soil, cobble, and gravel. No emergent or overhanging vegetation were present at the site, but sparse clumps of grass occupied the margin. Upland habitat was made up of blue oak rangeland, cudweed, dried aster, and buckthorn with approximately 1 percent canopy cover on the west side of the site. A horsehair snake (*Nematomorpha* sp.) was observed at the site during the survey.

F90 holds water for at least 20 weeks during the CRLF breeding season and therefore represents potential CRLF breeding habitat. However, lack of overhanging and emergent or aquatic vegetation diminishes the potential suitability of this site.
