**ENDANGERED SPECIES ACT-LISTED  
AMPHIBIANS - CALIFORNIA  
RED-LEGGED FROG  
STUDY REPORT  
DON PEDRO PROJECT  
FERC NO. 2299**

**Prepared for:**  
**Turlock Irrigation District – Turlock, California**  
**Modesto Irrigation District – Modesto, California**

**Prepared by:**  
**HDR Engineering, Inc.**

**January 2013**

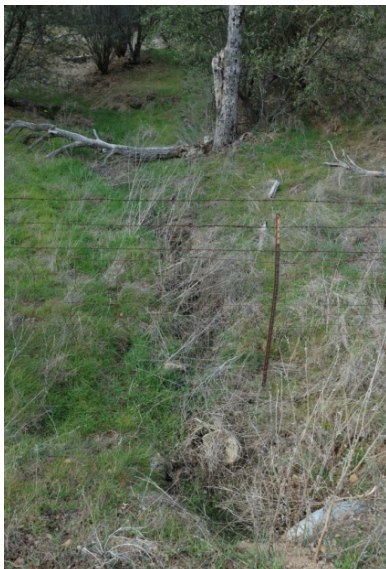
F91 is a 117-m-long section of an unnamed seasonal tributary to Don Pedro Reservoir, located west of Moccasin Creek D Road, 235 m southeast of Don Pedro Reservoir within the FERC Project Boundary. F91 is 10.5 km from the nearest known CRLF occurrence. NWI data for the area do not show a wetland feature in the area of the site.

Upland habitat was a mix of blue oak and foothill pine woodland with 20 percent canopy cover at the site.

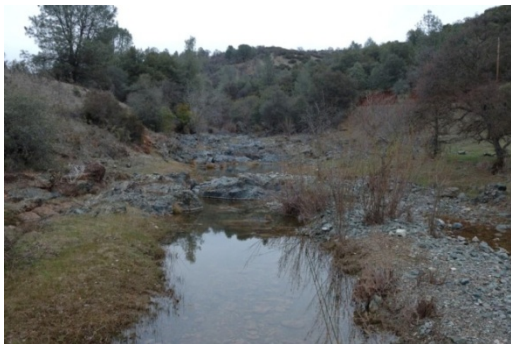
*F100*

F100 is a 167-m-long section of Hatch Creek, a perennial tributary to Don Pedro Reservoir that crosses Sunset Oaks Lane, 235 m southeast of Don Pedro Reservoir within the FERC Project Boundary. F100 is 3 km from the nearest known CRLF occurrence. NWI data for the area do not show a wetland feature in the area of the site.

Pools measuring up to 6 m x 15 m and 0.8 m deep were present at the site. The substrate was made up of subangular cobble and boulder. The banks consisted of gently sloping soil covered in burrows. Emergent vegetation consisted of grasses, with willows overhanging the site in the margin. Willows were the dominant species at the site. Upland habitat was oak woodland with chaparral. Trout, approximately 6 inches long, were observed at the time of the survey.
