**ENDANGERED SPECIES ACT-LISTED
AMPHIBIANS - CALIFORNIA
TIGER SALAMANDER
STUDY REPORT
DON PEDRO PROJECT
FERC NO. 2299**

Prepared for:
Turlock Irrigation District – Turlock, California
Modesto Irrigation District – Modesto, California

Prepared by:
HDR Engineering, Inc.

January 2013

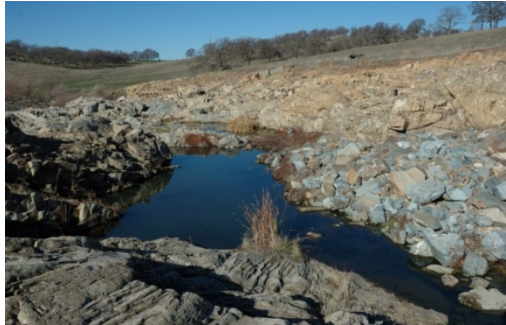
F78 is a perennial, freshwater pond, located west of Bonds Flat Road, 200 m west of Don Pedro Reservoir, within the FERC Project Boundary. NWI data for the area do not show a wetland feature in the area of the site. SSURGO data classify soils in this location as Whiterock-Rock outcrop-Auburn.

The nearest known CTS occurrence is located 2.8 miles southeast. F78 holds water for at least 10 weeks during the CTS breeding season and may represent potentially suitable CTS breeding habitat. The site is situated in suitable upland habitat with underground retreats present.

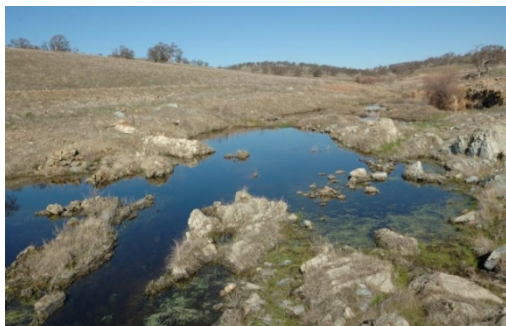
F80 is a perennial, freshwater pond, located southwest of Bonds Flat Road, 480 m southwest of Don Pedro Reservoir, within the FERC Project Boundary. NWI data for the area do not show a wetland feature in the area of the site. SSURGO data classify soils in this location as Whiterock-Rock outcrop-Auburn.

The nearest known CTS occurrence is located 2.8 miles east. F80 holds water for at least 10 weeks during the CTS breeding season and may represent potentially suitable CTS breeding habitat. The site is situated in suitable upland habitat with underground retreats present.
