**WETLAND HABITATS ASSOCIATED WITH  
DON PEDRO RESERVOIR  
STUDY REPORT  
DON PEDRO PROJECT  
FERC NO. 2299**

**Prepared for:**  
**Turlock Irrigation District – Turlock, California**  
**Modesto Irrigation District – Modesto, California**

**Prepared by:**  
**HDR Engineering, Inc.**

**January 2013**

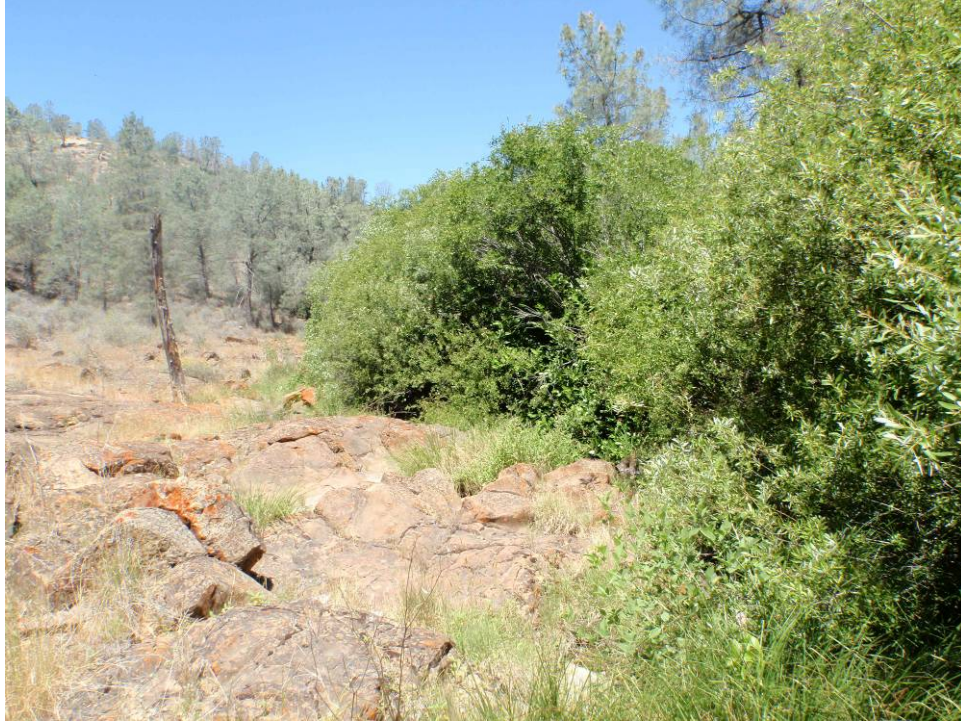
**Photo 1.** Sixbit Gulch Large bedrock and boulder outcrops occurred along the perimeter of the wetland in this moderately confined drainage.

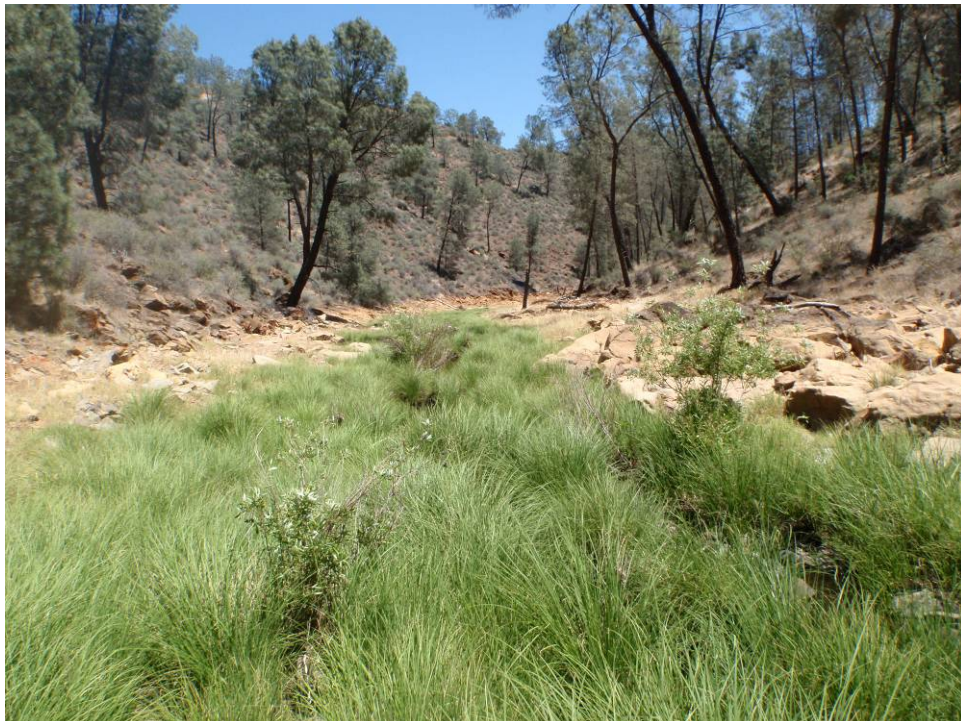
**Photo 2.** Sixbit Gulch Hummocks of naked sedge (*Carex nudata*) intermixed with Sonoma hedgenettle (*Stachys stricta*), springseep monkeyflower (*Mimulus guttatus*), and an occasional red willow (*Salix laevigata*).

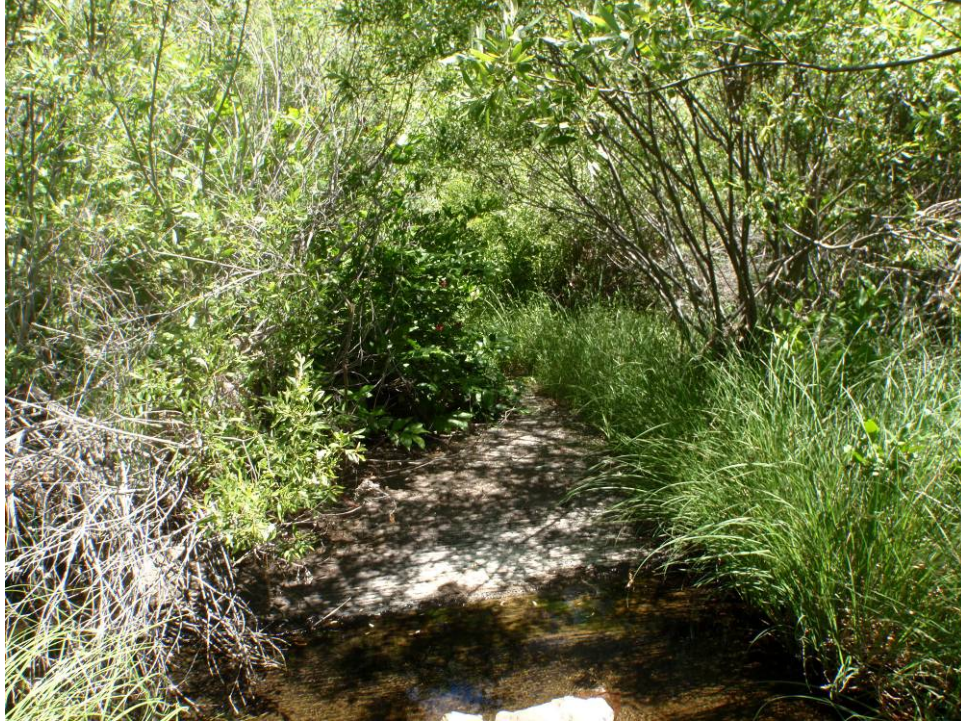
**Photo 3.** Sixbit Gulch A paved road crossed the channel near transect SG-06, which appears to be unused due to dense vegetation coverage. The road provides an opening in the dense riparian shrubs for sedge, springseep monkey flower (*Mimulus guttatus*) and Sonoma hedgenettle (*Stachys stricta*) to flourish

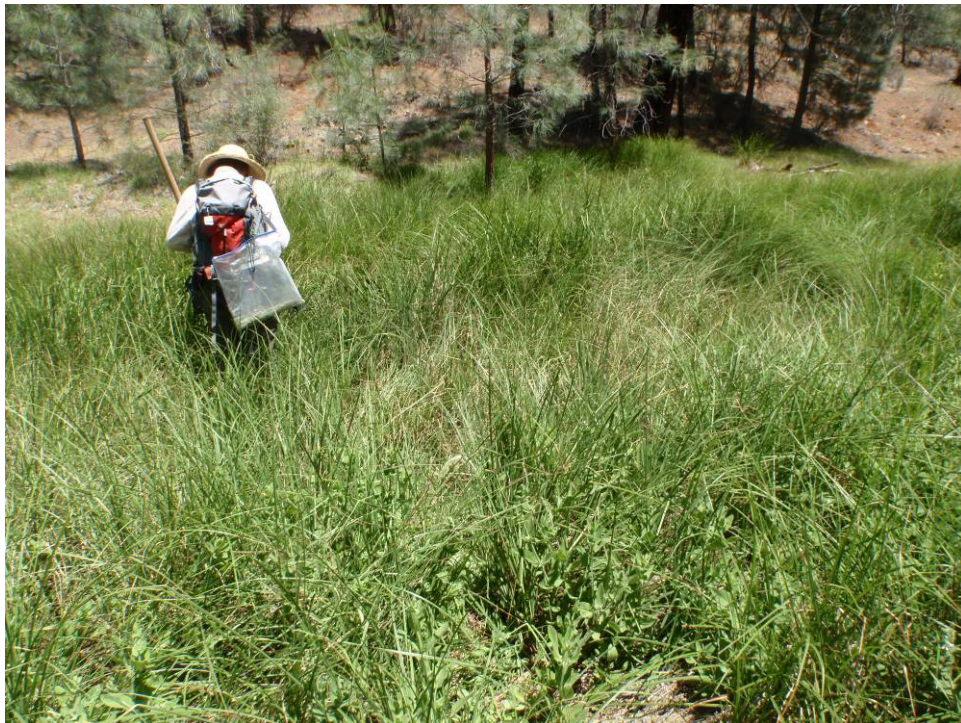
**Photo 4.** Poorman's Gulch Shallow soils overlay bedrock substrates, with hummocks of naked sedge and mixed herbs.

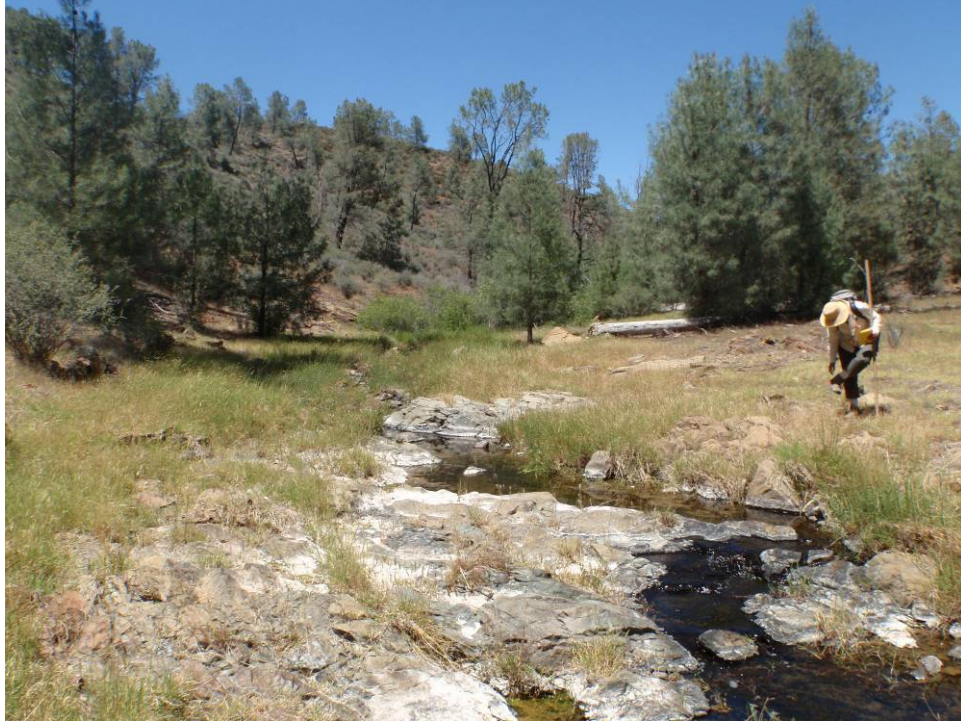
**Photo 5.** Poorman's Gulch Exposed bedrock supports perennial ryegrass (*Lolium perenne*), and annual beardgrass (*Polypogon monspeliensis*) at the perimeter.

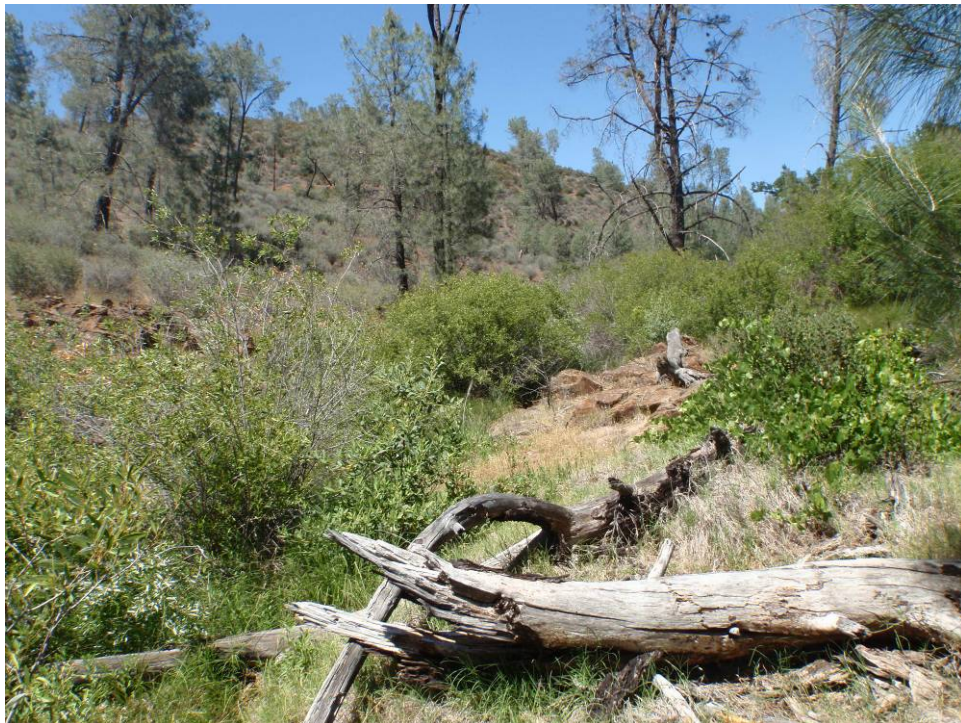
**Photo 6.** Poorman's Gulch Patches of red willow and spice bush (*Calycanthus occidentalis*) alternated with naked sedge hummocks and open bedrock, which occurred more frequently around pools located at the upstream end of the Assessment Area (AA) .

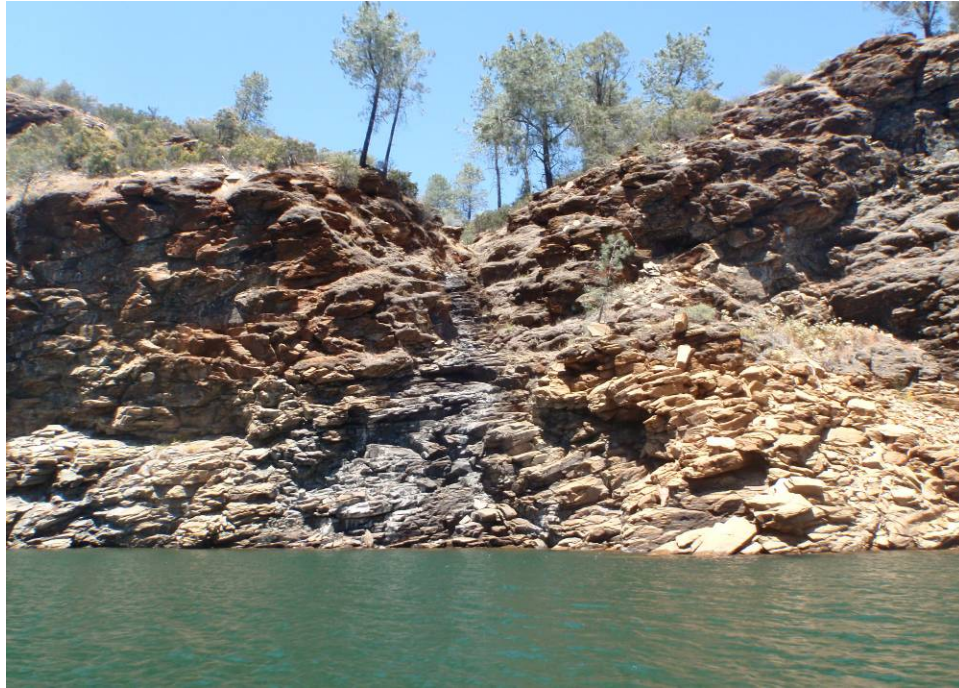
conditions (Attachment A, Figure 3). Survey from the boat on the Reservoir confirmed that no wetland conditions are present (Attachment B, Photo 7); this is supported by botanical surveys performed for Study Reports TR-01, Special Status Plants; TR-02, ESA- and CESA-Listed Plants Study; and TR-04, Noxious Weed Survey (TID/MID 2013). No wetland assessment was performed at this site.

**Photo 7.** Three Springs Gulch Reconnaissance efforts using aerial photography and boat survey indicated that wetlands are not supported by Three Springs Gulch within or near the Project Boundary.

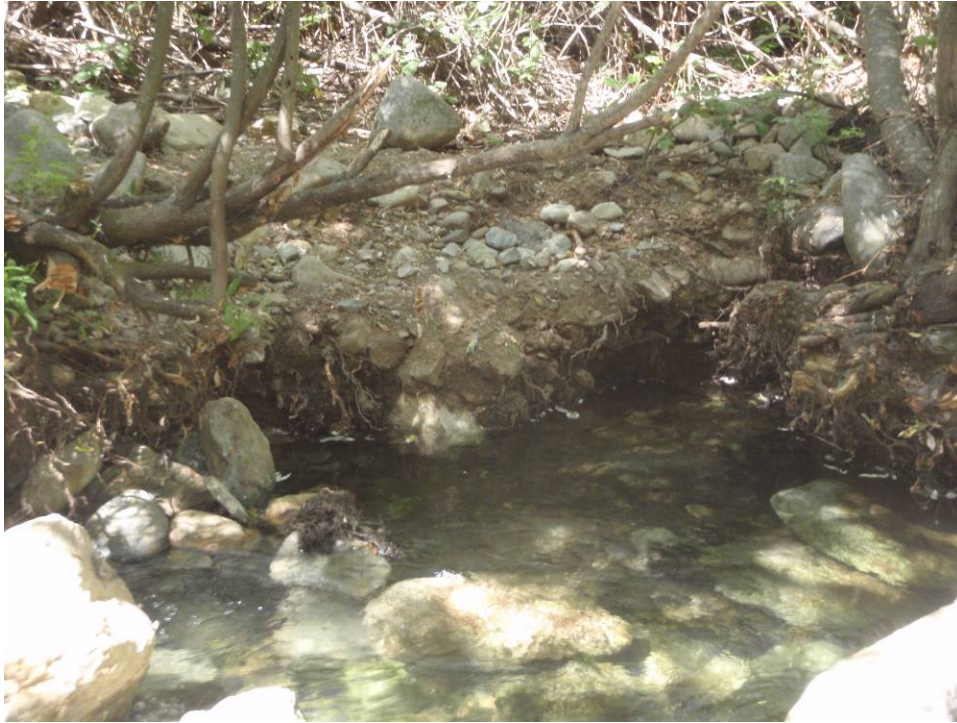
The creek is accessed frequently by fishermen, with trails weaving through upslope Himalayan blackberries, black mustard (*Brassica nigra*), and other weedy species. The river left bank just upstream of the Hatchery discharge has a short erosional area, where the dirt bank has collapsed (Attachment B, Photo 9), although established root systems on either side will prevent extension of the bank failure. The Highway 120 Bridge crosses over the creek near Transect MC-12, but does not create a break in riparian vegetation connectivity. Large rip-rap is present directly downstream of the bridge pillars on both sides, and some concrete paving (about 12 square meters) occurs in the channel. The paving does not appear to have a negative impact, with small sediments and aquatic plants covering a large portion of it.

**Photo 9.** Moccasin Creek The creek is accessed frequently by fishermen, with trails throughout upland areas and into the riparian zone. The left bank just upstream of the discharge point had a short erosional area, where the dirt bank has collapsed; however the established root systems have stabilized the soil and prevented complete bank failure

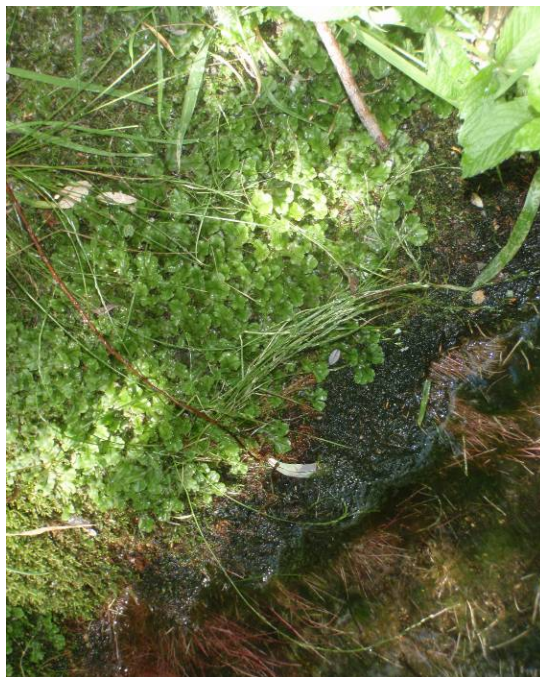
Exposed alder roots within the wetted edge, diverse aquatic vegetation, and abundant bryophytes (non-vascular plants such as mosses and liverworts) on the banks indicate a healthy system with minimal fluctuation in flows (Attachment B, Photo 10). Macroinvertebrates, passerines, and fish were observed at the time of the survey, and no bullfrogs were observed.

**Photo 10.** Moccasin Creek Exposed alder roots at the wetted edge, diverse aquatic vegetation, and abundant bryophytes on the banks indicated a healthy system with minimal fluctuation in flows.

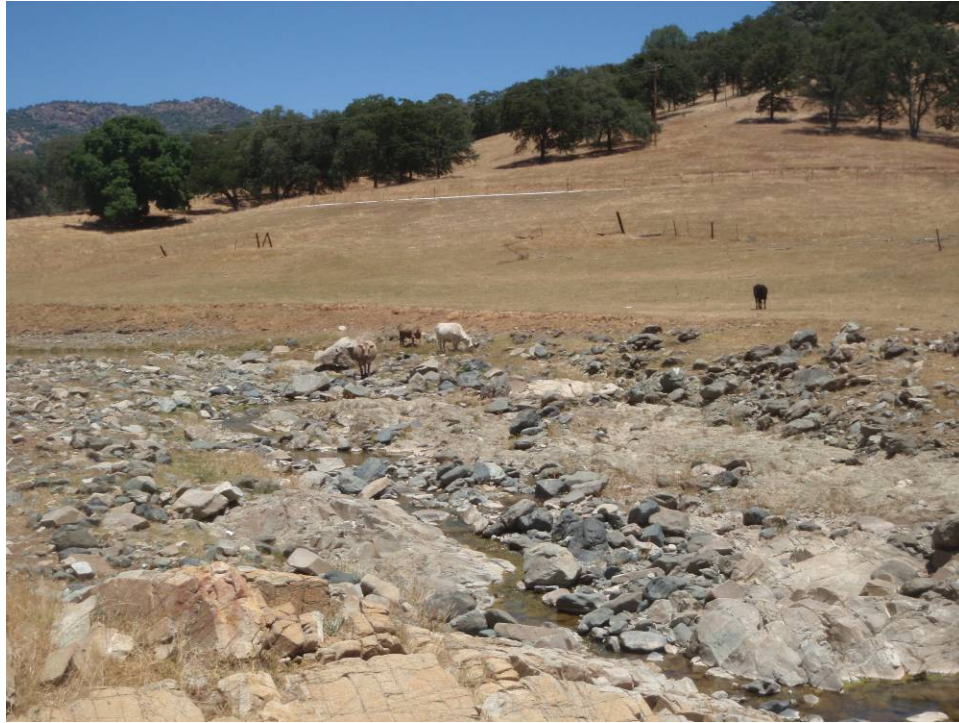
**Photo 11. Hatch Creek** Cattle grazing was present within Hatch Creek and surrounding upland areas

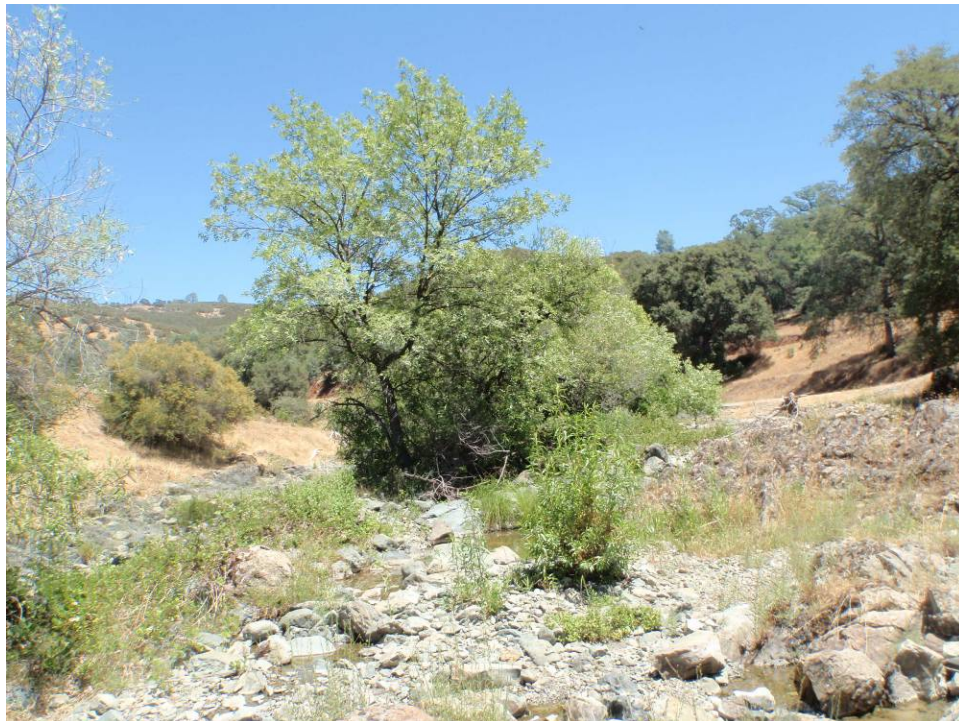
**Photo 12. Hatch Creek** Red willow, mule fat (*Baccharis salicifolia*), and spice bush were present between stretches of open, rocky banks and pools. Himalayan blackberry (*Rubus armeniacus*) was present on many of the banks under canopy of red willow or upland canyon live oaks (*Quercus chrysolepis*)

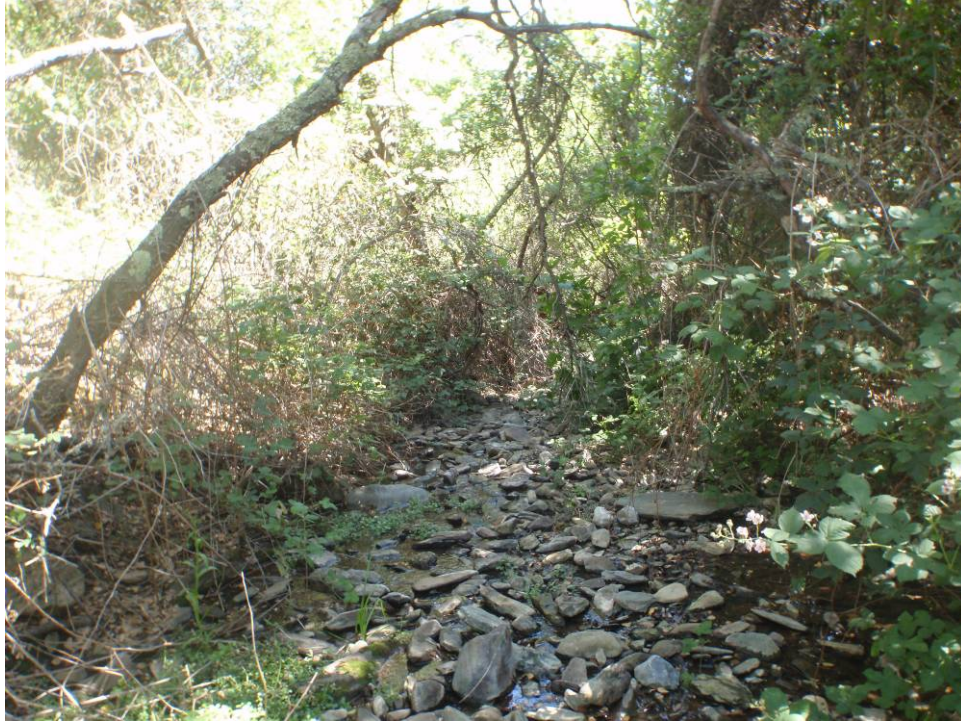
**Photo 15.** Kanaka Creek Downstream of the highway, multiple vertical layers of vegetation were present in horizontally diverse patches

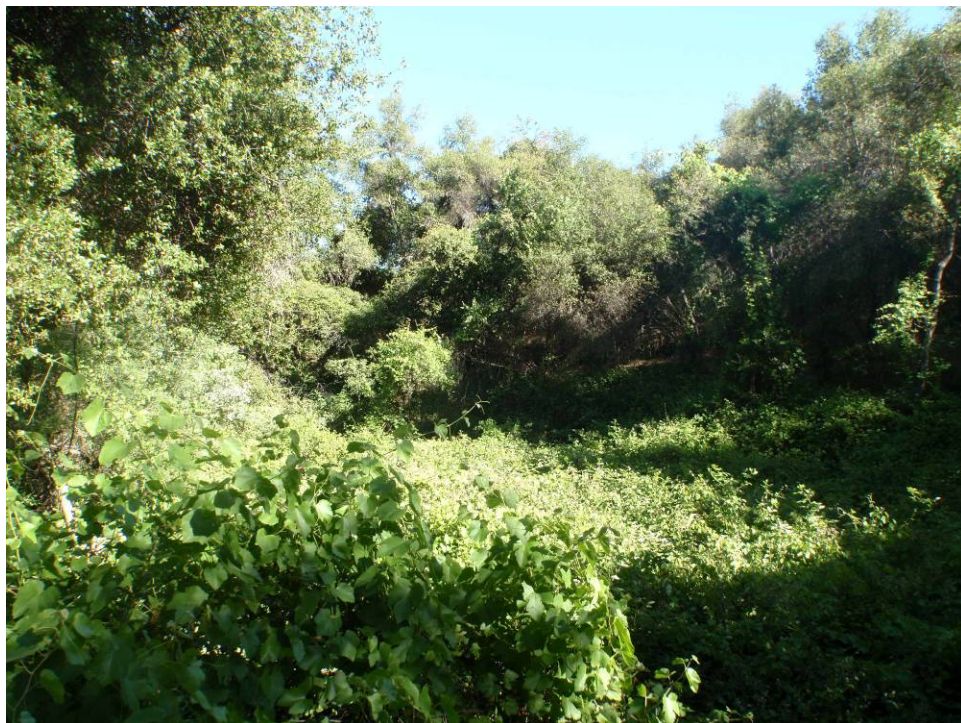
**Photo 16.** Kanaka Creek Upper portions of the creek had reduced species richness and horizontal complexity due to the dominance of Himalayan blackberry and fig (*Ficus carica*) dominance over the mid and tall layers of vegetation.

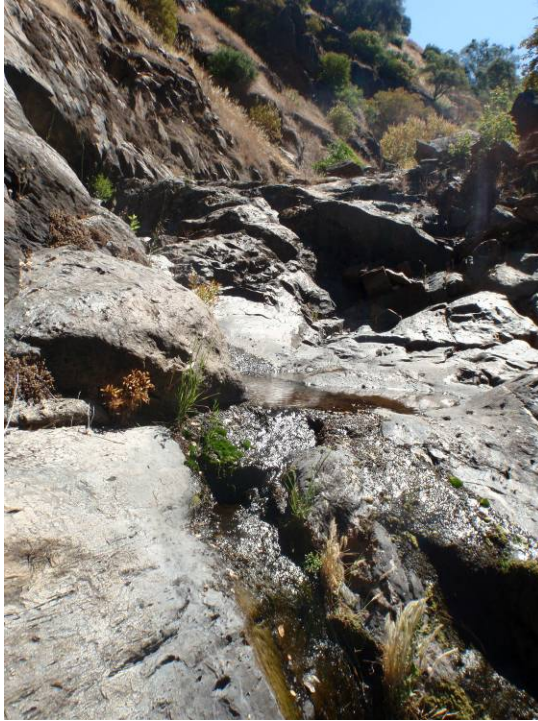
**Photo 17.** Deer Creek The majority of the channel was comprised of bedrock streambed and banks and supports very limited vegetation

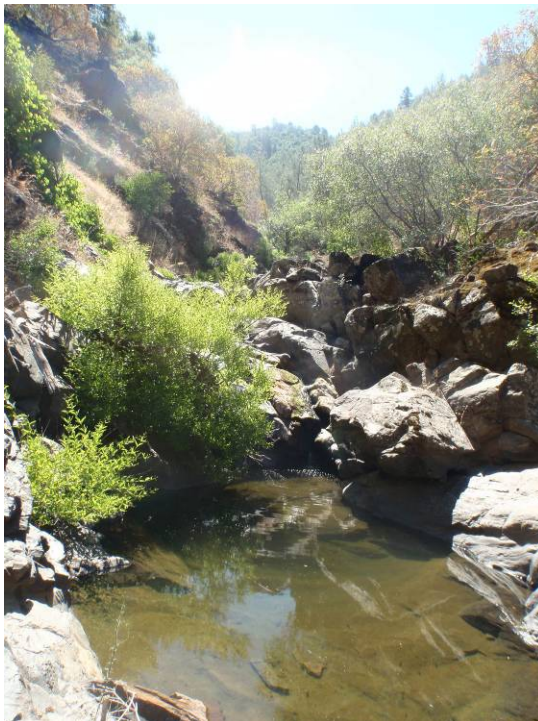
**Photo 18.** Deer Creek The landscape near the channel alternates between nearly barren areas of open bedrock and lower-gradient portions that support shrubs. Bedrock pools are present throughout the channel and support macroinvertebrates, crawfish, and bullfrogs (*Rana catesbiana*)

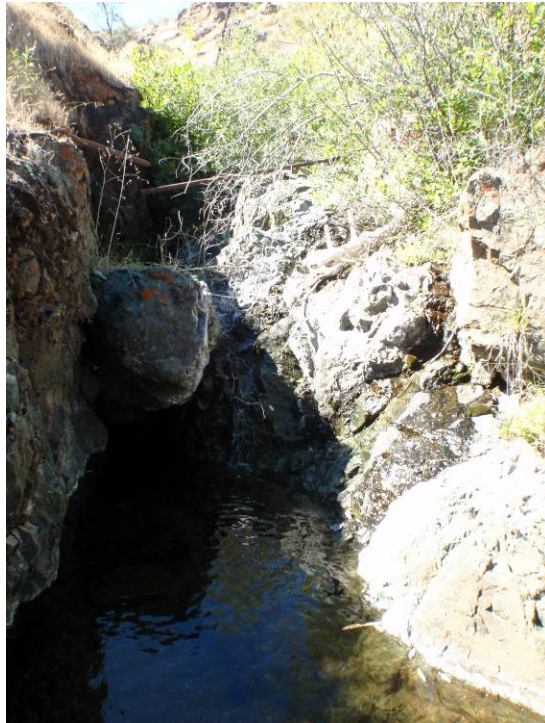
**Photo 19.**      **Drainage #7** The upland grasslands end abruptly at the edge of the drainage that has nearly vertical bedrock walls and bedrock floors

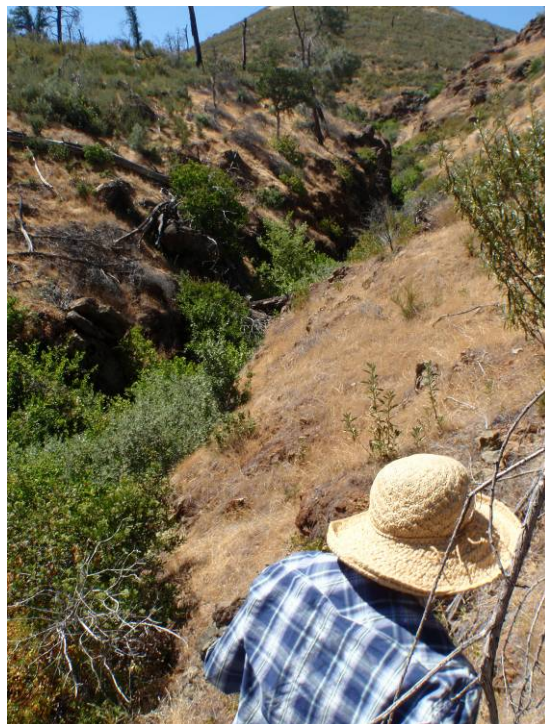
**Photo 20.**      **Drainage #7** Limited shrubs, such as buckeye (*Aesculus californica*), red willow, and spice bush grew from within the vertical-walled drainage, with the canopy just overtopping the banks of the channel

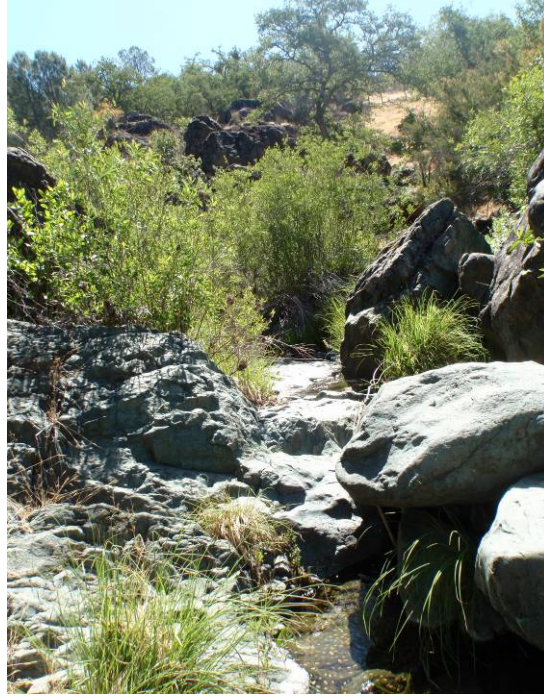
**Photo 21.**      **Drainage #8** The lower portion of the channel was comprised mainly of bedrock and boulders. Vegetation was limited and included red willows and small patches of naked sedge or stream orchid (*Epipactis gigantea*) that occurred in crevices between boulders

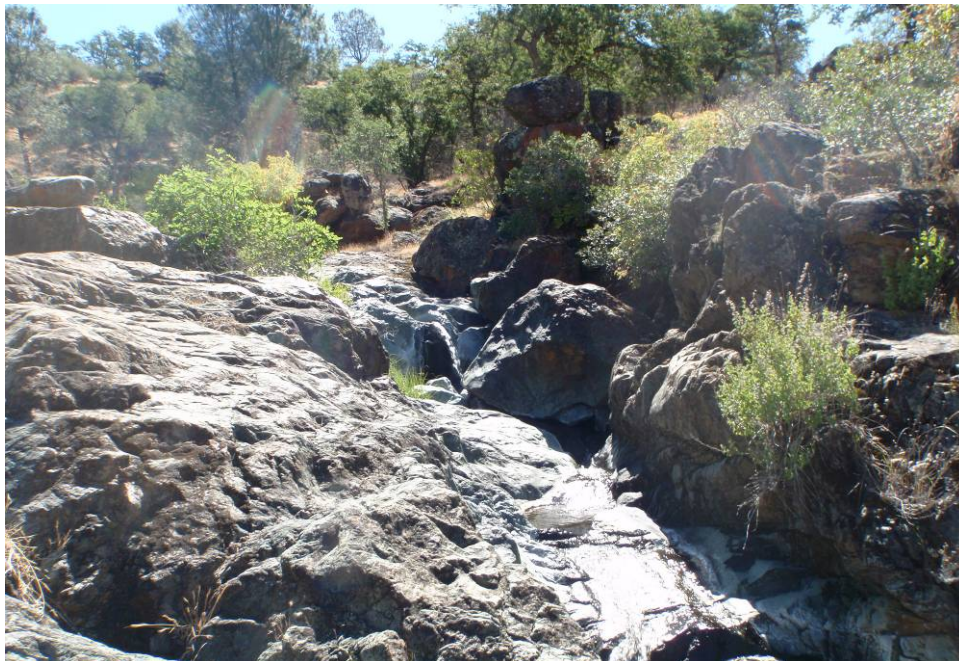
**Photo 22.**      **Drainage #8** The upper portion of Drainage #8 had a steep gradient with the streambed and banks comprised exclusively of bedrock and boulders. A series of falls, plunge-pools, chutes, and sheets formed the channel; intermittent red willows, spice bush, and buckeyes occurred in areas where sediment was present and at the channel's edge
