**STUDY REPORT TR-08  
CALIFORNIA TIGER SALAMANDER**

**ATTACHMENT A**

**CTS SITE ASSESSMENT**

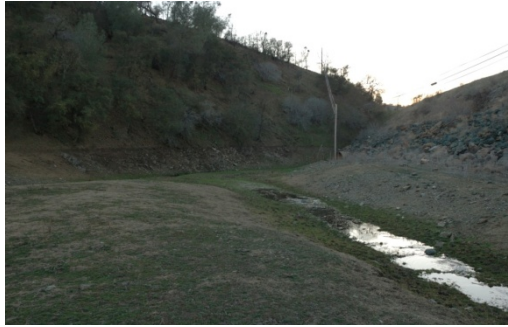
*F3*

F3 is a freshwater pond formed at the confluence of three perennial tributaries to Don Pedro Reservoir, located east of SR 182, 65 m east of Don Pedro Reservoir, and within the FERC Project Boundary. NWI data for the area depict a palustrine, unconsolidated bottom, permanently flooded, diked/impounded (PUBHh) wetland feature in the area of the site. SSURGO data classify soils in this location as Rock outcrop-Henneke-Delpiedra.

The site was assessed on February 8, 2012. The bank full width was estimated at 1.5 m with a maximum depth of 0.5 m. The stream gradient was approximately 3 percent. Pools measuring up to 5 m x 1.5 m and 0.1 m deep were present at the site. Non-pool habitat was made up of riffles. Substrate consisted of silt. Banks were gently sloping with an incised vegetated channel. The dominant emergent and margin vegetation was grass with no overhanging vegetation present. Surrounding upland habitat consisted of blue oak pastureland. A juvenile American bullfrog was observed during the survey. Numerous burrows measuring approximately 2 inches in diameter were present in the upland area.

The nearest known CTS occurrence is located 2.9 miles west. F3 holds water for at least 10 weeks during the CTS breeding season and may represent potentially suitable CTS breeding habitat. The site is situated in suitable upland habitat with underground retreats present.

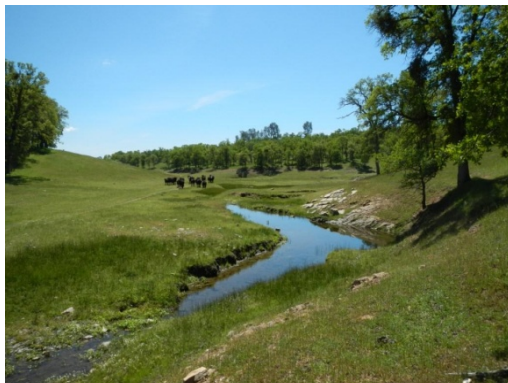
*F13*

F13 is a 736-m-long section of an unnamed perennial tributary to 49er Bay, located 15 m south of Old Don Pedro Road, partially below the high water line of Don Pedro Reservoir and within the FERC Project Boundary. NWI data for the area depict a riverine, intermittent, streambed, seasonally flooded (R4SBC) wetland feature in the area of the site. SSURGO data classify soils in this location as Whiterock-Rock outcrop-Auburn.

habitat consisted of low gradient run and riffle. The substrate was made up of organic matter, soil, and some subangular cobbles. Stream banks were mainly low gradient vegetated soil, and those around non-pool habitat were undercut by the stream. Emergent vegetation was made up of rushes, grasses, forbs, and submerged pondweed with no vegetation overhanging the site. Upland habitat was made up of oak savannah with 60 percent canopy cover. Larval western toads (*Anaxyrus boreas*), adult and juvenile American bullfrogs, larval sierran treefrog, and fish were all observed during the site visit. A small dirt road crossed the stream within the site. A cluster of burrows 4 - 5 inches in diameter were observed in the steep sections of the bank.

The nearest known CTS occurrence is located 5.1 miles south. F13 holds water for at least 10 weeks during the CTS breeding season and may represent potentially suitable CTS breeding habitat. The site is situated in suitable upland habitat with underground retreats present.

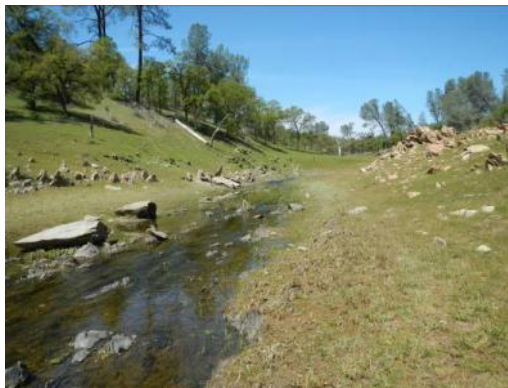
F15 is a 1,218-m-long section of Big Creek and associated tributaries, located partially below the high water line of Don Pedro Reservoir within the FERC Project Boundary. NWI data for the area depict a riverine, intermittent, streambed, seasonally flooded (R4SBC) wetland feature from the mouth at the reservoir upstream. SSURGO data classify soils in this location as Whiterock-Rock outcrop-Auburn.

bank full width of the stream was observed to be 7 - 8 m with a depth of 0.5 m. The stream gradient was 2 - 4 percent. Pools measuring up to 1 m x 3 m and 1.5 m deep were present in the stream. Non-pool habitat consisted of riffle, run, and cascade. The substrate was made up of bedrock, gravel, cobble, and boulder. Stream banks were low gradient near the stream, turning to steeper rolling hills. Emergent and margin vegetation were a combination of grasses and forbs with no vegetation overhanging the site. Upland habitat was a mixed oak and foothill pine savannah with approximately 45 percent canopy cover. Juvenile and larval American bullfrogs were present throughout the site, and 3 western toads were observed in amplexus during the survey. A bald eagle was observed feeding on a bass near the stream with a juvenile or subadult nearby. Horses were observed grazing near the stream. Two burrows were present in the hillside near the stream, measuring between 1.5 and 2 inches in diameter.

The nearest known CTS occurrence is located 6.3 miles south. F15 holds water for at least 10 weeks during the CTS breeding season and may represent potentially suitable CTS breeding habitat. The site is situated in suitable upland habitat with underground retreats present.

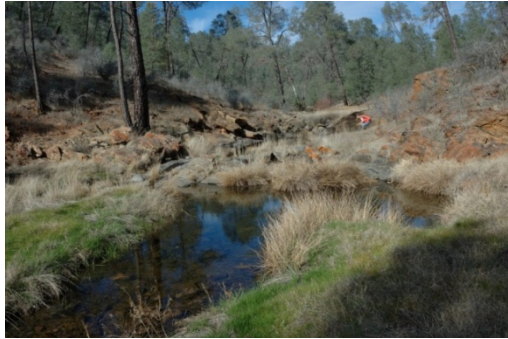
F17 is a 187-m-long section of Poor Man's Gulch, below the high water line of Don Pedro Reservoir within the FERC Project Boundary. NWI data for the area depict a riverine, intermittent, streambed, seasonally flooded (R4SBC) wetland feature in the area of the site. SSURGO data classify soils in this location as Whiterock-Rock outcrop-Auburn.

The nearest known CTS occurrence is located 9.3 miles south. F17 holds water for at least 10 weeks during the CTS breeding season and may represent potentially suitable CTS breeding habitat. The site is situated in suitable upland habitat with underground retreats present.

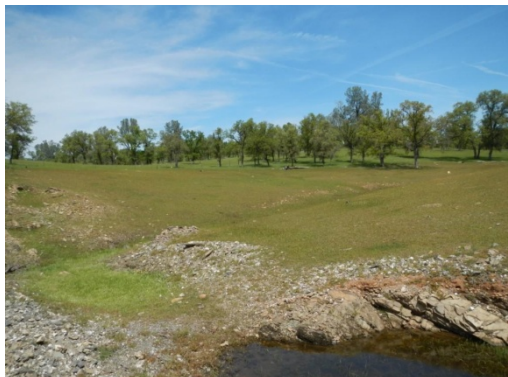
F22 is a 145-m-long section of an unnamed perennial tributary to the Big Creek arm of Don Pedro Reservoir, located 10 m north of Don Pedro Reservoir within the FERC Project Boundary. NWI data for the area depict a riverine, intermittent, streambed, seasonally flooded (R4SBC) wetland feature in the area of the site. SSURGO data classify soils in this location as Whiterock-Rock outcrop-Auburn.

survey. Emergent vegetation at both the stream and the pond was a mix of grasses and forbs, with no overhanging vegetation. Vegetation in the margin was mostly grasses. Upland habitat was made up of a gently sloping meadow with oak above the high water line of the reservoir. American bullfrogs and small fish were observed at the site during the survey. Multiple burrows measuring 2 inches in diameter were present along the bank and three additional 5 - 7 inches in diameter burrows were associated with a tree trunk.

The nearest known CTS occurrence is located 6.2 miles south. F22 holds water for at least 10 weeks during the CTS breeding season and may represent potentially suitable CTS breeding habitat. The site is situated in suitable upland habitat with underground retreats present.

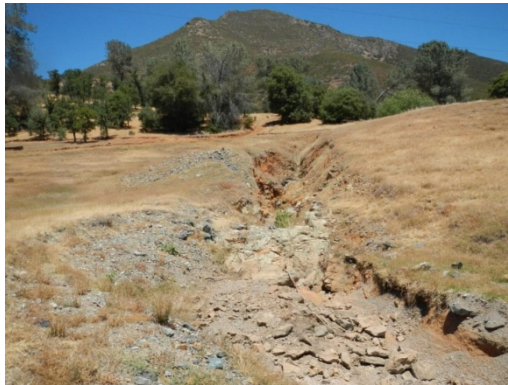
**F24**

F24 is a 77-m-long section of an ephemeral tributary to the upper bay of Don Pedro Reservoir, below the high water line of Don Pedro Reservoir within the FERC Project Boundary. NWI data for the area depict a riverine, intermittent, streambed, seasonally flooded (R4SBC) wetland feature in the area of the site. SSURGO data classify soils in this location as Rock outcrop-Henneke-Delpiedra.

The site was assessed on June 19, 2012. F24 is in east of the group of seven other ephemeral tributaries to the upper bay of Don Pedro Reservoir. The site is adjacent to a large constructed gravel slope and beneath power lines. The bank full width was 3 m with a depth of 1.25 m. The stream gradient was 6 percent. The stream was dry at the time of survey, but it was assumed that pools up to 5m x 2m would be present during flow conditions. Non-pool habitat was assumed to be a mix of cascade and riffle. The substrate was made up of soil and gravel with bedrock in the upstream portion. Stream banks were steeply incised and made up of a combination of soil and gravel with bedrock upstream. Emergent and margin vegetation consisted of desiccated grasses and forbs, with no overhanging vegetation. Upland habitat was a mix of pine and oak with 60 percent canopy cover. No fish or amphibians were observed; however, fish are known to be present in Don Pedro Reservoir. No evidence of burrowing mammals was present.

The nearest known CTS occurrence is located 7.6 miles south. F24 holds water for at least 10 weeks during the CTS breeding season. The site is situated in suitable upland habitat, but no underground retreats were observed during the survey.

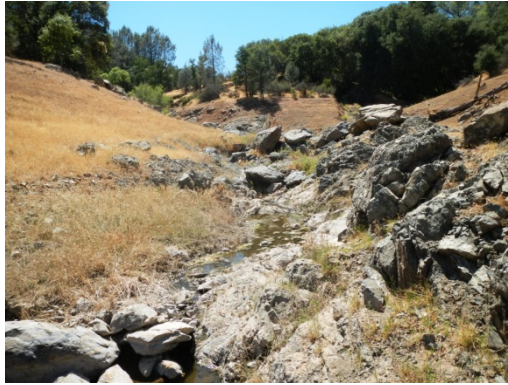
**F25**

F25 is a 54-m-long section of an unnamed perennial tributary to Don Pedro Reservoir, located below the high water line of Don Pedro Reservoir and within the FERC Project Boundary in Wreck Bay. NWI data for the area depict a riverine, intermittent, streambed, temporarily flooded (R4SBA) wetland feature in the area. SSURGO data classify soils in this location as Whiterock-Rock outcrop-Auburn.

The nearest known CTS occurrence is located 8.2 miles south. F25 holds water for at least 10 weeks during the CTS breeding season and may represent potentially suitable CTS breeding habitat. The site is situated in suitable upland habitat with underground retreats present.

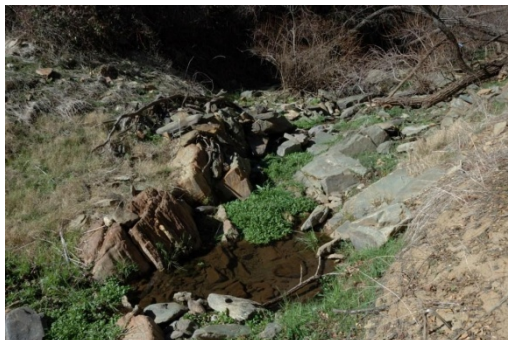
**F30**

F30 is a 321-m-long section of a perennial tributary to Don Pedro Reservoir, Kanaka Creek, located south of Jacksonville Road, partially below the high water line of Don Pedro Reservoir, and within the FERC Project Boundary. NWI data for the area depict a riverine, intermittent, streambed, seasonally flooded (R4SBC) wetland feature from the mouth at the reservoir upstream including Site F30. SSURGO data classify soils in this location as Whiterock-Rock outcrop-Auburn.

in combination with buckthorn and willow. Emergent vegetation was made up of water purslane (*Ludwigia* sp.), beggar-tick (*Bidens* sp.), and algae. Margin vegetation consisted of annual and perennial grasses and asters (*Asteracea*) and vetch (*Vicia* sp). Surrounding upland habitat included foothill pine and interior live oak. No fish or amphibians were observed; however, fish are known to be present in Don Pedro Reservoir. Burrows measuring 1 - 3 inches were densely concentrated in the hillsides surrounding the site.

The nearest known CTS occurrence is located 11.3 miles south. F30 holds water for at least 10 weeks during the CTS breeding season and may represent potentially suitable CTS breeding habitat. The site is situated in suitable upland habitat with underground retreats present.

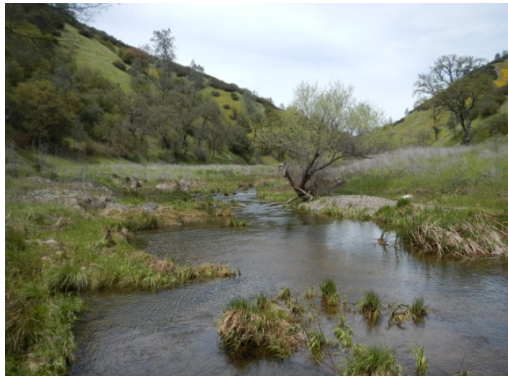
F35 is a 173-m-long section of Woods Creek, located below the high water line of Don Pedro Reservoir within the FERC Project Boundary. NWI data for the area depict a lacustrine, littoral, unconsolidated shore, seasonally flooded, diked/impounded (L2USCh) wetland feature in the area of the site. SSURGO data classify soils in this location as Whiterock-Rock outcrop-Auburn.

The nearest known CTS occurrence is located 13.7 miles southwest. F35 holds water for at least 10 weeks during the CTS breeding season and may represent potentially suitable CTS breeding habitat. The site is situated in suitable upland habitat with underground retreats present.

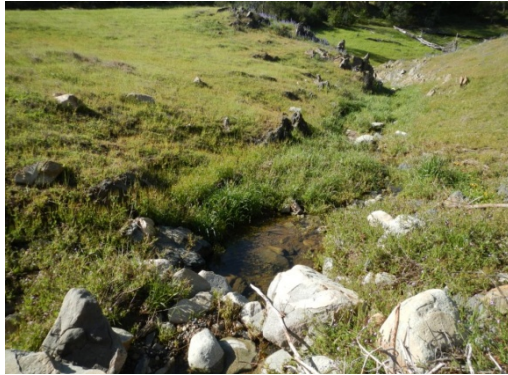
F36 is a 78-m-long section of a seasonal unnamed tributary to Don Pedro Reservoir, located below the high water line of Don Pedro Reservoir within the FERC Project Boundary. NWI data for the area depict a lacustrine, limnetic, unconsolidated bottom, permanently flooded, diked/impounded (L1UBHh) wetland feature in the area of the site. SSURGO data classify soils in this location as Rock outcrop-Henneke-Delpiedra.

The nearest known CTS occurrence is located 2.7 miles southwest. F35 holds water for at least 10 weeks during the CTS breeding season. The site is situated in suitable upland habitat, but no underground retreats were observed during the survey.

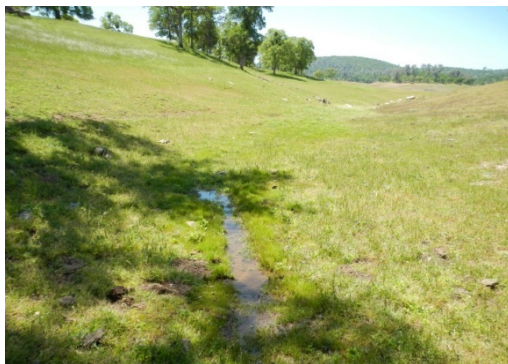
F39 is a 24-m-long section of a seasonal unnamed tributary to Don Pedro Reservoir's 49er Bay, 185 m northwest of Don Pedro Reservoir within the FERC Project Boundary. NWI data for the area depict a riverine, intermittent, streambed, temporarily flooded (R4SBA) wetland feature in the area of the site. SSURGO data classify soils in this location as Whiterock-Rock outcrop-Auburn.

gradient, vegetated soil. Emergent vegetation was a mix of forbs and grasses with no overhanging vegetation. Upland habitat was oak savannah with approximately 40 percent canopy cover. Residential homes and associated structures were located nearby the site. No amphibians or fish were observed during the survey. Three or four burrows, measuring 5 - 6 inches in diameter, were present near the stream and the adjacent stream.

The nearest known CTS occurrence is located 4.5 miles south. F39 holds water for at least 10 weeks during the CTS breeding season and may represent potentially suitable CTS breeding habitat. The site is situated in suitable upland habitat with underground retreats present.

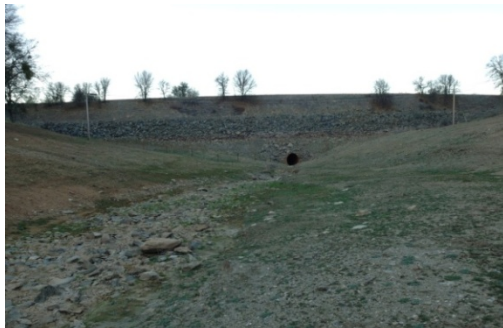
F40 is a palustrine freshwater pond, located south of US Hwy 132, below the high water line of Don Pedro Reservoir and within the FERC Project Boundary. NWI data for the area depict a palustrine, unconsolidated shore, seasonally flooded, diked/impounded (PUSCh) wetland feature in the area of the site. SSURGO data classify soils in this location as Whiterock-Rock outcrop-Auburn.

The site was assessed on February 8, 2012. F40 is a pond located above a culvert within a gently sloping drainage. The site covers approximately 14,300 m<sup>2</sup>; the maximum observed water depth was greater than 2 m; the bank full depth was greater than 2 m. The pond was dry at the time of assessment. Substrate consisted of soil, silt, bedrock, and boulders. Emergent vegetation consisted of sparse grass and forbs, the dominant vegetation in the area. No vegetation was overhanging the pond. Sierran treefrog was heard calling but was not observed. Upland habitat was made up of blue oak pastureland. Burrows measure 2 - 4 inches in diameter were abundant in clusters along the banks and upslope.

The nearest known CTS occurrence is located 2.6 miles west. Hydrological conditions at F40 vary greatly from year to year depending on reservoir operations. In most years F40 holds water for at least 10 weeks during the CTS breeding season and may represent potentially suitable CTS breeding habitat. The site is situated in suitable upland habitat with underground retreats present.

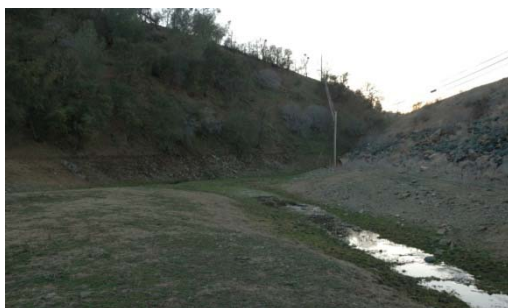
F41 is a freshwater pond formed at the confluence of three perennial tributaries to Don Pedro Reservoir, located east of SR 182, 65 m east of Don Pedro Reservoir, and within the FERC Project Boundary. NWI data for the area depict a palustrine, unconsolidated bottom, permanently flooded, diked/impounded (PUBHh) wetland feature in the area of the site. SSURGO data classify soils in this location as Rock outcrop-Henneke-Delpiedra.

The site was assessed on February 8, 2012. The bank full width was estimated at 1.5 m with a maximum depth of 0.5 m. The stream gradient was approximately 3 percent. Pools measuring up to 5 m x 1.5 m and 0.1 m deep were present at the site. Non-pool habitat was made up of riffles. Substrate consisted of silt. Banks were gently sloping with an incised vegetated channel. The dominant emergent and margin vegetation was grass with no overhanging vegetation present. Surrounding upland habitat consisted of blue oak pastureland. A juvenile American bullfrog was observed during the survey. Numerous burrows measuring approximately 2 inches in diameter were present in the upland

The nearest known CTS occurrence is located 2.8 miles west. F41 holds water for at least 10 weeks during the CTS breeding season. The site is situated in suitable upland habitat with underground retreats present.

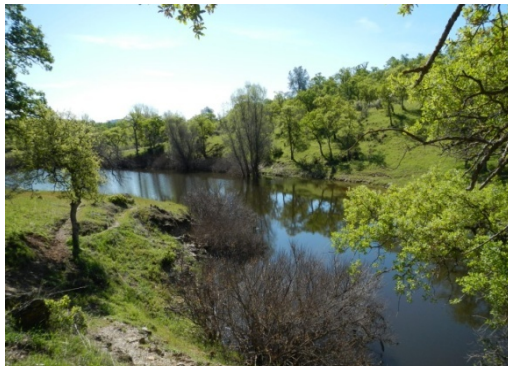
F43 is a palustrine, freshwater pond created by a natural impoundment within West Big Fork Creek, located below the high water line of Don Pedro Reservoir and within the FERC Project Boundary. NWI data for the area depict a palustrine, unconsolidated bottom, permanently flooded, diked/impounded (PUBHh) wetland feature in the area of the site. SSURGO data classify soils in this location as Whiterock-Rock outcrop-Auburn.

The site was assessed on April 17, 2012. F43 is adjacent to site F21. The site covers approximately 9,900 m<sup>2</sup>; the maximum observed water depth was greater than 2 m; the bank full depth was greater than 2 m. Substrate consisted mostly of organic matter and silt with some small gravel. The banks of the pond were mostly vegetated and varied from low grade to somewhat steep with angular bedrock outcroppings. Emergent vegetation was dominated by grasses, but included a mix of grasses and forbs with willows overhanging. The margins were vegetated with grasses and forbs. An abundance of large woody debris was present at the time of survey. Upland habitat consisted of rolling hills dominated by oak with a few large willows near the pond. An unidentified frog species jumped into the pond while vocalizing and a western pond turtle was seen basking on the opposite side of the pond. No evidence of burrowing mammals was present.

The nearest known CTS occurrence is located 6.0 miles south. F43 holds water for at least 10 weeks during the CTS breeding season. The site is situated in suitable upland, but no underground retreats were observed during the survey.

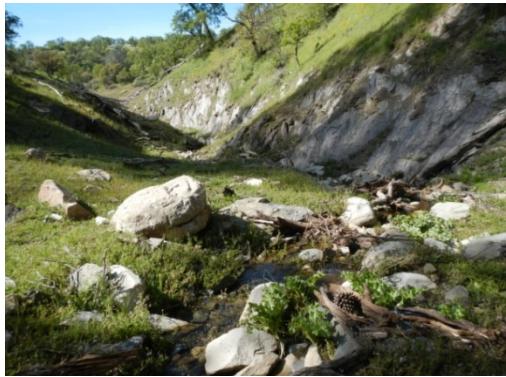
F53 is a 62-m-long section of a seasonal unnamed tributary to Don Pedro Reservoir, 8 m northwest of Don Pedro Reservoir and within the FERC Project Boundary. NWI data for the area depict a palustrine, scrub-shrub temporarily flooded (PSSA) wetland feature in the area of the site. SSURGO data classify soils in this location as Rock outcrop-Henneke-Delpiedra.

The nearest known CTS occurrence is located 2.4 miles southwest. It is unknown if F53 holds water for at least 20 weeks during the CTS breeding season and may represent potentially suitable CTS breeding habitat. The site is situated in suitable upland habitat with underground retreats present.

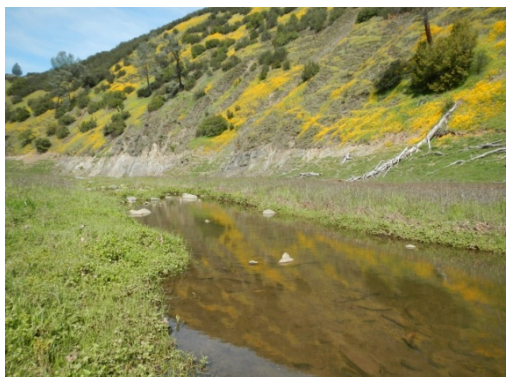
F60 is a seasonal, freshwater pond, located below the high water line of Don Pedro Reservoir, within the FERC Project Boundary. NWI data for the area depict a palustrine, emergent, temporarily flooded, diked/impounded (PEMAh) wetland feature in the area of the site. SSURGO data classify soils in this location as Whiterock-Rock outcrop-Auburn.

The site was assessed on April 18, 2012. F60 is a pond fed by a seasonal branch of a creek. The site covers approximately 650 m<sup>2</sup>; the maximum observed water depth was greater than 1 m; the bank full depth was

Submerged vegetation consisting of duckweed and algae was present in the upstream end of the pool. Upland habitat was a mix of Manzanita and chamise with some oak and foothill pine with approximately 20 percent canopy cover. Adult, juvenile, and many larval American bullfrog were observed during the survey. No evidence of burrowing mammals was present.

The nearest known CTS occurrence is located 14.0 miles southwest. F60 holds water for at least 10 weeks during the CTS breeding season. The site is situated in suitable upland, but no underground retreats were observed during the survey.

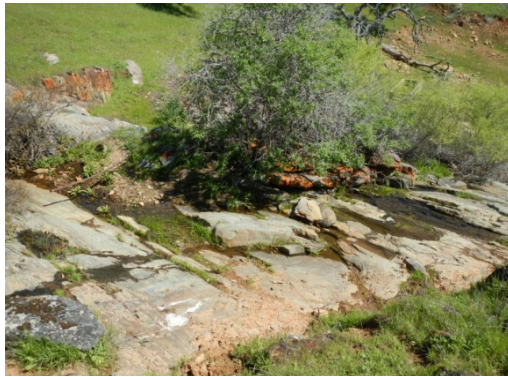
*F68*

F68 is a 34-m-long section of a seasonal unnamed tributary to Don Pedro Reservoir, located partially below the high water line of Don Pedro Reservoir within the FERC Project Boundary. NWI data for the area depict a palustrine, emergent, saturated (PEMB) wetland feature in the area of the site. SSURGO data classify soils in this location as Whiterock-Rock outcrop-Auburn.

The site was assessed on April 19, 2012. F68 flows over a valley created by bedrock outcropping within a vegetated hillside. The bank full width of the stream was observed to be 5 m with a depth of 1 - 3 m. The stream gradient was 5 - 12 percent. Pools measuring up to 1 m x 3 m and 0.25 m deep were present in the stream. Non-pool habitat consisted of high gradient riffle. The substrate was made up of bedrock with some soil and gravel. Stream banks were moderately sloping with vegetated soil lining the bedrock. Emergent vegetation was a mix of sparse grass and forbs with thick willows in the stream and overhanging the site. Upland habitat was made up of oak savannah with 30 - 60 percent canopy cover. A large metal pipe was observed in the stream channel. Clusters of burrows measuring 2 - 3 inches in diameter were present on the bank, but had been inundated by high flows.

The nearest known CTS occurrence is located 3.5 miles southeast. F68 holds water for at least 10 weeks during the CTS breeding season and may represent potentially suitable CTS breeding habitat. The site is situated in suitable upland habitat with underground retreats present.

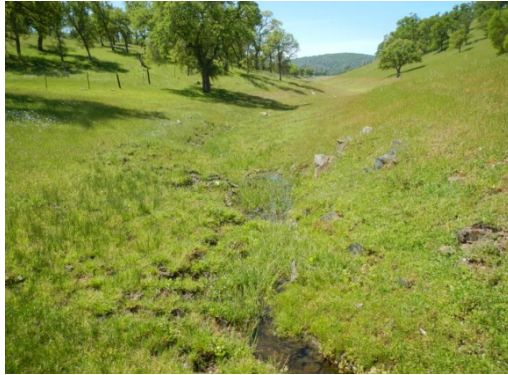
**F75**

F75 is a 49-m-long section of a seasonal unnamed tributary to Don Pedro Reservoir, located 110 m northeast of Don Pedro Reservoir within the FERC Project Boundary. NWI data for the area do not show a wetland feature at the site. SSURGO data classify soils in this location as Whiterock-Rock outcrop-Auburn.

The site was assessed on April 19, 2012. F75 flows in a depression through a hilly, vegetated area. The bank full width of the stream was observed to be 4 m with a depth of 0.25 m. The stream gradient was 0 -1 percent.

Pools measuring up to 4 m x 6 m and 0.5 m deep were

present in the stream. Non-pool habitat consisted of run and low gradient riffle. The substrate was made up of soil and organic matter with a few subangular cobbles. Stream banks varied from low to higher gradient, somewhat incised, and vegetated throughout the stream channel. Emergent vegetation was a mix of grasses, rushes, and forbs with no vegetation overhanging the site. Upland habitat was made up of oak savannah with 60 percent canopy cover. A juvenile American bullfrog was observed in a pool upstream of the site. Fences were present at the site, but grazing was still occurring along the stream. No evidence of burrowing mammals was present.

The nearest known CTS occurrence is located 4.8 miles south. F75 holds water for at least 10 weeks during the CTS breeding season and may represent potentially suitable CTS breeding habitat. No underground retreats were observed during the survey, but suitable upland habitat may be present.

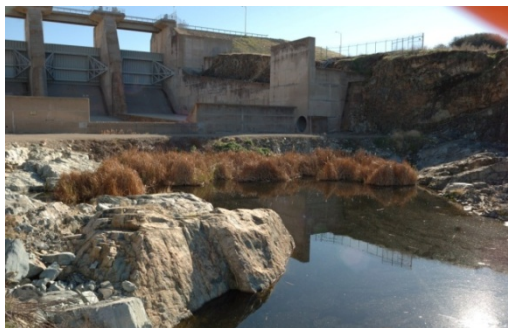
**F77**

F77 is a series of perennial, freshwater ponds, located east of Bonds Flat Road, 110 m west of Don Pedro Reservoir, within the FERC Project Boundary. NWI data for the area do not show a wetland feature in the area of the site. SSURGO data classify soils in this location as Whiterock-Rock outcrop-Auburn.

scoured bedrock channel. Observed water depth ranged from 0.1 m at small ponds to greater than 2 m at large ponds; the bank full depth was estimated to be greater than 3 m. The substrate was made up of bedrock and boulders. Emergent vegetation consisted of cattail, monkeyflower, bulrush, and primrose (*Ludwigia* sp.) with no vegetation overhanging the site or in the margin. Upland habitat was made up of angular cobble with no canopy over the site. An unidentified frog, red-wing blackbirds (*Agelaius phoeniceus*), and waterfowl were observed at the site.

American bullfrogs have been observed at the site in the past. Burrows measuring 2 inches in diameter were sparsely distributed near the pond and more densely distributed along the gravel road.

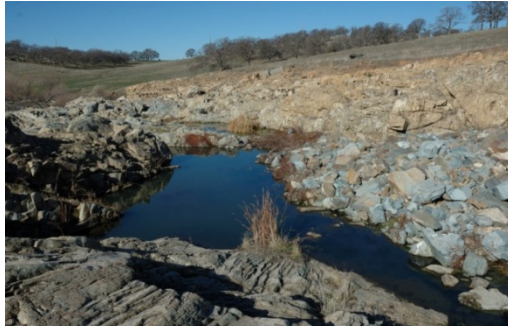
F78 is a perennial, freshwater pond, located west of Bonds Flat Road, 200 m west of Don Pedro Reservoir, within the FERC Project Boundary. NWI data for the area do not show a wetland feature in the area of the site. SSURGO data classify soils in this location as Whiterock-Rock outcrop-Auburn.

The site was assessed on February 8, 2012. F77 is located east of site F78, within the spillway channel. The site covers approximately 250 m<sup>2</sup>; the maximum observed water depth was greater than 2 m; the bank

full depth was estimated to be 4 m. Emergent vegetation consisted of cattail, bulrush, primrose, and fern (*Azolla* sp.) with no vegetation overhanging the site. Some deciduous trees were present in the margin. Upland habitat was made up of oak pastureland and the nearby highway. Small frogs, likely American bullfrogs, were present at the site along with various waterfowl. Some burrows measuring approximately 3 inches in diameter were observed upslope of the site, along the road.

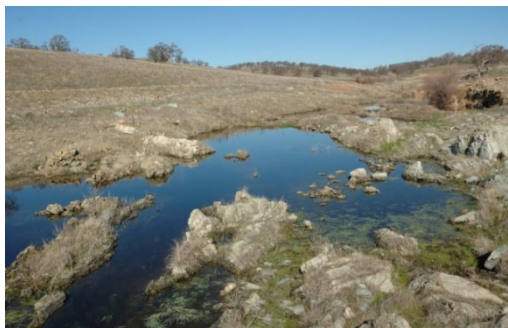
F80 is a perennial, freshwater pond, located southwest of Bonds Flat Road, 480 m southwest of Don Pedro Reservoir, within the FERC Project Boundary. NWI data for the area do not show a wetland feature in the area of the site. SSURGO data classify soils in this location as Whiterock-Rock outcrop-Auburn.

The site was assessed on February 8, 2012. F80 is located south of site F79, connected to the Tuolumne River. The site covers approximately 6,500 m<sup>2</sup>; the maximum observed water depth was greater than 2 m; the

were present in the margin. Dominant species at the site were cattail and upland grasses. Upland habitat was blue oak rangeland with no canopy cover at the site. Fish presence is highly likely in the pond due to the connection with the Tuolumne River, although no fish were observed at the time of the survey. Waterfowl and red wing blackbirds were observed during the survey. Burrows measuring 2 - 3 inches in diameter were sparsely distributed in the upland area.

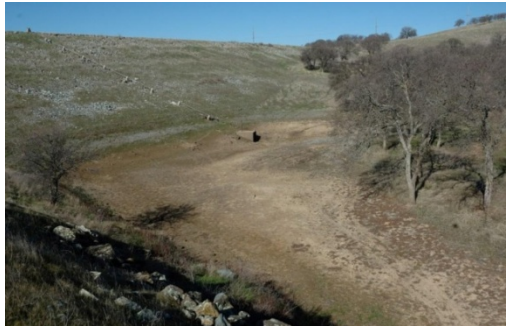
F81 is a man-made, freshwater stock pond above a small dam, located southwest of Bonds Flat Road, 800 m southwest of Don Pedro Reservoir, within the FERC Project Boundary. NWI data for the area do not show a wetland feature in the area of the site. SSURGO data classify soils in this location as Whiterock-Rock outcrop-Auburn.

The site was assessed on February 8, 2012. F81 is located southwest of site F80, and is generally manually filled by the Tuolumne Irrigation District each year at the request of a local cattle rancher. The site covers approximately 3,565 m<sup>2</sup>; the maximum observed water depth was 2 m; the bank full depth was greater than 4 m. The substrate consisted of soil with a limited amount of bedrock. Emergent vegetation consisted of primrose and bulrush with sparse blue oak overhanging the site. Grasses were the dominant vegetation at the site. Upland habitat was blue oak pastureland with approximately 20 percent canopy cover on the northeast side of the site and may represent potentially suitable CTS breeding habitat. Clusters of burrows measuring 3 - 6 inches in diameter were observed in the bank upslope of the pond.

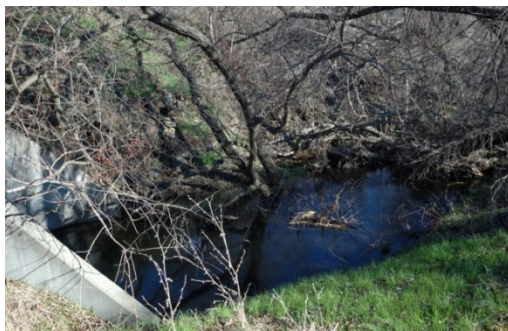
F84 is a 357-m-long section of a Big Creek, a perennial tributary to Don Pedro Reservoir that crosses and is adjacent to La Grange Road, within the FERC Project Boundary. NWI data for the area do not show a wetland feature in the area of the site. SSURGO data classify soils in this location as Whiterock-Rock outcrop-Auburn.

The site was assessed on February 8, 2012. F84 is made up of a pool within a stream running under La Grange Road through a culvert. The maximum observed water
