**STUDY REPORT TR-03
WETLAND HABITATS**

ATTACHMENT B

REPRESENTATIVE PHOTOGRAPHS

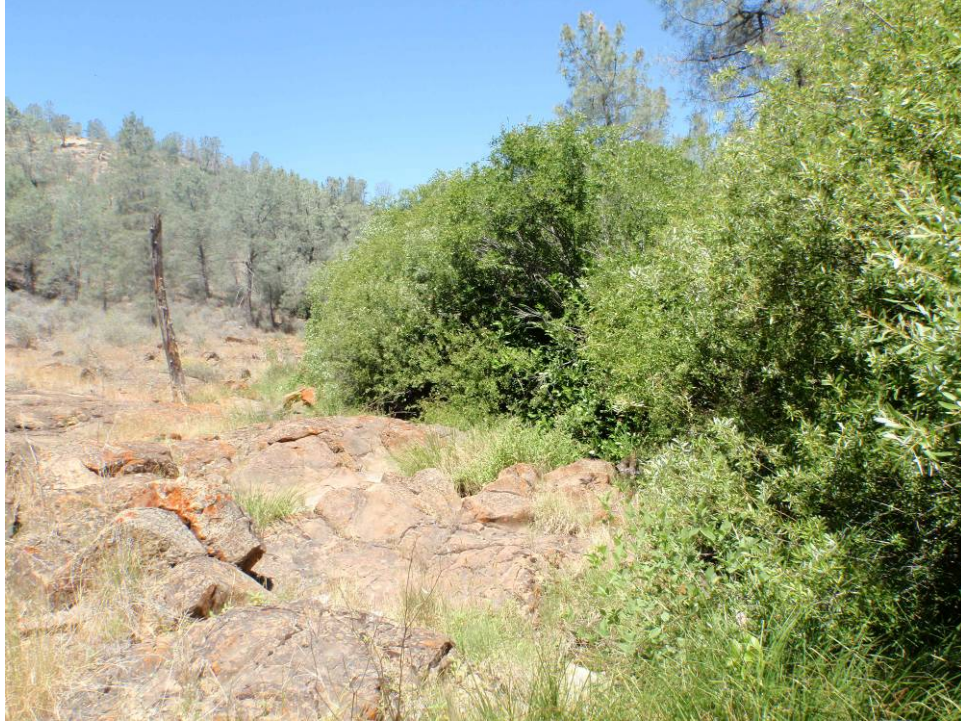
Photo 1. Sixbit Gulch Large bedrock and boulder outcrops occurred along the perimeter of the wetland in this moderately confined drainage.

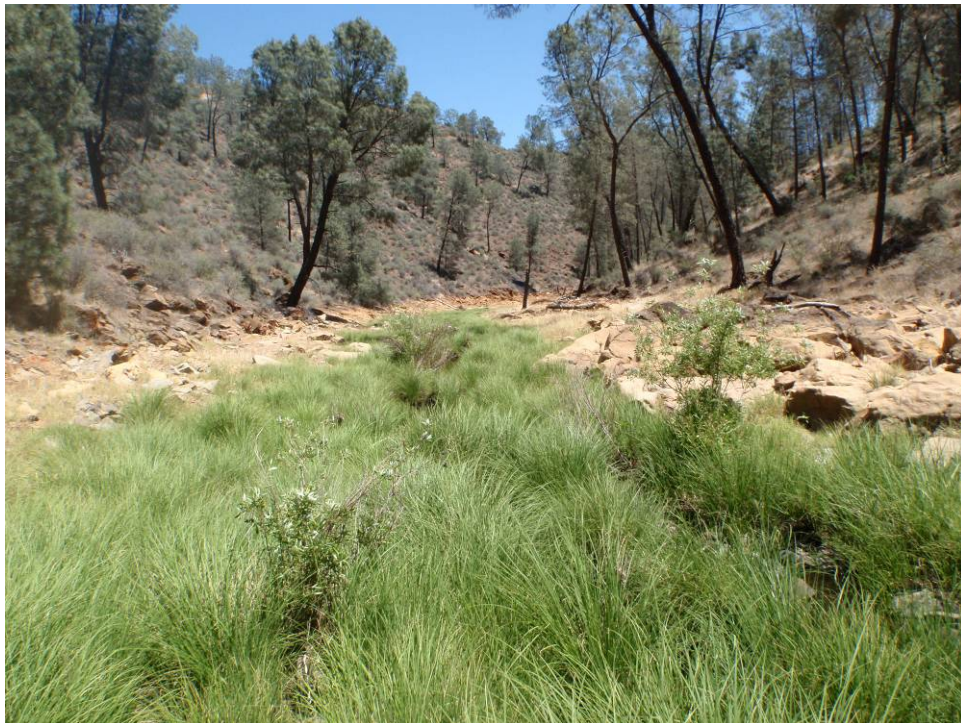
Photo 2. Sixbit Gulch Hummocks of naked sedge (*Carex nudata*) intermixed with Sonoma hedgenettle (*Stachys stricta*), springseep monkeyflower (*Mimulus guttatus*), and an occasional red willow (*Salix laevigata*).

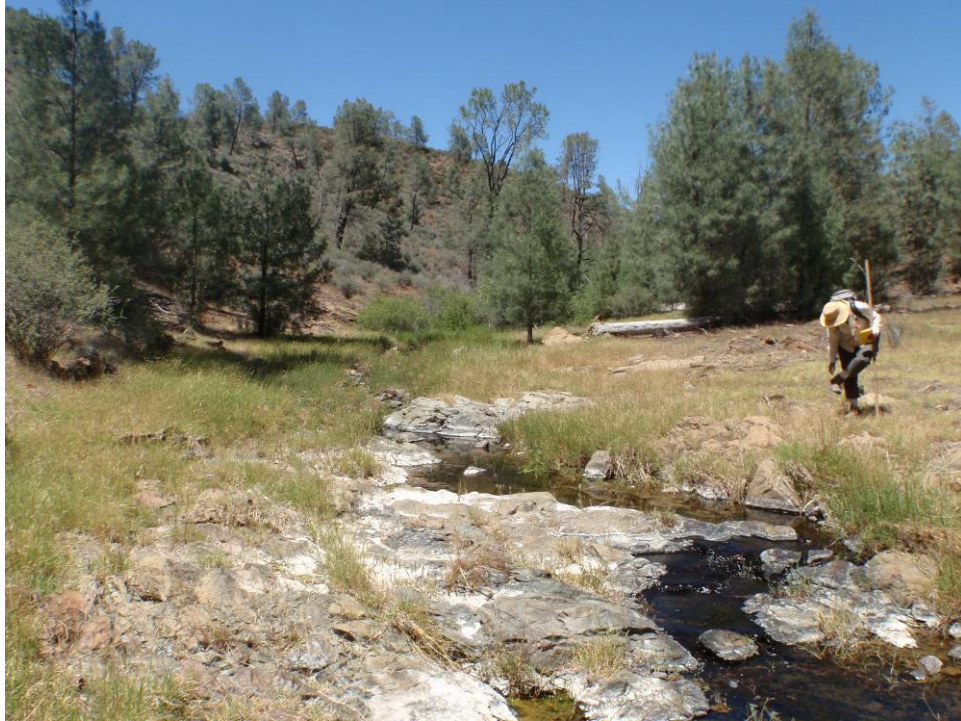
Photo 5. Poorman's Gulch Exposed bedrock supports perennial ryegrass (*Lolium perenne*), and annual beardgrass (*Polypogon monspeliensis*) at the perimeter.

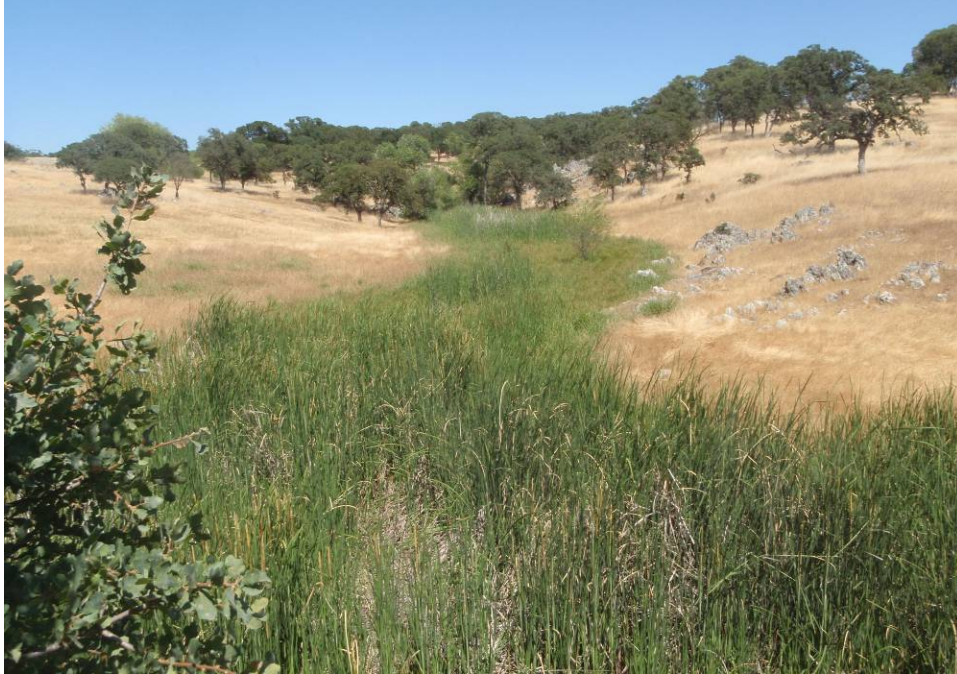
Photo 13. Big Creek The Big Creek channel had no distinct bed or banks and consisted of a shallow depression formed by hillslopes converging. The creek supported primarily herbaceous species, such as broad-leaved cattail (*Typha latifolia*), tall flatsedge (*Cyperus eragrostis*), annual beard grass, dallisgrass (*Paspalum dilatatum*), spike rush (*Eleocharis ovata*), and lady's thumb (*Persicaria maculosa*).

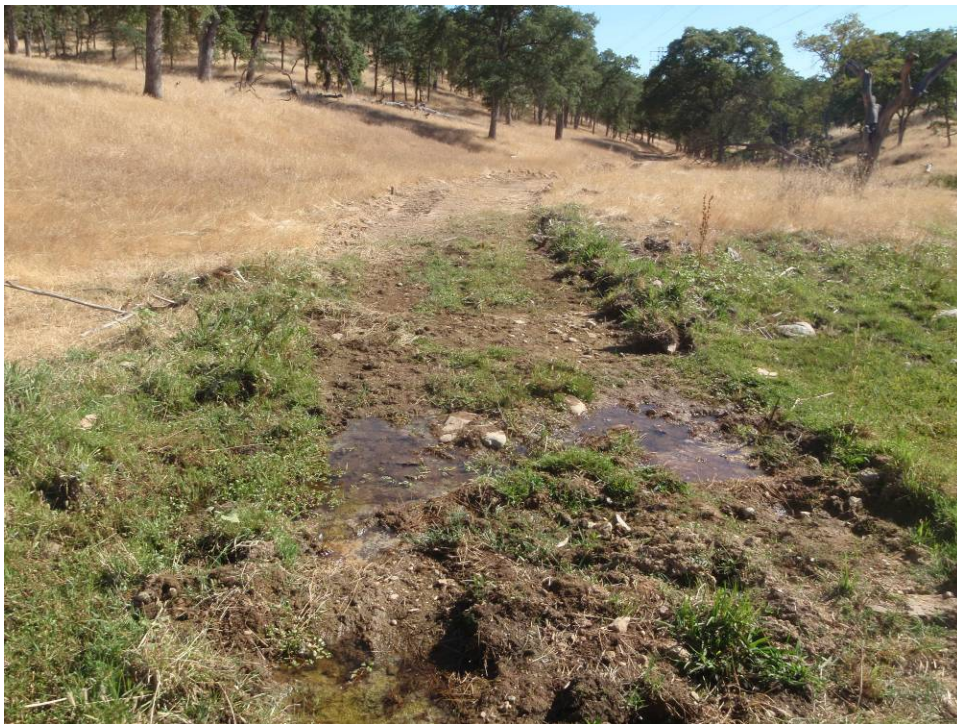
Photo 14. Big Creek The wetland is heavily influenced by cattle, as evident by grazed herbs and hoof puncture. Vehicles cross the wetland perpendicularly with no evidence of adverse effects on the wetland.
