# **LOWER TUOLUMNE RIVER RIPARIAN INFORMATION AND SYNTHESIS STUDY**

**STUDY REPORT  
DON PEDRO PROJECT  
FERC NO. 2299**

**Prepared by:**  
**Stillwater Sciences**

**January 2013**

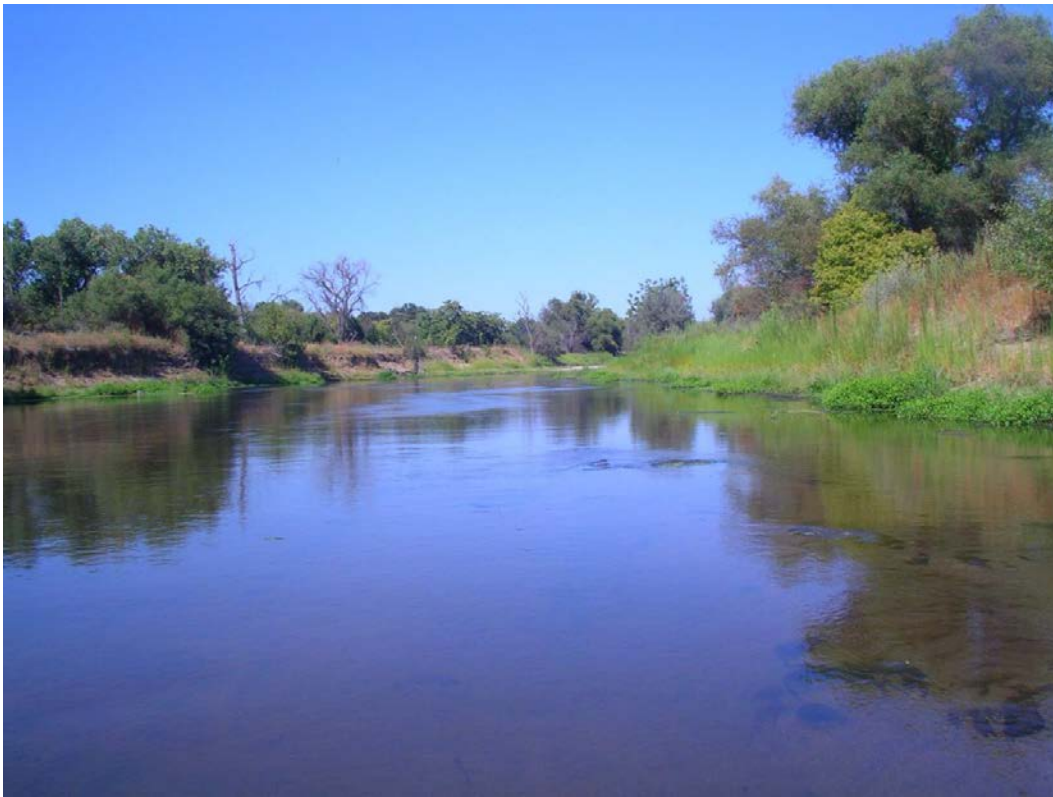
**Figure 5.1-1. Reach 1 supports a very low gradient unshaded channel with eroding, sparsely vegetated banks.**

Banks along several areas of this reach are also stabilized with rip-rap, further limiting the formation of fresh and diverse riparian areas through river meandering. Small pockets of riparian vegetation grow along the banks and within the rip-rap and along the upper edge of the levees. Tree of heaven, an invasive non-native species, was recorded in this reach (Stillwater Sciences 2008) as well as giant reed (*Arundo donax*), tree tobacco (*Nicotiana glauca*), and eucalyptus (2012 surveys). Since the 1996 vegetation survey, the extent of tree tobacco, giant reed, and tree of heaven decreased slightly while the extent of other non-native species appears to have remained stable.

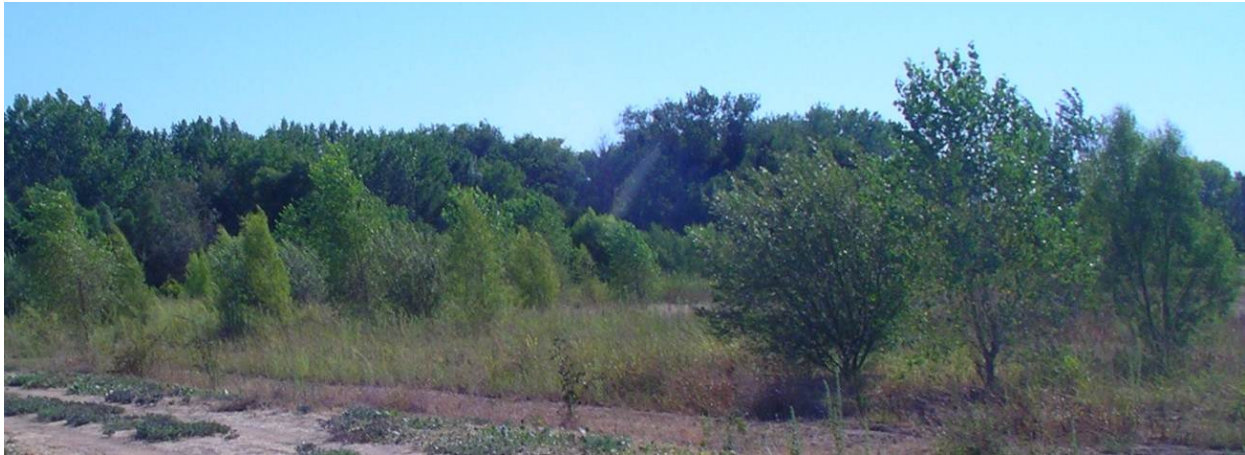
**Figure 5.1-2. Photograph of Grayson Ranch restoration project, showing different ages of plantings in the foreground vs. the background.**

that the plantings are healthy and growing; thus the restoration of riparian vegetation on the floodplain and along the newly constructed sloughs appears successful, but no quantitative monitoring assessments are available (Figure 5.1-2).

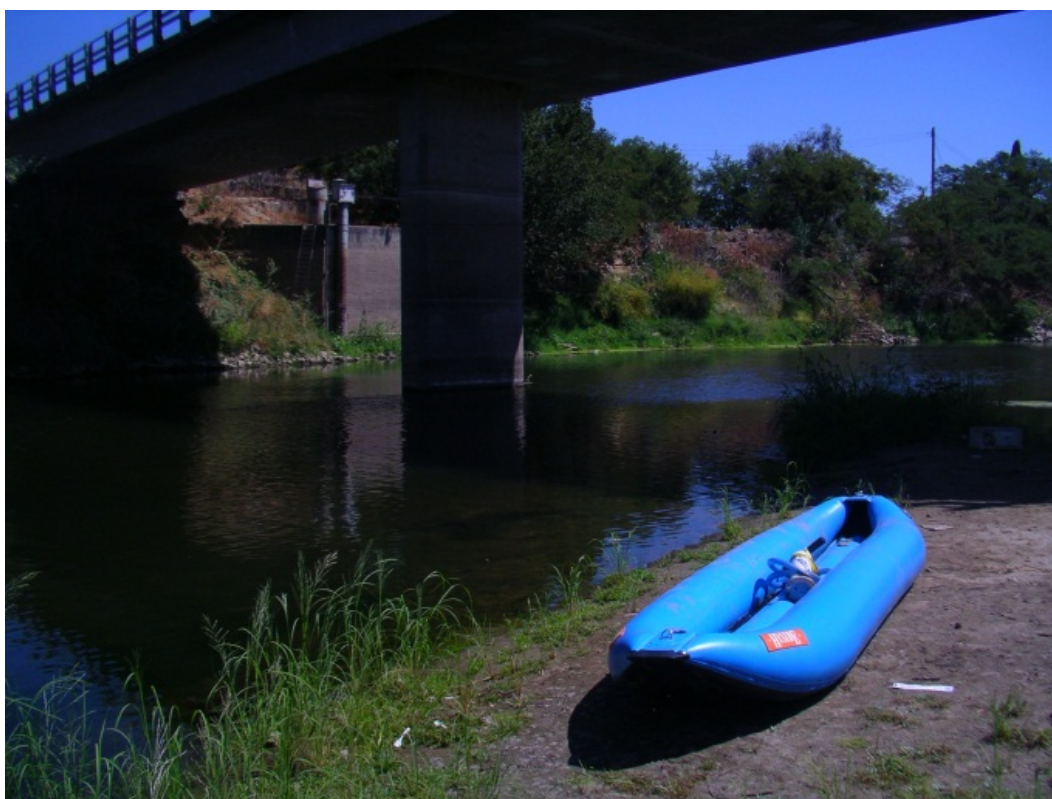
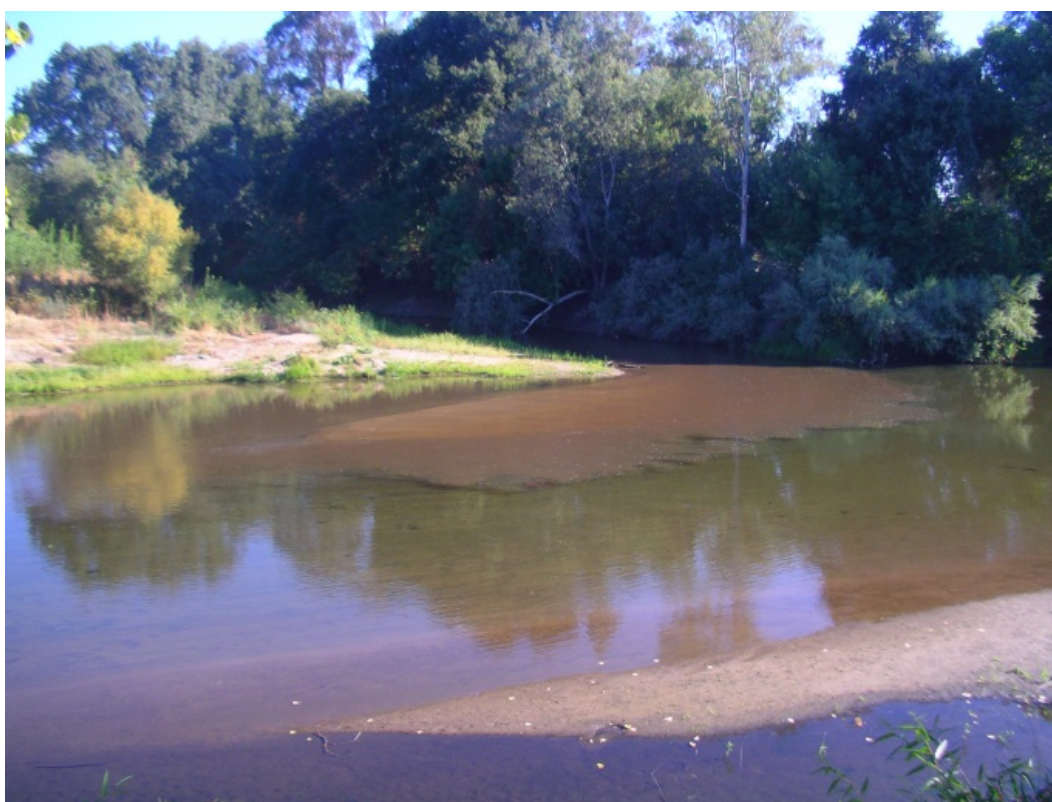
**Figure 5.1-3. Views of lower Tuolumne River along Urban Reach 2; (A) Highway 99 underpass,**

**(B) Dry Creek confluence just upstream of Highway 99.  
Tuolumne River Regional Park**

Reach 2 runs through the neighboring cities of Ceres and Modesto and under State Highway 99 (Figure B-3 in Attachment B and Figure 5.1-3 below). This reach supports approximately 34 acres of riparian vegetation per river mile, roughly one-half the density observed along Reach 1. The narrow, 20–150 ft band of native riparian vegetation that lines the channel downstream of Modesto is dominated by box elder and narrow-leaf willow; mature stands of valley oak and cottonwood occur along the upper edge of many of the levees (McBain and Trush 2000). Stands

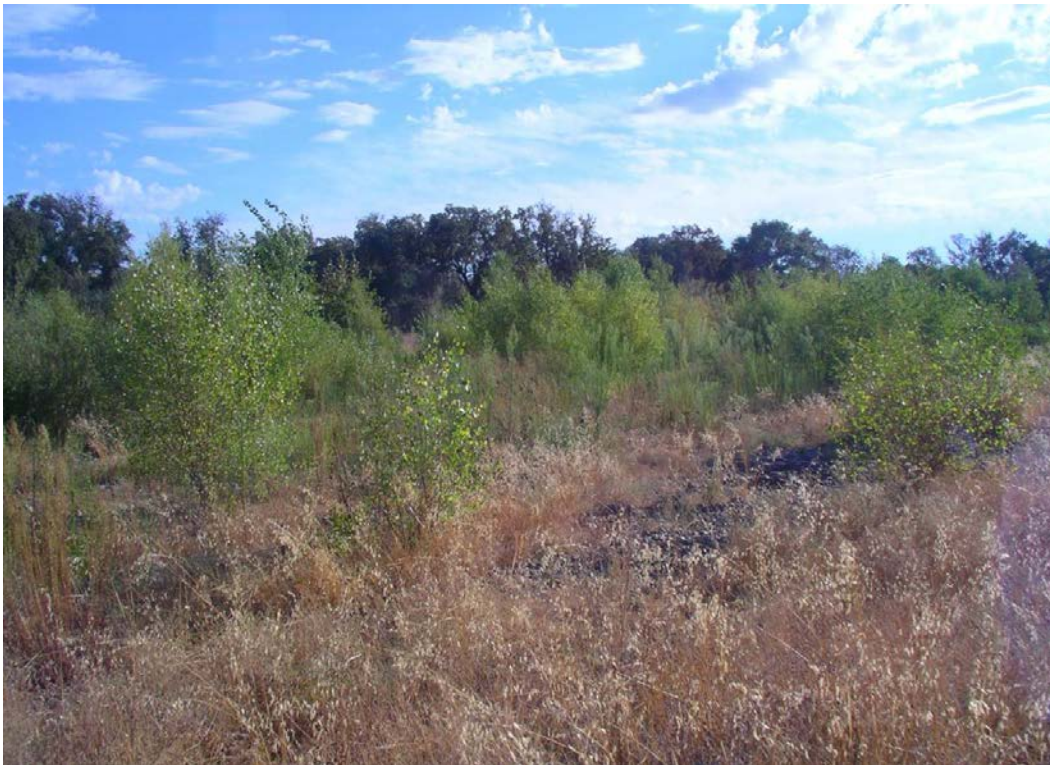
**Figure 5.1-4. Several patches of young Fremont cottonwood occupy areas of low relative elevation along the north side of Reach 6 in the Bobcat Flat restoration area.**

now support patches of recently planted cottonwood (2005), valley oak, and mixed willow (Figure 5.1-4). As an unintended consequence of this restoration, excavated ponded areas are also supporting rich populations of the highly invasive aquatic weed, water hyacinth (*Eichhornia crassipes*) (Figure 5.1-5). Areas on the south side of the channel have not been re-contoured and the large ridges of tailings separate portions of the floodplain from the main channel and create local low relative elevation pockets of high moisture colonized by native riparian plants (Figure 5.1-6). Other areas of this reach support a patchwork of riparian vegetation interspersed with open European grasses and weeds and/or sparsely vegetated tailings. This reach includes the only sites where McBain and Trush (2000) reported finding multiple age classes of Fremont cottonwood that were not actively planted, indicating that natural recruitment continues to occur in this area, in contrast to other areas of the lower Tuolumne.

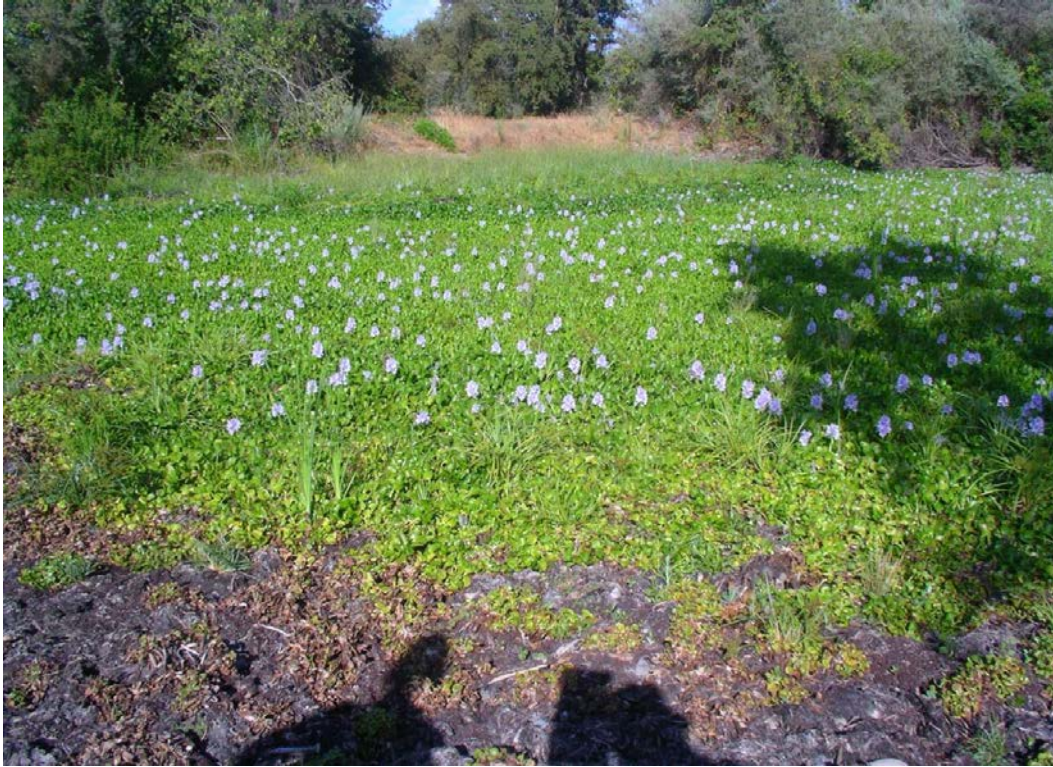
**Figure 5.1-5. Water hyacinth crowds ponded areas created by depressions in the low elevation portions of Reach 6.**

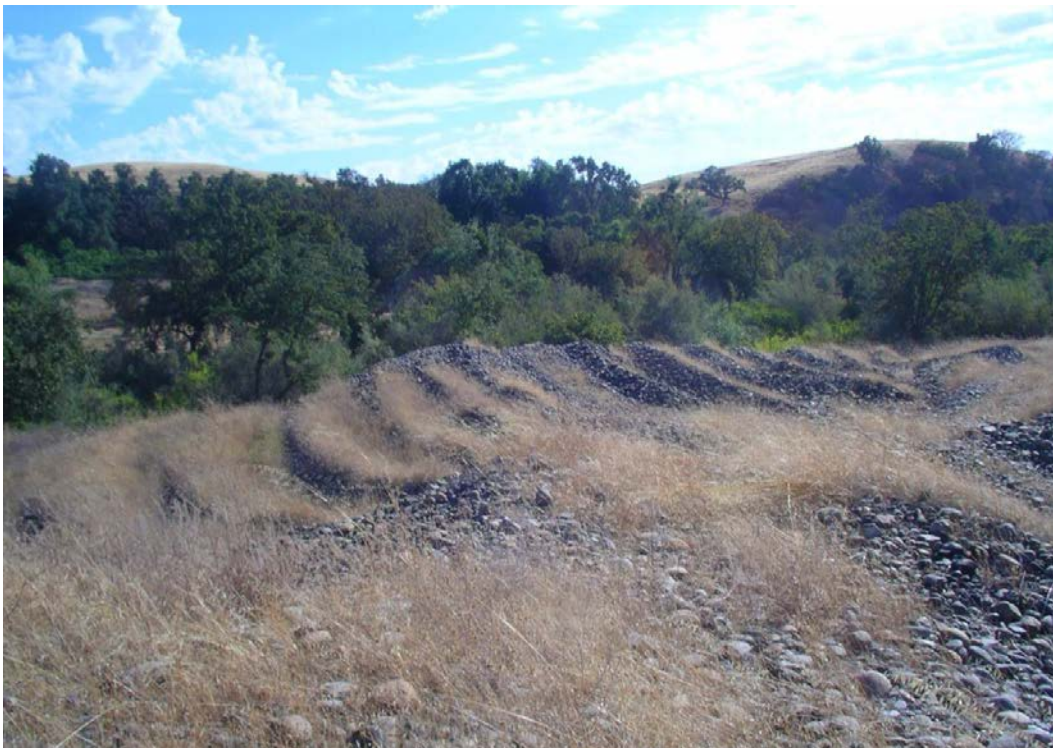
**Figure 5.1-6. View looking south, with main channel in back of photographer, from top of mine tailing pile along Reach 6. Valley oaks and mixed willows in foreground have colonized side channel area created by tailings.**

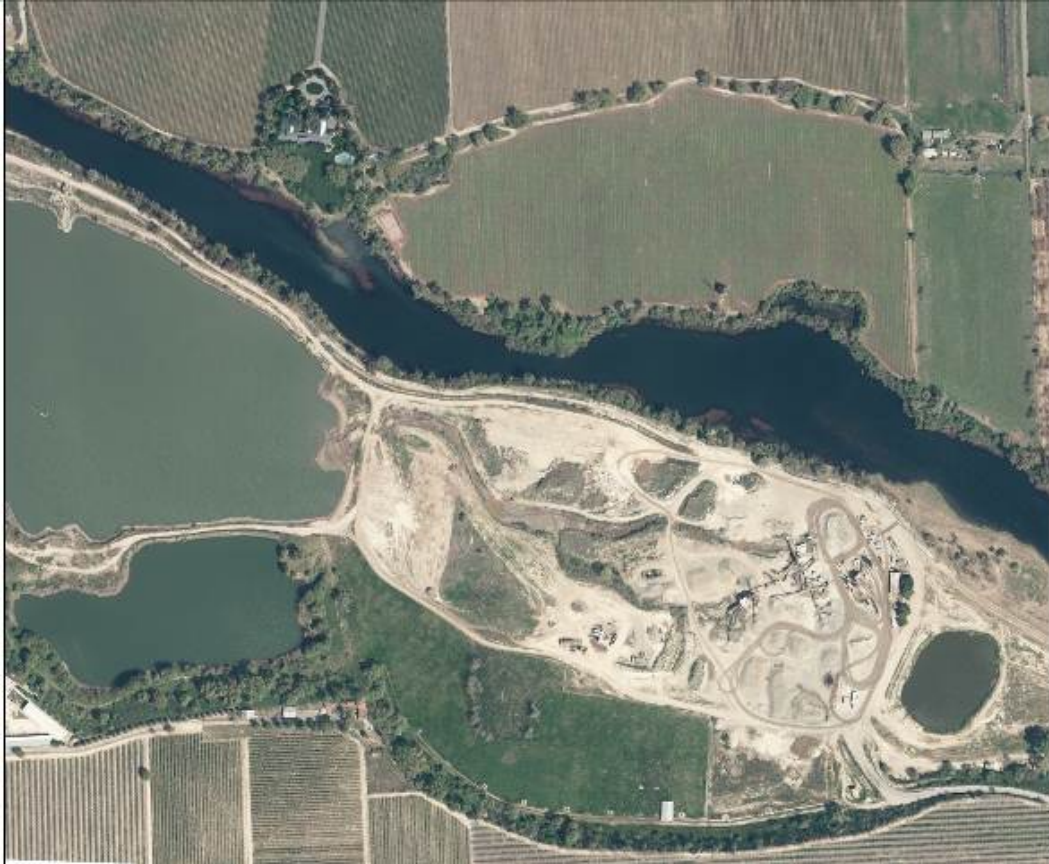
**Figure 5.2-1. Active and legacy gravel mining operations can preclude development of riparian vegetation in areas of the historical floodplain that extend from River Mile 24-50 along the lower Tuolumne River.**

Aggregate mining continues in localized areas from Hughson to La Grange (RM 24-50). Gravel mining of historic floodplains leaves deep ponds precariously close to the channel, protected from channel capture by levees. Space available for riparian vegetation development is also highly constrained due to the replacement of floodplain surface by gravel pits and, since the top soil has been removed from the active gravel mining operations, few or no native species can become established in the remaining open floodplain areas (Figure 5.2-1). Riparian vegetation along the steep levee banks is cleared and regeneration prevented with the intent of maintaining levee integrity. Gravel pits become filled with ground water and support populations of non-native aquatic plant species, such as water hyacinth. These gravel pits are deep (up to 38 ft deep) and up to 400 ft wide, and by occupying large portions of the floodplain, constrain the channel to a stationary and narrow area (McBain and Trush 2000). Therefore, channel meander is prevented in these reaches, along with associated riparian vegetation development and diversity.

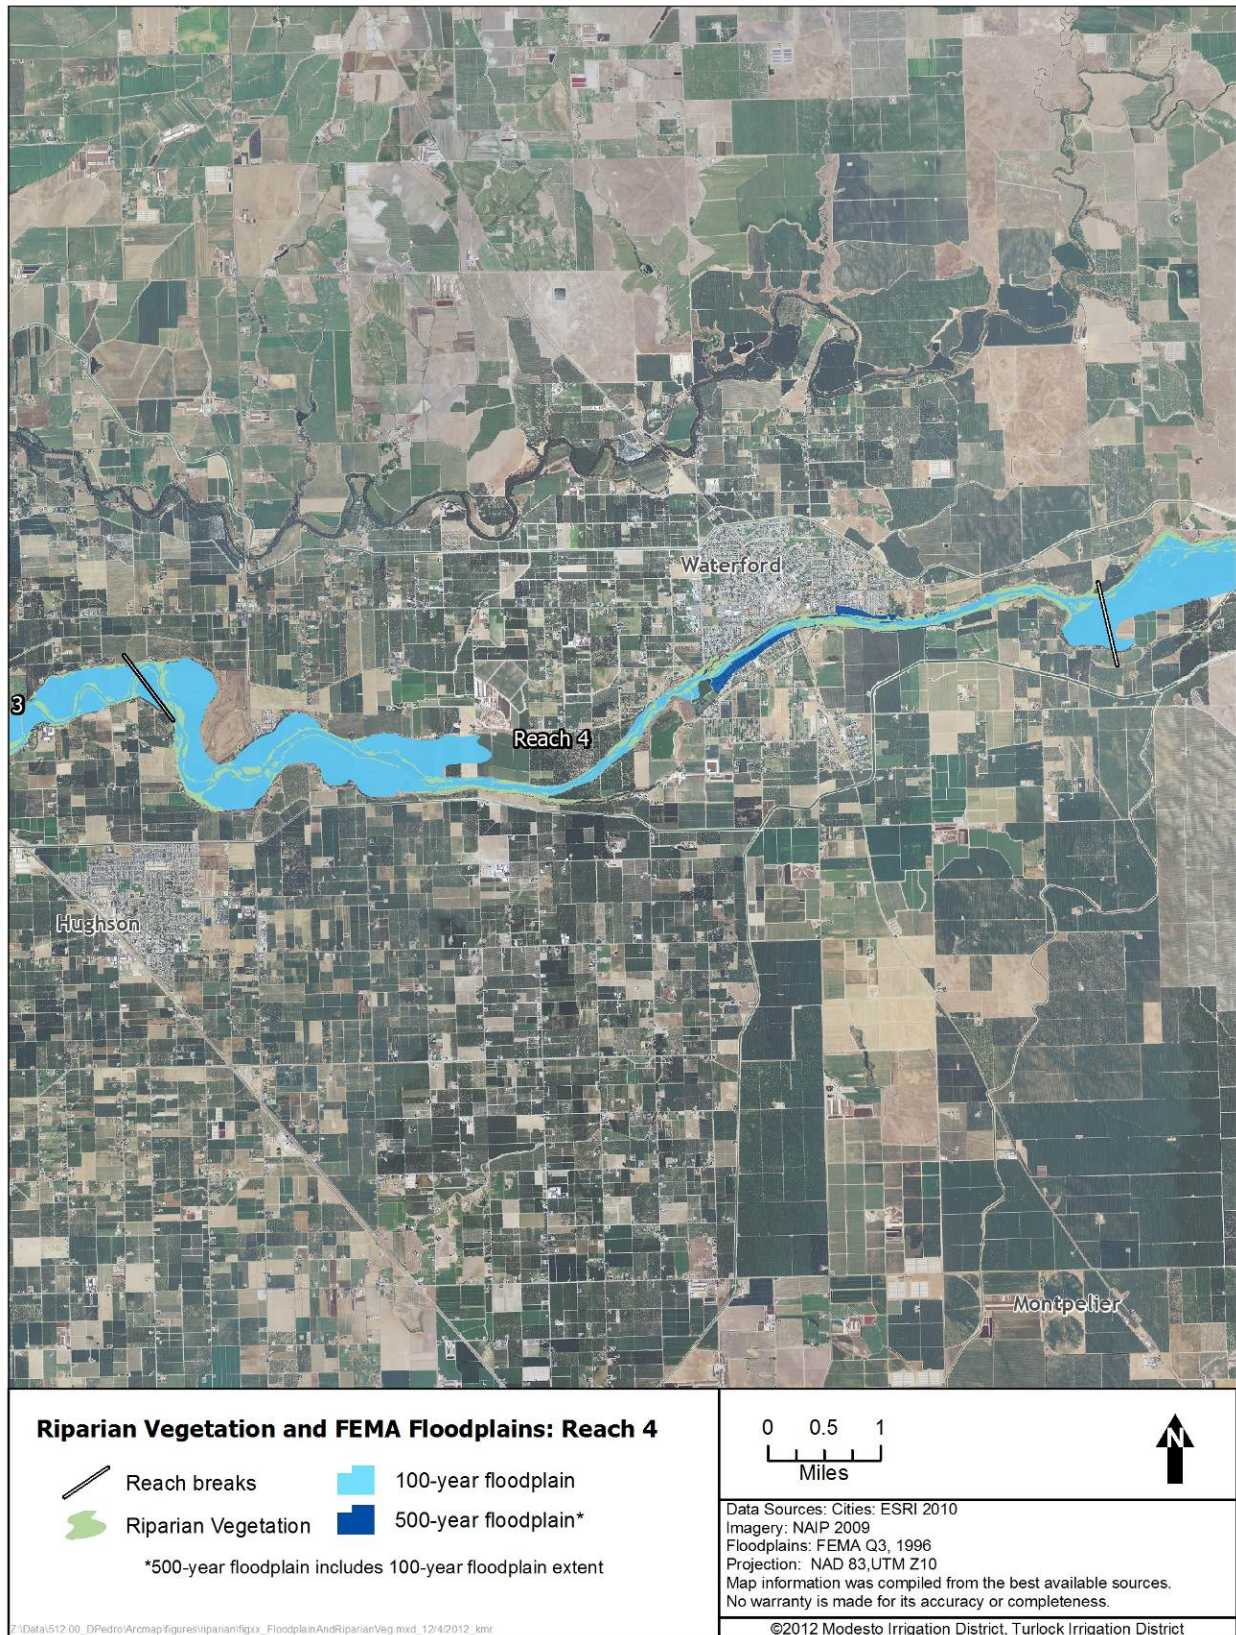
**Figure D-4. Riparian vegetation and FEMA floodplains along Reach 4 of the lower Tuolumne River.**
