STUDY REPORT TR-07 CALIFORNIA RED-LEGGED FROG

ATTACHMENT A

DETAILED SITE ASSESSMENT RESULTS

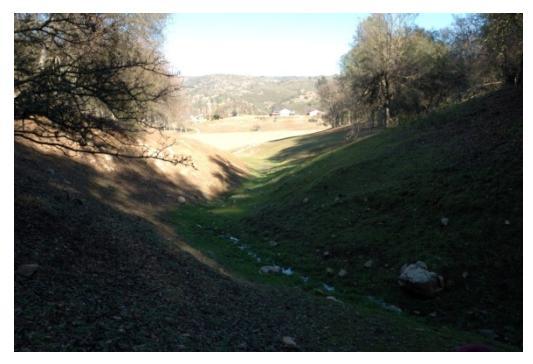
F1 is a 58-m-long section of an unnamed tributary, a tributary to the Hatch Creek arm of Don Pedro Reservoir, located partially below the high water line of the reservoir within the FERC Project Boundary. F1 is 2.7 km from the nearest known CRLF occurrence. National Wetlands Inventory (NWI) data (USFWS 2012) depict a riverine, intermittent, streambed, temporarily flooded (R4SBA) wetland feature in the area of the site.

F1 does not hold water for at least 20 weeks during the CRLF breeding season and therefore does not represent potential CRLF breeding habitat.

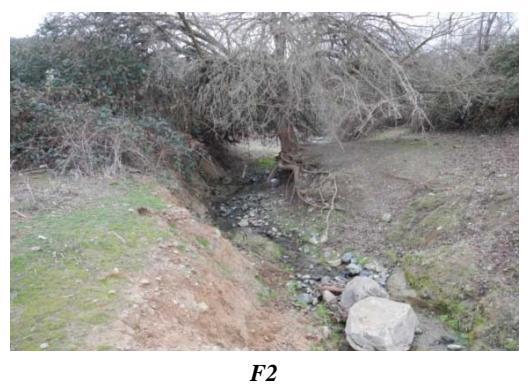
F2 is a 112-m-long section of an unnamed intermittent tributary to Don Pedro Reservoir, located approximately 65 m west of Marsh Flat Road, partially below the high water line of Don Pedro Reservoir, and within the FERC Project Boundary. F2 is 2.5 km from the nearest known CRLF occurrence. NWI data depict F2 as a riverine, intermittent, streambed, seasonally flooded (R4SBC) wetland feature.

The site was assessed on February 7, 2012. F2 is adjacent to F63. The bank full width was estimated to

be 2 m and the bank full depth was estimated to be 1.5 meter. The stream gradient was 4 percent. One pool was present, measuring approximately 6 m x 2 m, with a maximum depth of 0.2 meter. Non-pool habitat was riffle. The substrate was sand and vegetated soil. The banks were steeply sloping and consisted of vegetated soil that was eroded in places. Upland grasses made up the emergent vegetation and aquatic vegetation was dominated by duckweed (*Lemna* sp.). Oak and Himalayan blackberry (*Rubus discolor*) were overhanging. No fish or amphibians were observed; however, fish are known to be present in Don Pedro Reservoir. Surrounding upland habitat was a combination of oak and foothill pine woodland; below the high water line, canopy cover was minimal.

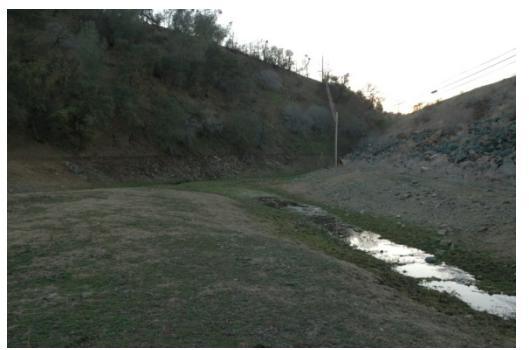
F3 is a freshwater pond formed at the confluence of three perennial tributaries to Don Pedro Reservoir, located east of SR 182, 65 m east of Don Pedro Reservoir, and within the FERC Project Boundary. F3 is 4 km from the nearest known CRLF occurrence. NWI data for the area depict a palustrine, unconsolidated bottom, permanently flooded, diked/impounded (PUBHh) wetland feature in the area of the site.

full width was estimated at 1.5 m with a maximum depth of 0.5 m. The stream gradient was approximately 3 percent. Pools measuring up to 5 m x 1.5 m and 0.1 m deep were present at the site. Non-pool habitat was made up of riffles. Substrate consisted of silt. Banks were gently sloping with an incised vegetated channel. The dominant emergent and margin vegetation was grass with no overhanging vegetation present. Surrounding upland habitat consisted of blue oak (*Quercus douglasii*) pastureland. A juvenile American bullfrog was observed during the survey.

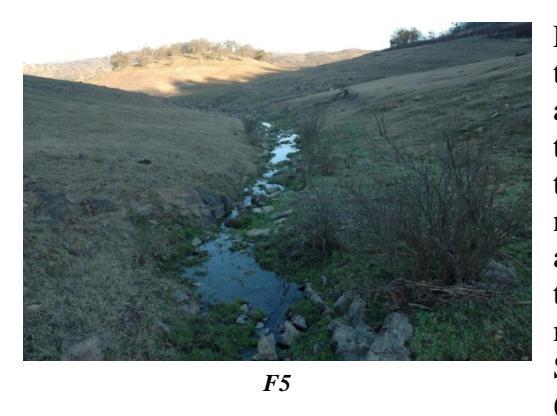
Site F5

F5 is a 152-m-long section of an unnamed intermittent tributary Don Pedro to Reservoir. located approximately 75 m north of SR 132, partially below the high water line of Don Pedro Reservoir and within the FERC Project Boundary. F5 is 4 km from the nearest known CRLF occurrence. NWI data for the area depict a riverine, intermittent, streambed, temporarily flooded (R4SBA) wetland feature from the mouth of the reservoir to 350 m upstream, including Site F5, which becomes a freshwater emergent seasonal (PEMC) wetland feature further upstream.

The site was assessed on February 8, 2012. The bank full width was estimated at 1.5 m and depth was 0.5 m. The stream gradient was 3.5 percent. Pools measuring up to 3 m x 0.75 m and 0.1 m deep were present in the stream. Non-pool habitat was a mix of riffle, cascade, and run. The substrate consisted of angular cobbles and boulders. The banks of the channel were incised and consisted of soil with emergent vegetation. Willows (*Salix* sp.) and grasses were the dominant vegetation at the site, with willows overhanging the stream. No fish or amphibians were observed; however, fish are known to be present in Don Pedro Reservoir. Surrounding upland habitat was blue oak pastureland, with the canopy cover minimal below the high water line and increasing to 30 percent upstream of the assessment location.

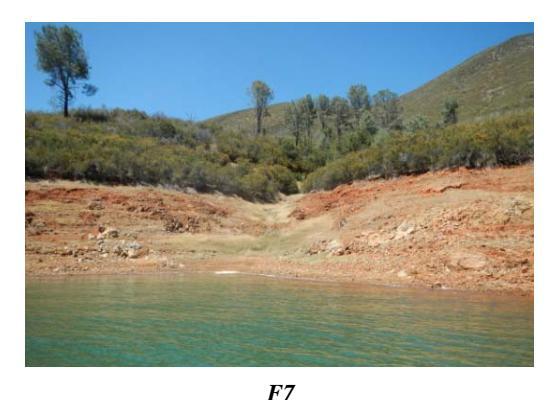
Site F7

F7 is a 32-m-long section of an ephemeral tributary to Don Pedro Reservoir at Upper Bay, below the high water line and within the FERC Project Boundary. F7 is 10 km from the nearest known CRLF occurrence. NWI data for the area depict a riverine, intermittent, streambed, temporarily flooded (R4SBA) wetland feature.

The site was assessed on June 19, 2012. F7 is in the vicinity of seven other ephemeral tributaries to Don Pedro Reservoir at Upper Bay. The bank full width

was 1 m with a depth of 0.25 m. The stream gradient was 4 percent. The stream was dry at the time of survey, but it was assumed that pools would be present during flow conditions. Non-pool habitat was assumed to be a mix of riffle and cascade. The substrate was made up of soil and

bedrock with some cobbles. The stream banks were very shallow and vegetated with grasses, sloping to steeper bedrock in places. Emergent vegetation consisted of grasses and forbs below the high water line. Buckthorn, oak, and foothill pine were overhanging the stream channel above the high water line and were the dominant vegetation in the uplands. No fish or amphibians were observed; however, fish are known to be present in Don Pedro Reservoir.

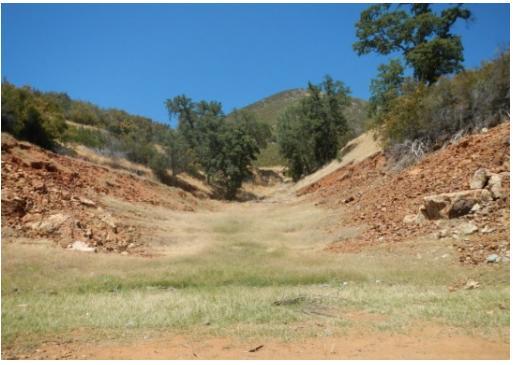
F8 is a 45-m-long section of an ephemeral tributary to the upper bay of Don Pedro Reservoir, below the high water line of Don Pedro Reservoir within the FERC Project Boundary. F8 is 10 km from the nearest known CRLF occurrence. NWI data for the area depict a riverine, intermittent, streambed, temporarily flooded (R4SBA) wetland feature in the area of the site.

was 1 m with a depth of 0.25 m. The stream gradient was 4 percent. The stream was dry at the time of survey, but it was assumed that no pools were present. Non-pool habitat was assumed to be riffle during flow conditions. The substrate was made up of soil and bedrock with some cobbles. The stream bank varied from gently sloping to steep bedrock and cobbles with grass present in flat areas. Emergent and margin vegetation consisted of grasses and forbs below the high water line, with buckthorn and oak in the upland and overhanging the stream channel in some areas. No fish or amphibians were observed; however, fish are known to be present in Don Pedro Reservoir.

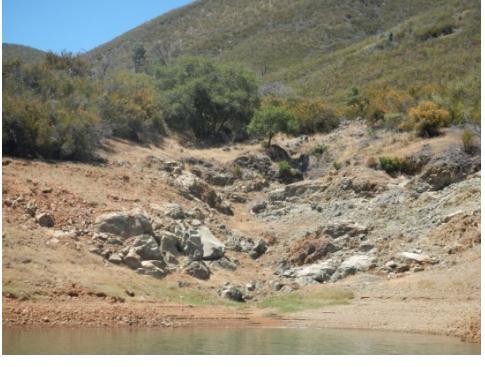
F9 is a 37-m-long section of an ephemeral tributary to the upper bay of Don Pedro Reservoir, below the high water line of Don Pedro Reservoir within the FERC Project Boundary. F9 is 9.8 km from the nearest known CRLF occurrence. NWI data for the area depict a riverine, intermittent, streambed, temporarily flooded (R4SBA) wetland feature in the area of the site.

was 2 m with a depth of 1 m. The stream gradient was 6 percent. The stream was dry at the time of survey, but it was assumed that pools would be present during flow conditions. Non-pool habitat was assumed to be a mix of cascade, riffle, and step-pool. The substrate was made up of soil and grasses that were present throughout the stream channel. Stream banks consisted of somewhat steep bedrock. Emergent and margin vegetation consisted of grasses, with one oak overhanging the stream channel. Upland habitat was dominated by buckthorn (*Ceanothus* sp.). No fish or amphibians were observed; however, fish are known to be present in Don Pedro Reservoir.

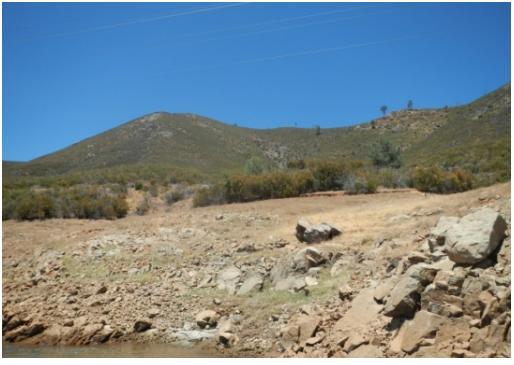
F10 is a 53-m-long section of an ephemeral tributary to the upper bay of Don Pedro Reservoir, below the high water line of Don Pedro Reservoir within the FERC Project Boundary. F10 is 9.7 km from the nearest known CRLF occurrence. NWI data for the area depict a riverine, intermittent, streambed, temporarily flooded (R4SBA) wetland feature in the area of the site.

defined stream channel, so bank full width and depth could not be estimated. The stream was dry at the time of survey, but it was assumed that no pools would be present. Non-pool habitat was assumed to be riffle during flow conditions. The substrate was made up of soil and grasses that were present throughout the stream channel. Emergent and margin vegetation consisted of desiccated grasses, with buckthorn and Manzanita in the upland and overhanging the stream channel in some areas. No fish or amphibians were observed; however, fish are known to be present in Don Pedro Reservoir.

F10 does not hold water for at least 20 weeks during the CRLF breeding season and therefore does not represent potential CRLF breeding habitat.

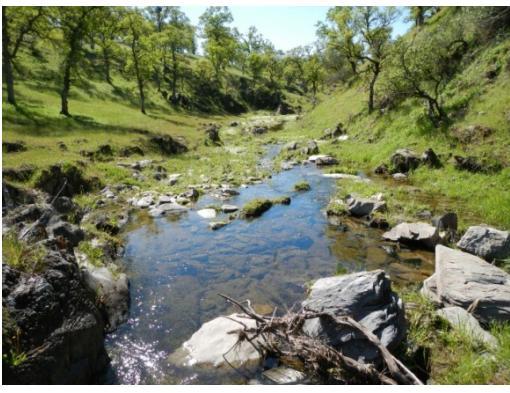
F11 is a 591-m-long section of West Fork Big Creek, a perennial tributary to Don Pedro Reservoir, located partially below the high water line of Don Pedro Reservoir within the FERC Project Boundary. F11 is 17 km from the nearest known CRLF occurrence. NWI data for the area depict a riverine, intermittent, streambed, seasonally flooded (R4SBC) wetland feature in the area of the site.

Pools measuring up to 2 m x 5 m and 0.75 m deep were present in the stream. Non-pool habitat consisted of riffle, run, and step-pool. The substrate was made up of bedrock and cobbles. Stream banks varied from low gradient to steeper areas of vegetated soil with some bedrock outcroppings. Emergent vegetation was a mix of grasses and forbs, with willow overhanging the site. Upland habitat was made up of oak, a few pines, and shrubs. American bullfrogs and small fish were observed at the site during the survey.

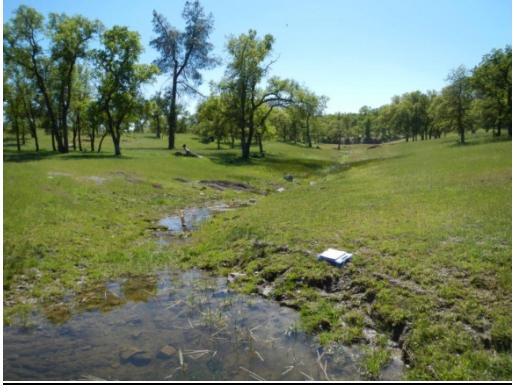
F12 is a 58-m-long section of an unnamed perennial tributary to the Big Creek arm of Don Pedro Reservoir, located 40 m northeast of Don Pedro Reservoir within the FERC Project Boundary. F12 is 8.7 km from the nearest known CRLF occurrence. NWI data for the area depict a riverine, intermittent, streambed, seasonally flooded (R4SBC) wetland feature in the area of the site.

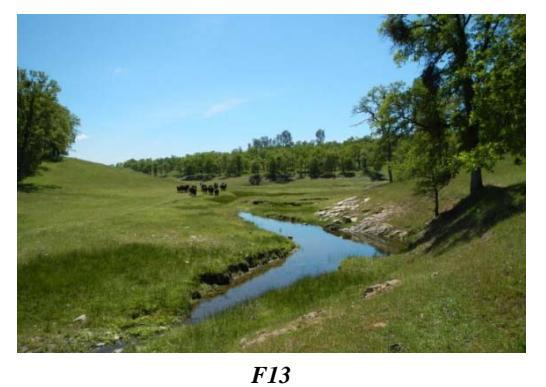
Site F13

F13 is a 736-m-long section of an unnamed perennial tributary to 49er Bay, located 15 m south of Old Don Pedro Road, partially below the high water line of Don Pedro Reservoir and within the FERC Project Boundary. F13 is 7.3 km from the nearest known CRLF occurrence. NWI data for the area depict a riverine, intermittent, streambed, seasonally flooded (R4SBC) wetland feature in the area of the site.

The site was assessed on April 19, 2012. F13 is a series of pools within a stream and is not located near any

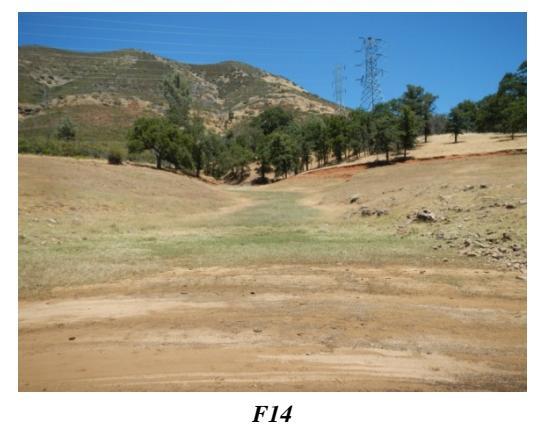
Site F14

F14 is a 45-m-long section of an ephemeral tributary to the upper bay of Don Pedro Reservoir, below the high water line of Don Pedro Reservoir within the FERC Project Boundary. F14 is 9.5 km from the nearest known CRLF occurrence. NWI data for the area depict a riverine, intermittent, streambed, temporarily flooded (R4SBA) wetland feature in the area of the site.

The site was assessed on June 19, 2012. F19 is in the vicinity of seven other ephemeral tributaries to the upper bay of Don Pedro Reservoir. The bank full width was 7–10m with a depth of 2-3 m, but the channel was

but it was assumed that no pools would be present. Non-pool habitat was assumed to be riffle during flow conditions. The substrate was made up of soil and grasses that were present throughout the stream channel. Stream banks were gently sloping and covered with grass with some rocks where the stream approached the reservoir. Emergent and margin vegetation consisted of grasses, with oak in the upland and overhanging the stream channel in the upstream portion of the site. Manzanita and buckthorn were also present in the upland habitat. No fish or amphibians were observed; however, fish are known to be present in Don Pedro Reservoir.

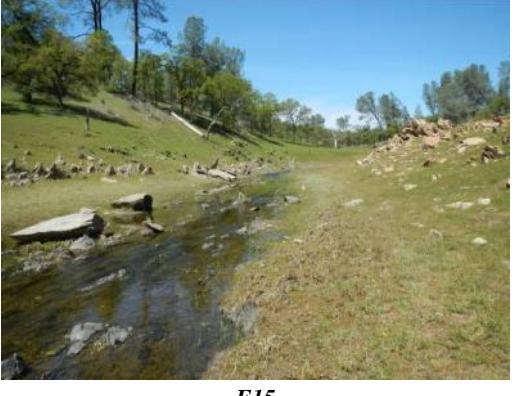
bank full width of the stream was observed to be 7 - 8 m with a depth of 0.5 m. The stream gradient was 2 - 4 percent. Pools measuring up to 1 m x 3 m and 1.5 m deep were present in the stream. Non-pool habitat consisted of riffle, run, and cascade. The substrate was made up of bedrock, gravel, cobble, and boulder. Stream banks were low gradient near the stream, turning to steeper rolling hills. Emergent and margin vegetation were a combination of grasses and forbs with no vegetation overhanging the site. Upland habitat was a mixed oak and foothill pine savannah with approximately 45 percent canopy cover. Juvenile and larval American bullfrogs were present throughout the site, and 3 western toads were observed in amplexus during the survey. A bald eagle was observed feeding on a bass near the stream with a juvenile or subadult nearby. Horses were observed grazing near the stream.

F15 holds water for at least 20 weeks during the CRLF breeding season and therefore represents potential CRLF breeding habitat. However, lack of overhanging vegetation and the presence of American bullfrogs diminish the potential suitability of this site.

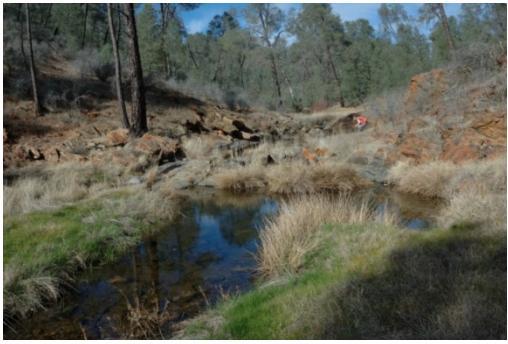
F17

stream gradient was 2 - 4 percent. Pools measuring up to 10 m x 6 m and 0.8 m deep were present in the stream. Non-pool habitat was a combination of cascade, step-pool, run, and low gradient riffle. The substrate was made up of bedrock, boulder, and subangular cobble. Stream banks were a mix of confined, steep rocky soil and low gradient vegetated soil. Emergent vegetation was consisted of grasses with foothill pine overhanging. Upland habitat was made up of foothill pine woodland and toyon (Heteromeles arbutifolia). No fish or amphibians were observed; however, fish are known to be present in Don Pedro Reservoir.

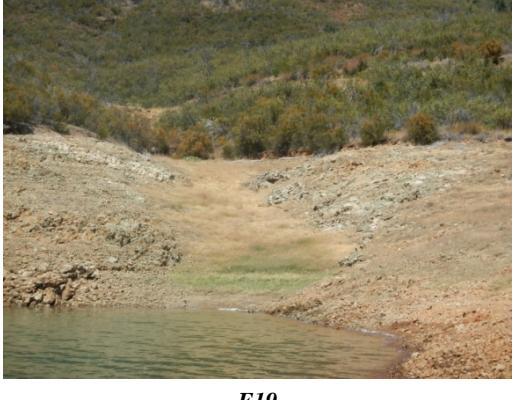
F19

well defined. The stream gradient was 6 percent. The stream was dry at the time of survey, but it was assumed that no pools would be present. Non-pool habitat was assumed to be riffle during flow conditions. The substrate was made up of soil and grasses that were present throughout the stream channel. Stream banks were gently sloping bedrock and gravel. Emergent and margin vegetation consisted of grasses, with buckthorn and other scrub/shrubs in the upland and overhanging the stream channel in the upstream portion of the site. No fish or amphibians were observed; however, fish are known to be present in Don Pedro Reservoir.

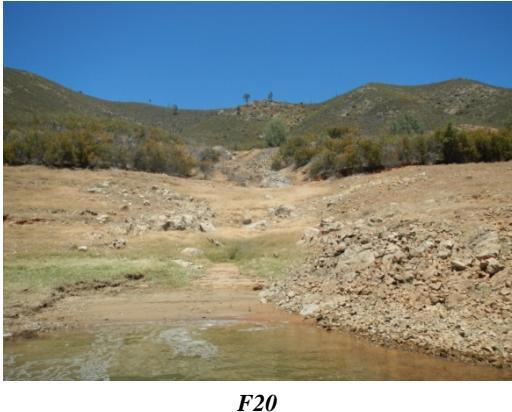
Site F20

F20 is a 33-m-long section of an ephemeral tributary to the upper bay of Don Pedro Reservoir, below the high water line of Don Pedro Reservoir within the FERC Project Boundary. F20 is 9.7 km from the nearest known CRLF occurrence. NWI data for the area depict a riverine, intermittent, streambed, temporarily flooded (R4SBA) wetland feature in the area of the site.

could not be estimated. The stream gradient was 6 percent. The stream was dry at the time of survey, but it was assumed that no pools would be present. Non-pool habitat was assumed to be a mix of riffle and cascade during flow conditions. The substrate was made up of soil and grasses that were present throughout the stream channel and bedrock with some cobbles in the upstream section. Emergent and margin vegetation consisted of grasses, with buckthorn in the upland and overhanging the stream channel in the upstream portion of the site. The upland habitat was a combination of pine and scrub/shrub. No fish or amphibians were observed; however, fish are known to be present in Don Pedro Reservoir.

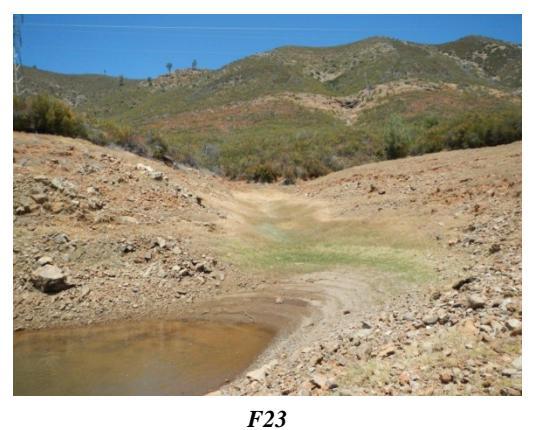
Site F23

F23 is a 48-m-long section of an ephemeral tributary to the upper bay of Don Pedro Reservoir, below the high water line of Don Pedro Reservoir within the FERC Project Boundary. F23 is 9.6 km from the nearest known CRLF occurrence. NWI data for the area depict a riverine, intermittent, streambed, temporarily flooded (R4SBA) wetland feature in the area of the site.

gradient was 4 percent. The stream was dry at the time of survey, but it was assumed that no pools would be present. Non-pool habitat was assumed to be riffle during flow conditions. The substrate was made up of soil and grasses that were present throughout the stream channel. Stream banks were gently sloping and vegetated, and become increasingly rocky towards the top of the slope. Emergent and margin vegetation consisted of grasses, with Manzanita and buckthorn in the upland and overhanging the stream channel in some areas. No fish or amphibians were observed; however, fish are known to be present in Don Pedro Reservoir.

F23 does not hold water for at least 20 weeks during the CRLF breeding season and therefore does not represent potential CRLF breeding habitat.

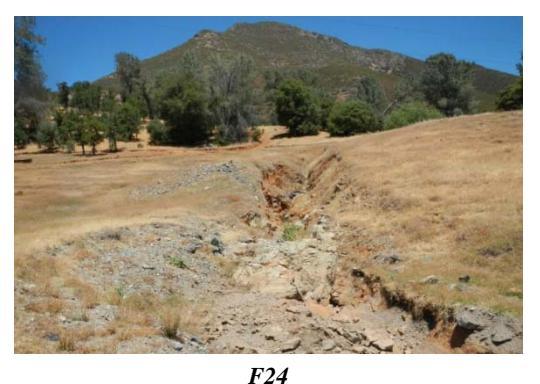
F24 is a 77-m-long section of an ephemeral tributary to the upper bay of Don Pedro Reservoir, below the high water line of Don Pedro Reservoir within the FERC Project Boundary. F24 is 9.1 km from the nearest known CRLF occurrence. NWI data for the area depict a riverine, intermittent, streambed, seasonally flooded (R4SBC) wetland feature in the area of the site.

to a large constructed gravel slope and beneath power lines. The bank full width was 3 m with a depth of 1.25 m. The stream gradient was 6 percent. The stream was dry at the time of survey, but it was assumed that pools up to 5m x 2m would be present during flow conditions. Non-pool habitat was assumed to be a mix of cascade and riffle. The substrate was made up of soil and gravel with bedrock in the upstream portion. Stream banks were steeply incised and made up of a combination of soil and gravel with bedrock upstream. Emergent and margin vegetation consisted of desiccated grasses and forbs, with no overhanging vegetation. Upland habitat was a mix of pine and oak with 60 percent canopy cover. No fish or amphibians were observed; however, fish are known to be present in Don Pedro Reservoir.

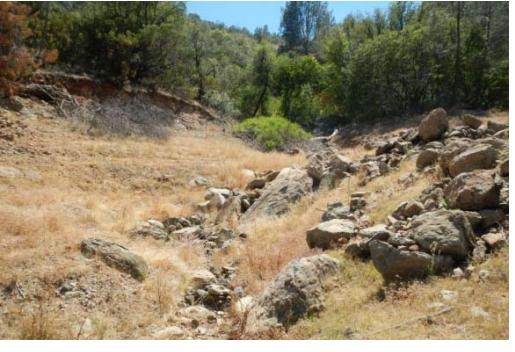
width was estimated at 2 m. The bank full width was estimated at 2 m with a maximum depth of 0.75 m. The stream gradient was 5 percent. The stream was dry at the time of survey, but it was assumed that pools measuring up to 1 m x 1 m during flow conditions. Non-pool habitat was assumed to be a mix of riffle and cascade. The substrate consisted of boulders and cobbles. The banks of the channel had a slightly steep grade with no abrupt drop off or incision and were vegetated to the stream. Emergent and margin vegetation consisted of grasses and forbs with willows overhanging. No amphibian or fish species were observed during the survey. Surrounding upland habitat included mixed oak and pine woodland with 90 percent canopy cover upstream, but no cover downstream.

F29 does not hold water for at least 20 weeks during the CRLF breeding season and therefore does not represent potential CRLF breeding habitat.

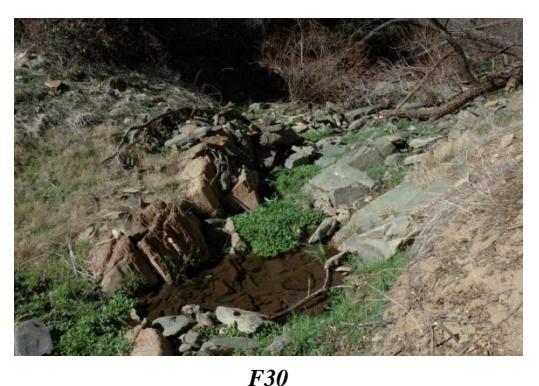
F30 is a 321-m-long section of a perennial tributary to Don Pedro Reservoir, Kanaka Creek, located south of Jacksonville Road, partially below the high water line of Don Pedro Reservoir, and within the FERC Project Boundary. F30 is 14.3 km from the nearest known CRLF occurrence. NWI data for the area depict a riverine, intermittent, streambed, seasonally flooded (R4SBC) wetland feature from the mouth at the reservoir upstream including Site F30.

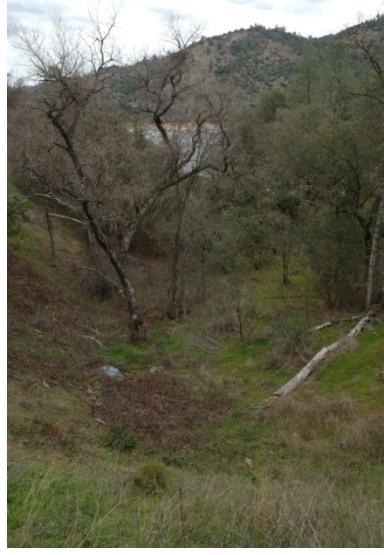
F31

consisted of riffle, but the stream was mostly dry at the time of the survey with some seepage at the culvert. Substrate was made up of angular cobble. The stream was channelized with incised banks, especially upstream of the culvert. Downstream of the culvert, no channel was visible at the time of the survey. No emergent vegetation was present, but the margins were vegetated with blackberry and upland grasses. Blackberry was overhanging the stream. Surrounding upland habitat included foothill pine, oak, and Manzanita (*Arctostaphylos* sp.). No fish or amphibians were observed; however, fish are known to be present in Don Pedro Reservoir.

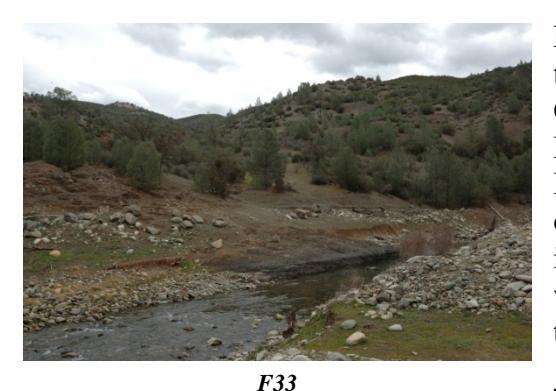
F33 is an 88-m-long section of an unnamed seasonal tributary to Don Pedro Reservoir, located south of Grizzly Road, partially below the high water line of Don Pedro Reservoir, and within the FERC Project Boundary. F33 is 11 km from the nearest known CRLF occurrence. NWI data for the area depict a riverine, intermittent, streambed, temporarily flooded (R4SBA) wetland feature upstream of the where the stream joins the river, including Site F33.

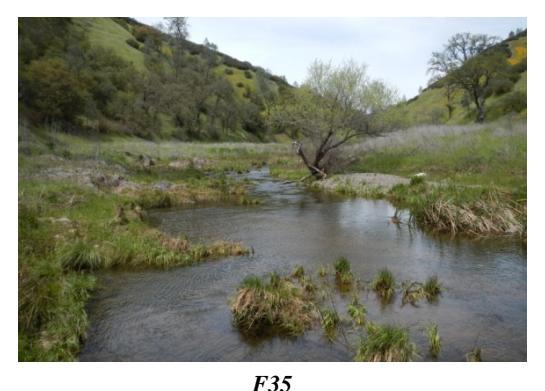
Site F35

F35 is a 173-m-long section of Woods Creek, located below the high water line of Don Pedro Reservoir within the FERC Project Boundary. F35 is 13.6 km from the nearest known CRLF occurrence. NWI data for the area depict a lacustrine, littoral, unconsolidated shore, seasonally flooded, diked/impounded (L2USCh) wetland feature in the area of the site.

F35 holds water for at least 20 weeks during the CRLF breeding season and therefore represents potential CRLF breeding habitat. However, the presence of fish and American bullfrogs diminishes the potential suitability of this site.

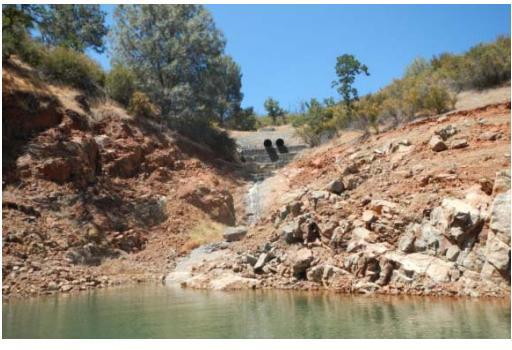
F38

from parallel culverts that cross a BLM road over rock face with no defined channel. The stream was dry at the time of survey, but it was assumed that two pools would be present during flow conditions. Non-pool habitat was assumed to be cascade. The substrate was made up of soil and grasses that were present throughout the stream channel. The bank consisted of cobbles on the bedrock outside of the rock face. Emergent and margin vegetation consisted of desiccated grasses, with buckthorn and other scrub/shrubs in the upland and overhanging the stream channel

in some areas. A few scattered oak and pine were also present in the upland. No fish or amphibians were observed; however, fish are known to be present in Don Pedro Reservoir.

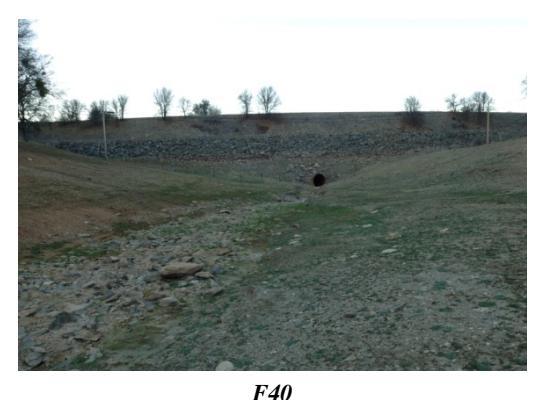
Site F40

F40 is a palustrine freshwater pond, located south of US Hwy 132, below the high water line of Don Pedro Reservoir and within the FERC Project Boundary. F40 is 4.4 km from the nearest known CRLF occurrence. NWI data for the area depict a palustrine, unconsolidated shore, seasonally flooded, diked/impounded (PUSCh) wetland feature in the area of the site.

drainage. The site covers approximately $14,300 \text{ m}^2$; the maximum observed water depth was greater than 2 m; the bank full depth was greater than 2 m. The pond was dry at the time of assessment. Substrate consisted of soil, silt, bedrock, and boulders. Emergent vegetation consisted of sparse grass and forbs, the dominant vegetation in the area. No vegetation was

overhanging the pond. Sierran treefrog was heard calling but was not observed. Upland habitat was made up of blue oak pastureland.

Hydrological conditions at F40 vary greatly from year to year depending on reservoir operations. In most years F40 holds water for at least 20 weeks during the CRLF breeding season and may represent potentially suitable CRLF. However, lack of overhanging vegetation diminishes the potential suitability of this site.

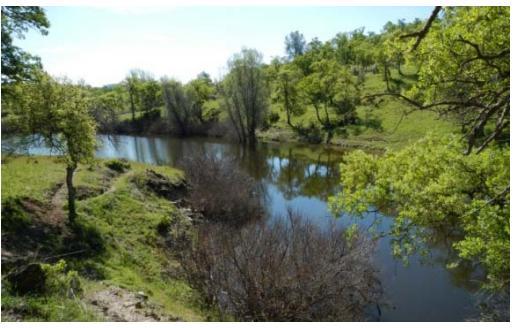
The site was assessed on April 17, 2012. F43 is adjacent to site F21. The site covers approximately 9,900 m^2 ; the maximum observed water depth was greater than 2 m; the bank full depth was greater than 2 m. Substrate consisted mostly of organic matter and silt with some small gravel. The banks of the pond were mostly vegetated and varied from low grade to somewhat steep with angular bedrock outcroppings. Emergent vegetation was dominated by grasses, but included a mix of grasses and forbs with willows overhanging. The margins were vegetated with grasses and forbs. An abundance of large woody debris was present at the time of survey. Upland habitat consisted of rolling hills dominated by oak with a few large willows near the pond. An unidentified frog species jumped into the pond while vocalizing and a western pond turtle was seen basking on the opposite side of the pond.

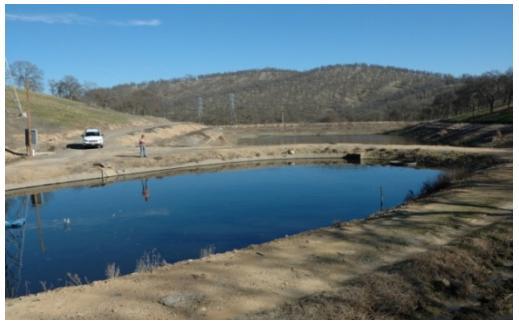
Site F45

F45 is a perennial, freshwater pond, located southwest of Bond Flat Road, 790 m south of Don Pedro Reservoir, and within the FERC Project Boundary. F45 is 7.3 km from the nearest known CRLF occurrence. NWI data for the area depict a palustrine, unconsolidated bottom, permanently flooded, diked/impounded (PUBHh) wetland feature in the area of the site.

F45 The site was assessed on February 8, 2012. F45 is a constructed sewage treatment pond located in an open herbaceous area, adjacent to F49. The site covers approximately 6,100 m²; the maximum observed water depth was greater than 2 m; the

bank full depth was estimated to be 5 m. Substrate consisted of soil that was vegetated with grasses. No emergent or overhanging vegetation was present, but some cattails were present in the margin. Upland habitat was made up of blue oak pastureland, with no canopy cover over the pond. Killdeer (*Charadrius vociferous*) and buffleheads (*Bucephala albeola*) were observed at the site.

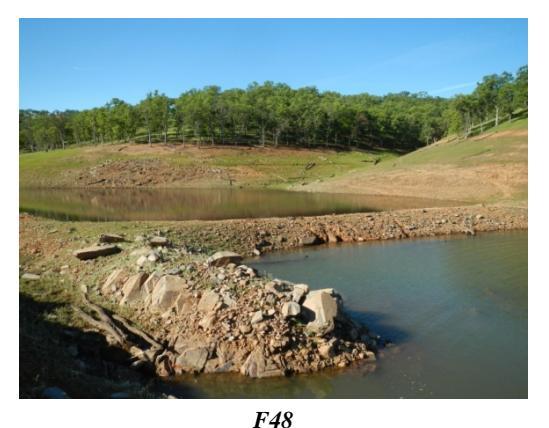
Site F48

F48 is a perennial, freshwater pond created by an impoundment in Lucas Gulch, located below the high water line of Don Pedro Reservoir, within the FERC Project Boundary. F48 is 4.5 km from the nearest known CRLF occurrence. NWI data for the area depict a palustrine, unconsolidated bottom, permanently flooded, diked/impounded (PUBHh) wetland feature in the area of the site.

The site covers approximately 1,585 m²; the maximum observed water depth was greater than 2 m; the bank full depth was greater than 2 m. Substrate consisted of soil with angular cobbles and gravel. The banks of the pond were moderately sloped with somewhat dense upland oaks on hilltops. Emergent vegetation was a mix of grasses, forbs, and monkey flower. No overhanging vegetation was present. Upland habitat consisted of oak savannah with approximately 90 percent canopy cover. Many western toad tadpoles were observed in the upstream shallow end of the pond.

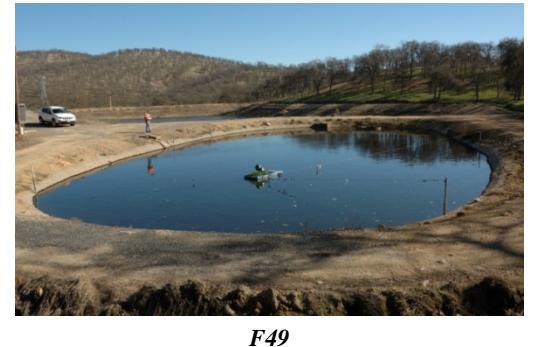
Site F49

F49 is a perennial, freshwater pond, located southwest of Bond Flat Road, 710 m south of Don Pedro Reservoir, and within the FERC Project Boundary. F49 is 7.4 km from the nearest known CRLF occurrence. NWI data for the area depict a palustrine, unconsolidated bottom, permanently flooded, diked/impounded (PUBHh) wetland feature in the area of the site.

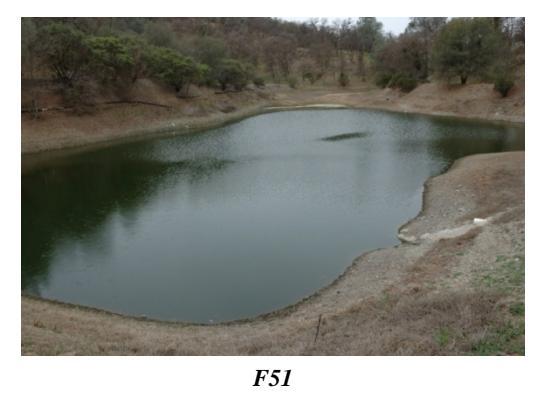
Site F51

F51 is a perennial, freshwater pond, located north of SR49, 195 m southeast of Don Pedro Reservoir, and within the FERC Project Boundary. F51 is 12.1 km from the nearest known CRLF occurrence. NWI data for the area depict a palustrine, unconsolidated bottom, permanently flooded, diked/impounded (PUBHh wetland feature in the area of the site.

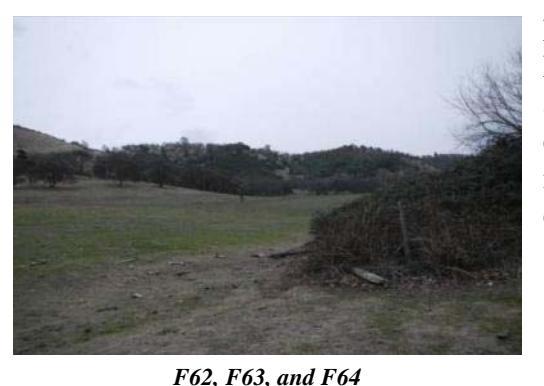
Sites F62, F63, and F64

F62, F63, and F64 are all upland areas located west of Marshes Flat Road, adjacent to Don Pedro Reservoir, and south of Hatch Creek. The sites were labeled as emergent wetlands on the NWI map and were therefore included in the assessment; however, no aquatic feature currently occurs at the mapped location. Upland grassy slopes occurred along the shoreline in this location.

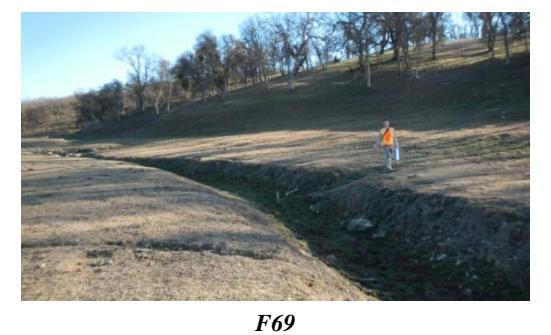
Site F69

F69 is a 658-m-long section of an unnamed perennial tributary to Don Pedro Reservoir, located north of Bonds Flat Road, partially below the high water line of Don Pedro Reservoir, and within the FERC Project Boundary. F69 is 5.1 km from the nearest known CRLF occurrence. NWI data for the area depict a palustrine, emergent, temporarily flooded, diked/impounded (PEMAh) wetland feature in the area of the site.

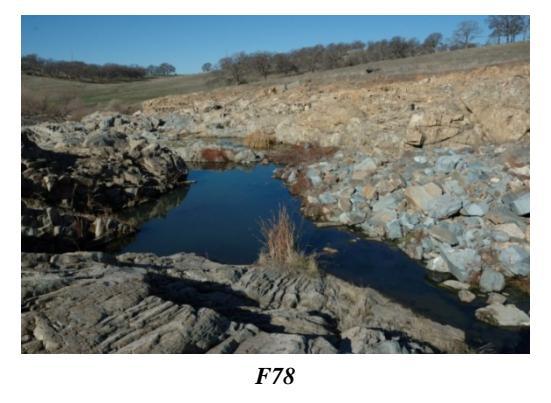
Site F78

F78 is a perennial, freshwater pond, located west of Bonds Flat Road, 200 m west of Don Pedro Reservoir, within the FERC Project Boundary. F78 is 8.8 km from the nearest known CRLF occurrence. NWI data for the area do not show a wetland feature in the area of the site.

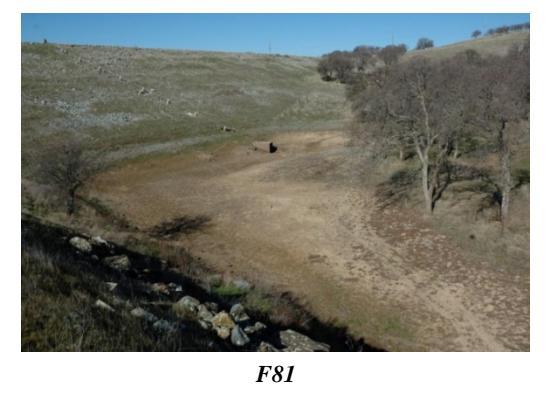
Site F81

F81 is a man-made, freshwater stock pond above a small dam, located southwest of Bonds Flat Road, 800 m southwest of Don Pedro Reservoir, within the FERC Project Boundary. F81 is 9.2 km from the nearest known CRLF occurrence. NWI data for the area do not show a wetland feature in the area of the site.

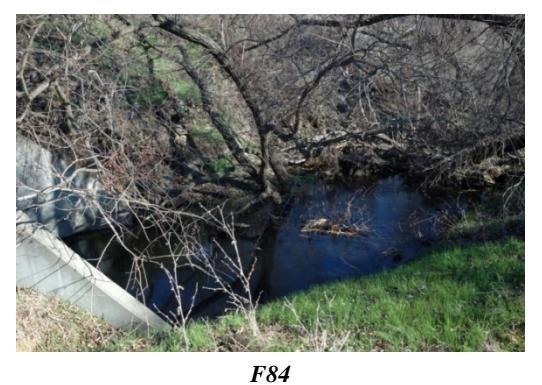
Site F84

F84 is a 357-m-long section of a Big Creek, a perennial tributary to Don Pedro Reservoir that crosses and is adjacent to La Grange Road, within the FERC Project Boundary. F84 is 7 km from the nearest known CRLF occurrence. NWI data for the area do not show a wetland feature in the area of the site.

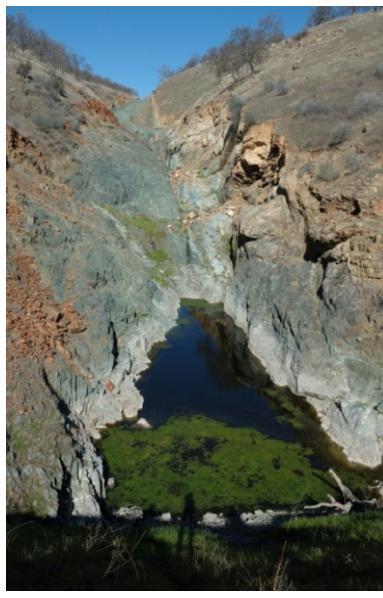
Site F89

F89 is a perennial, freshwater pond, located within a spillway, 1,800 m south of Don Pedro Reservoir, within the FERC Project Boundary. F89 is 9 km from the nearest known CRLF occurrence. NWI data for the area do not show a wetland feature in the area of the site.

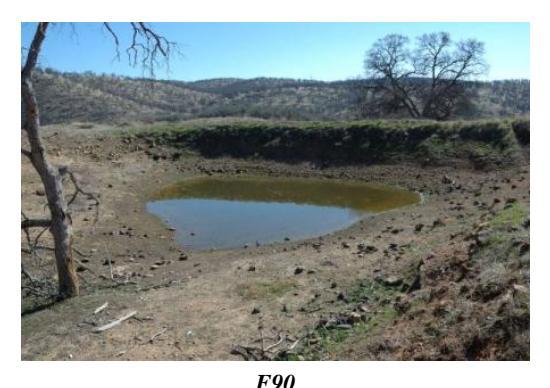
Site F90

F90 is a perennial, freshwater stock pond, located 1,200 m south of Don Pedro Reservoir, within the FERC Project Boundary. F90 is 8.6 km from the nearest known CRLF occurrence. NWI data for the area do not show a wetland feature in the area of the site.
