**VISUAL QUALITY
STUDY REPORT
DON PEDRO PROJECT
FERC NO. 2299**

Prepared for:
Turlock Irrigation District – Turlock, California
Modesto Irrigation District – Modesto, California

Prepared by:
HDR Engineering, Inc.

January 2013

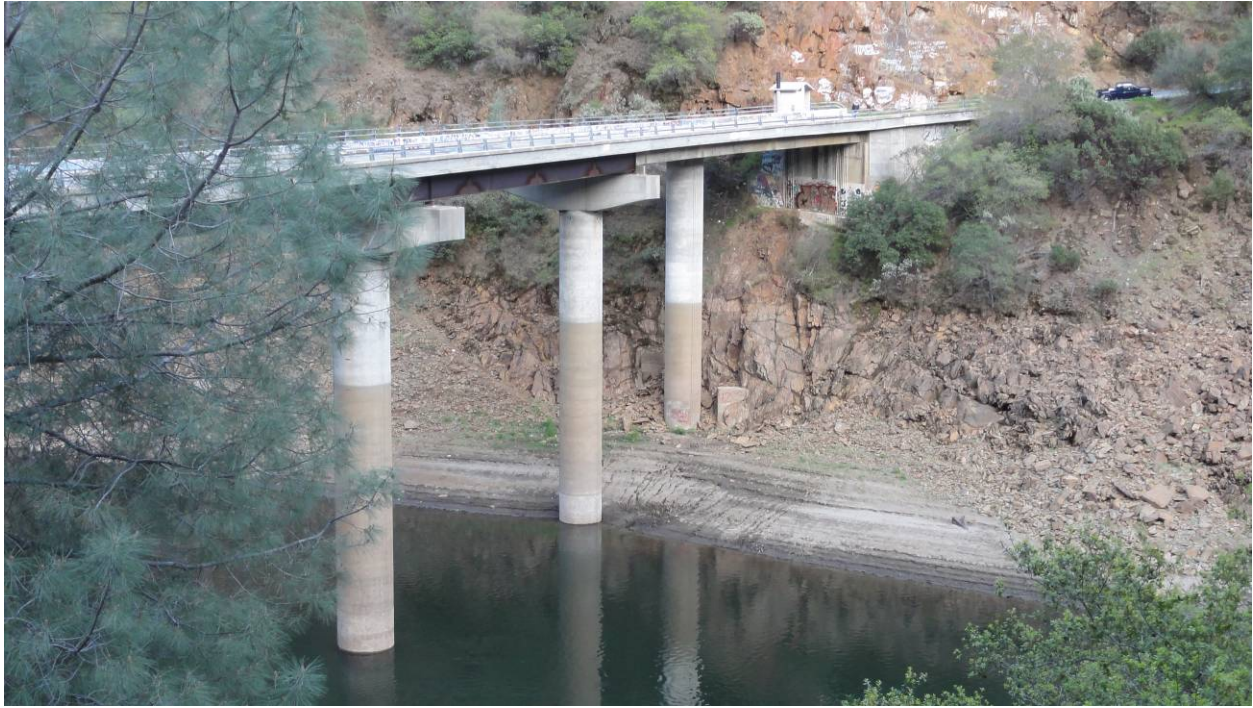
Figure 1. KOP 1. View of Ward's Ferry Bridge from Ward's Ferry Road. (March 2012)

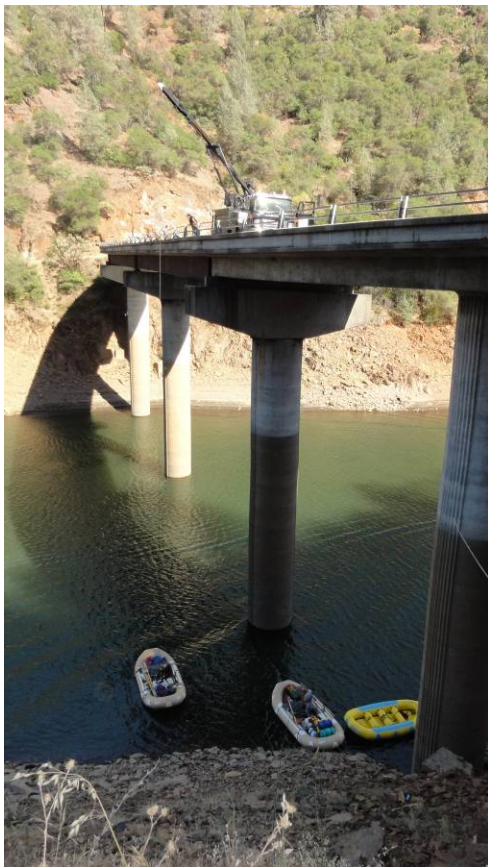
Figure 2. KOP 1. View of Ward's Ferry Bridge. (July 2012)

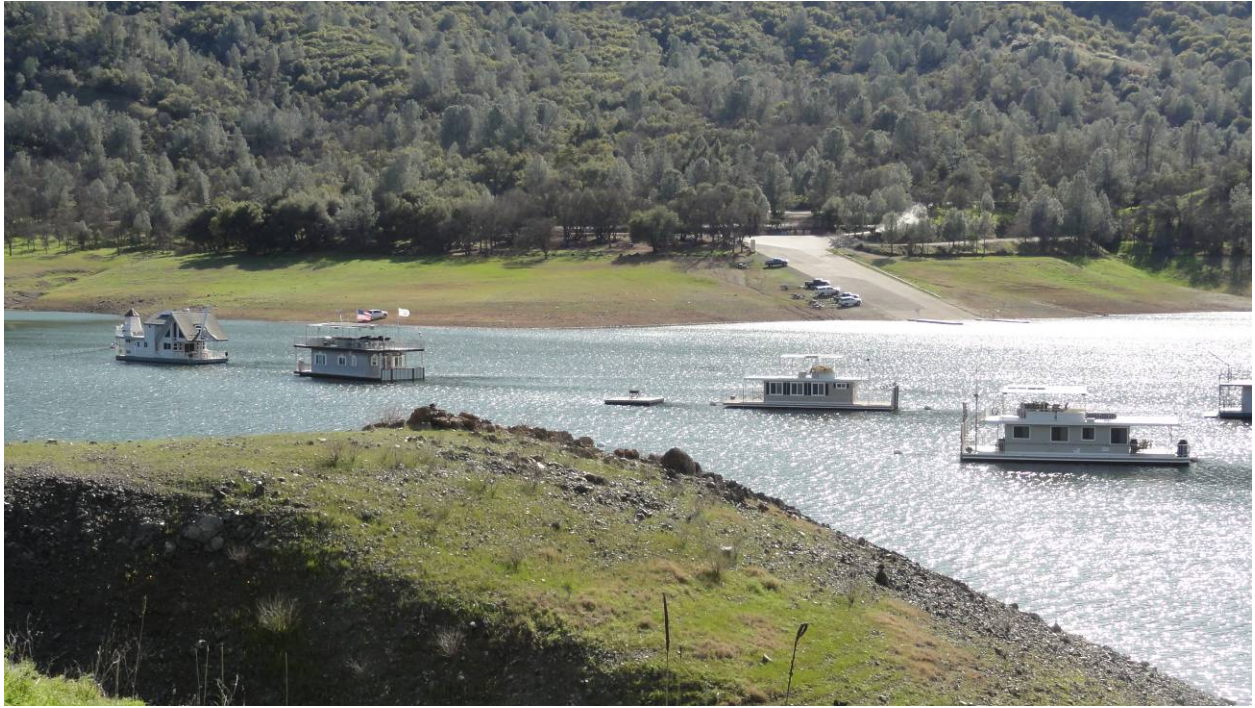
Figure 7. KOP 3. View from the end of Grizzly Road of houseboats and Moccasin Point Recreation Area boat ramp. (March 2012)

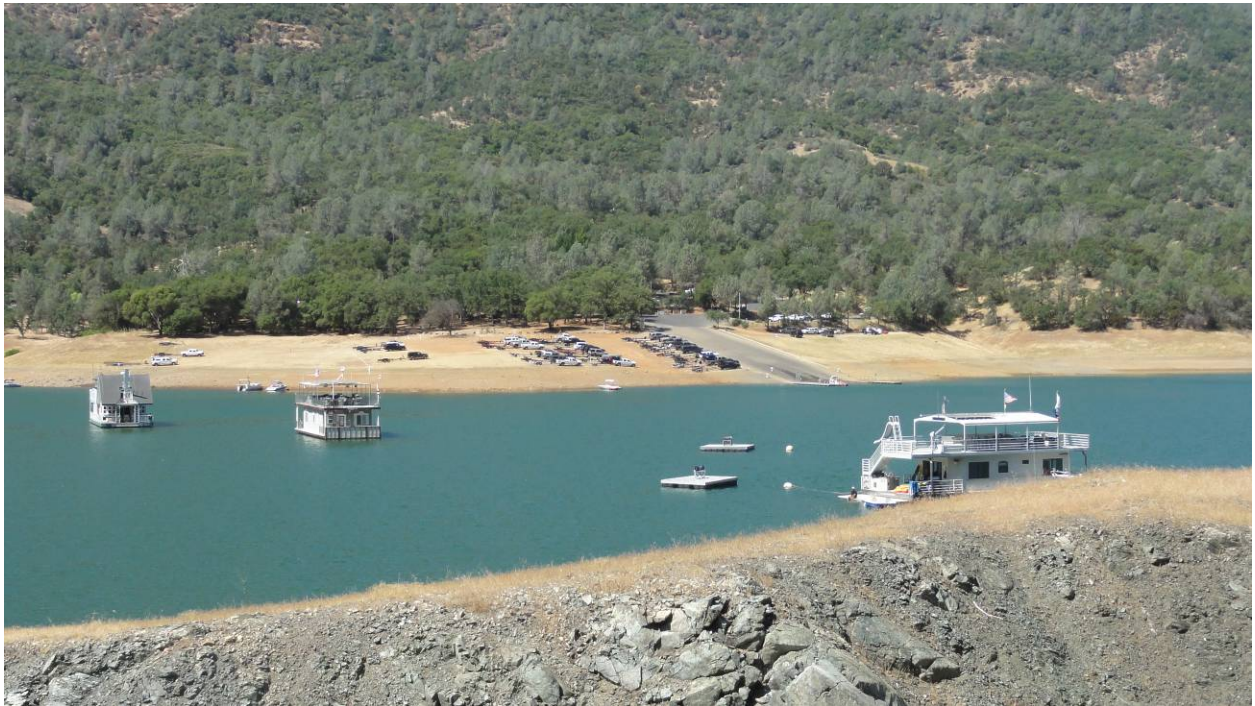
Figure 8. KOP 3. View from the end of Grizzly Road of houseboats and Moccasin Point Recreation Area boat ramp. (July 2012)

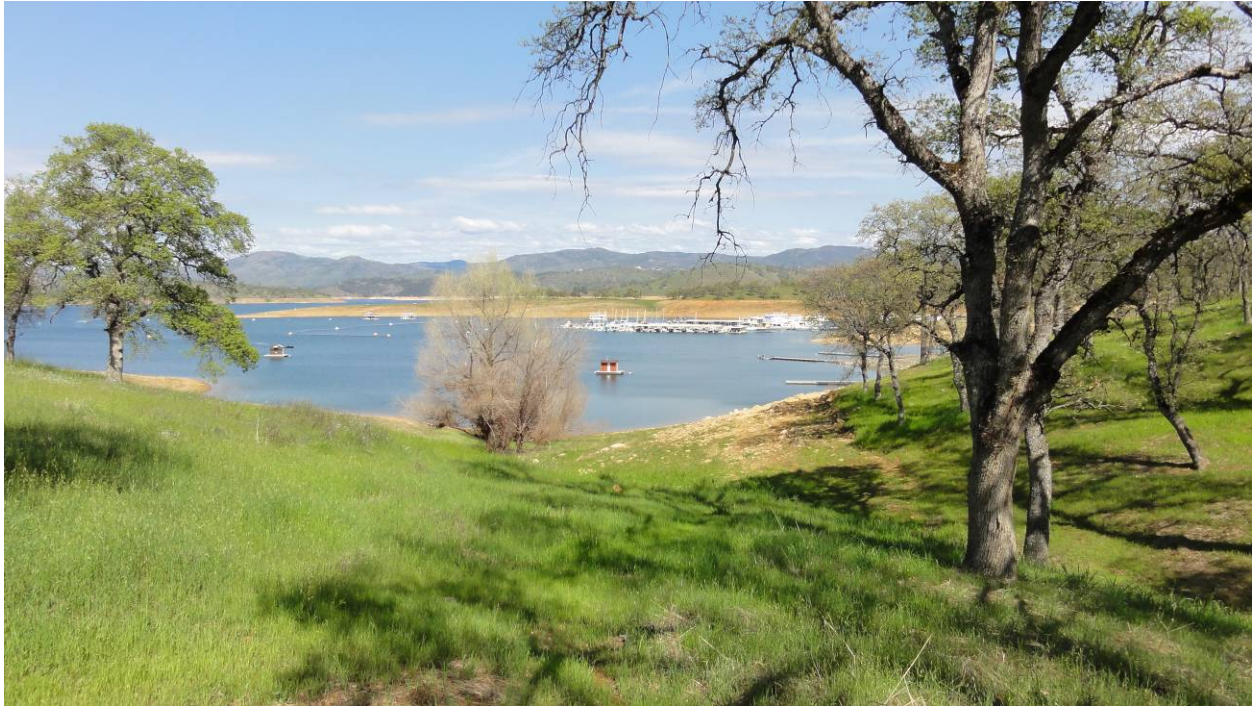
In the foreground is a houseboat mooring area with an associated marina which presents strong visual contrast, due to the bright white colors of the houseboats. From another vantage point within the campground is a second houseboat group which also is a strong visual contrast. This contrast is expected with houseboats and is part of the normal visual condition of recreation management on the reservoir.

Figure 15. KOP 7. View from campsite A19 at Fleming Meadows Recreation Area looking east at Don Pedro Reservoir and houseboat marina. (March 2012)

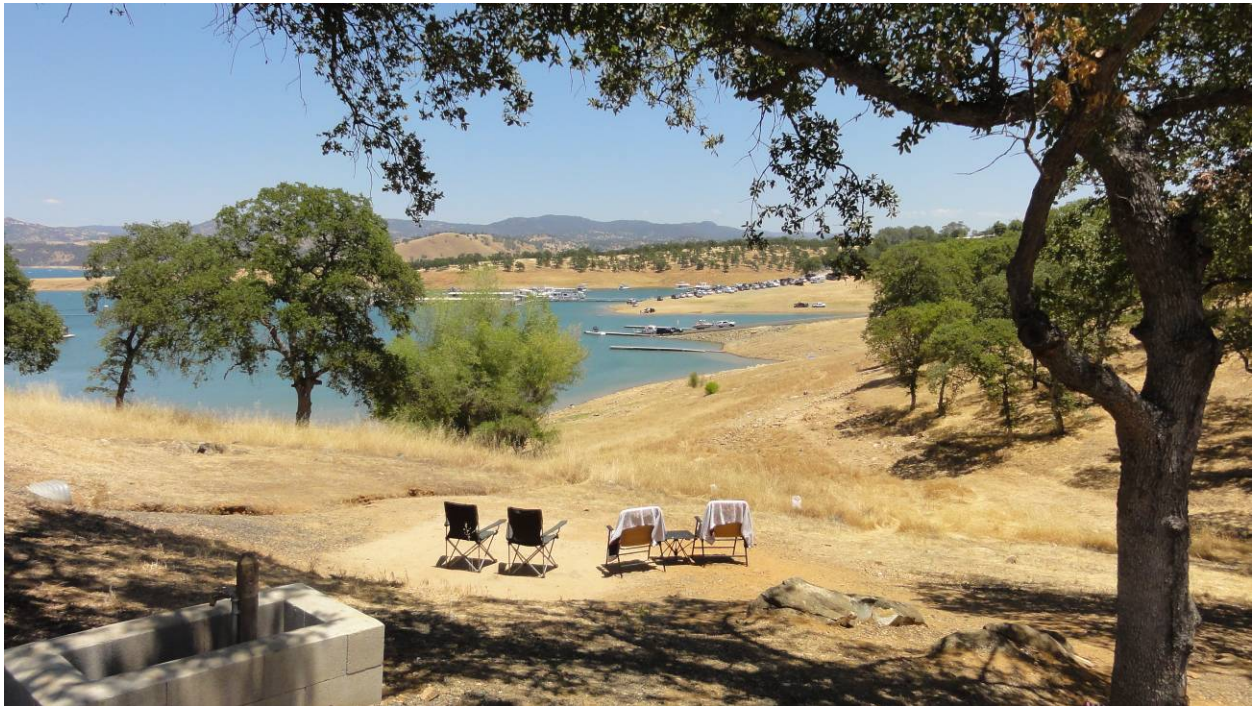
Figure 16. KOP 7. View from campsite A19 at Fleming Meadows Recreation Area looking east at Don Pedro Reservoir and houseboat marina. (July 2012)

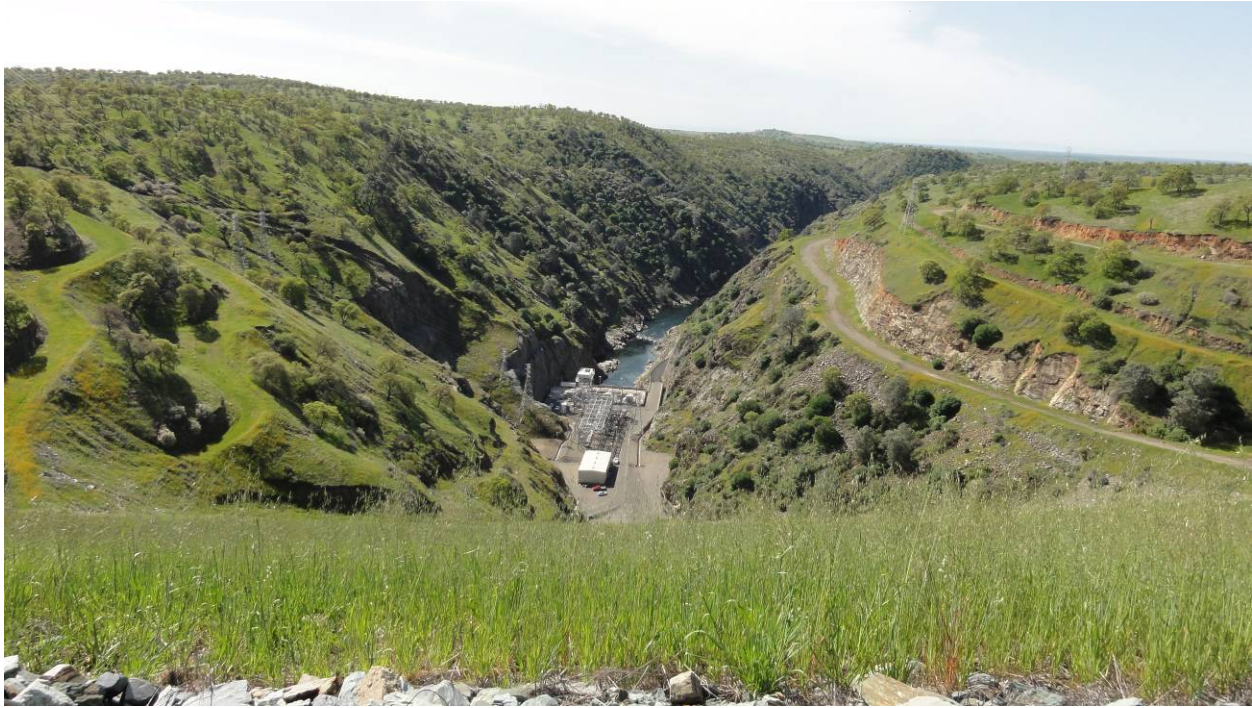
Figure 19. KOP 9. View south of powerhouse from Bonds Flat Road. Picture is taken from the vehicle passenger window at the center of the dam road. The powerhouse is located at the bottom of the canyon and is in the middle ground. (March 2012)

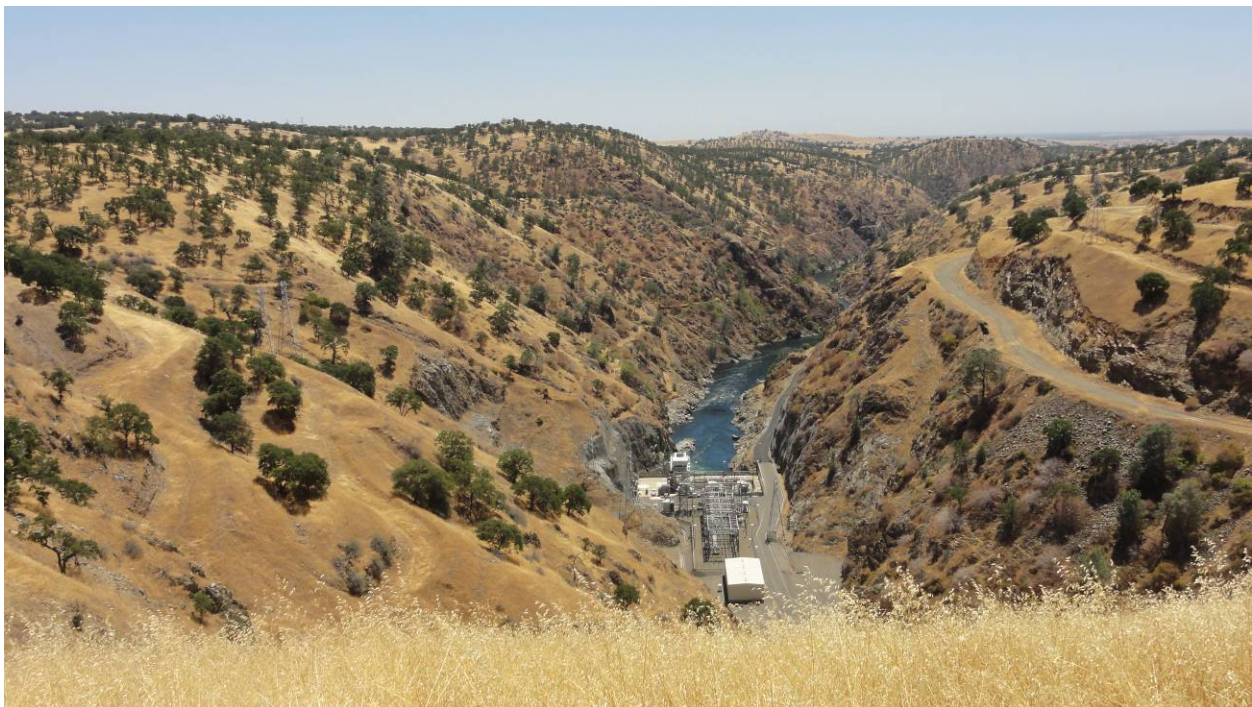
Figure 20. KOP 9. View south of powerhouse from Bonds Flat Road. Picture is taken from the passenger window at the center of the dam road. The powerhouse is located at the bottom of the canyon and is in the middle ground. (July 2012)

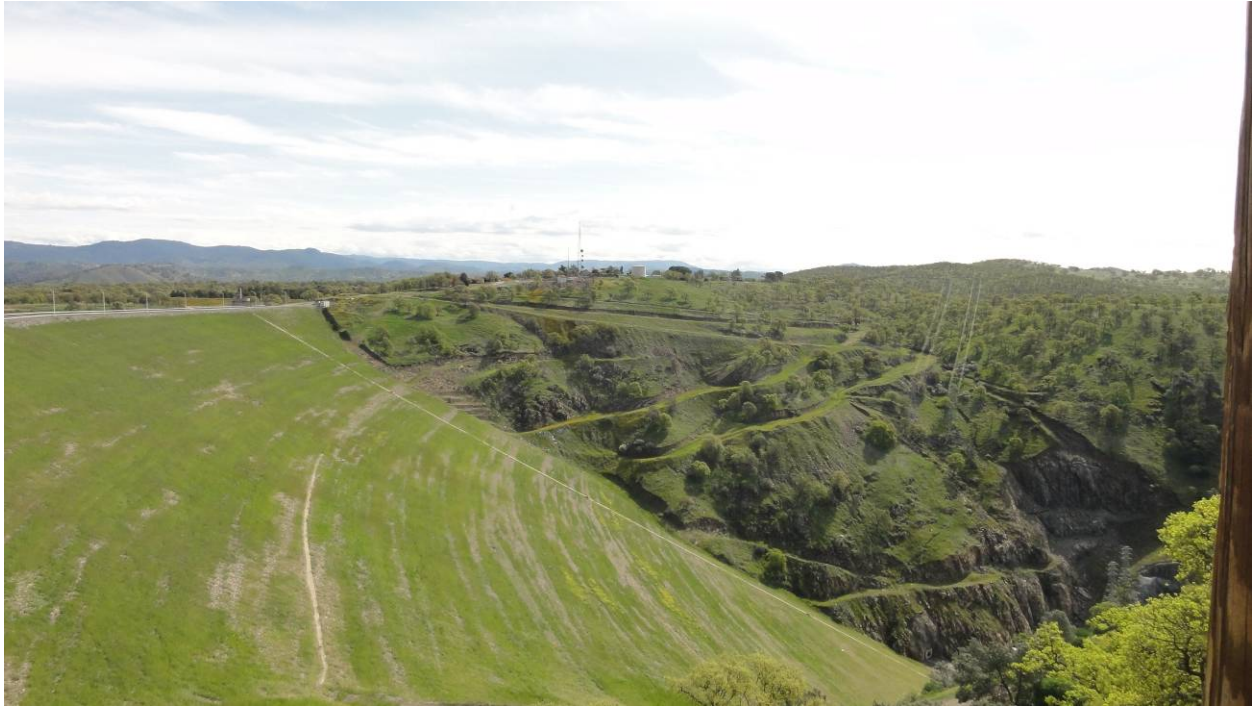
Figure 21. KOP 10. View east towards the Don Pedro Dam from Don Pedro Recreation Agency Headquarters and Visitors Center. (March 2012)

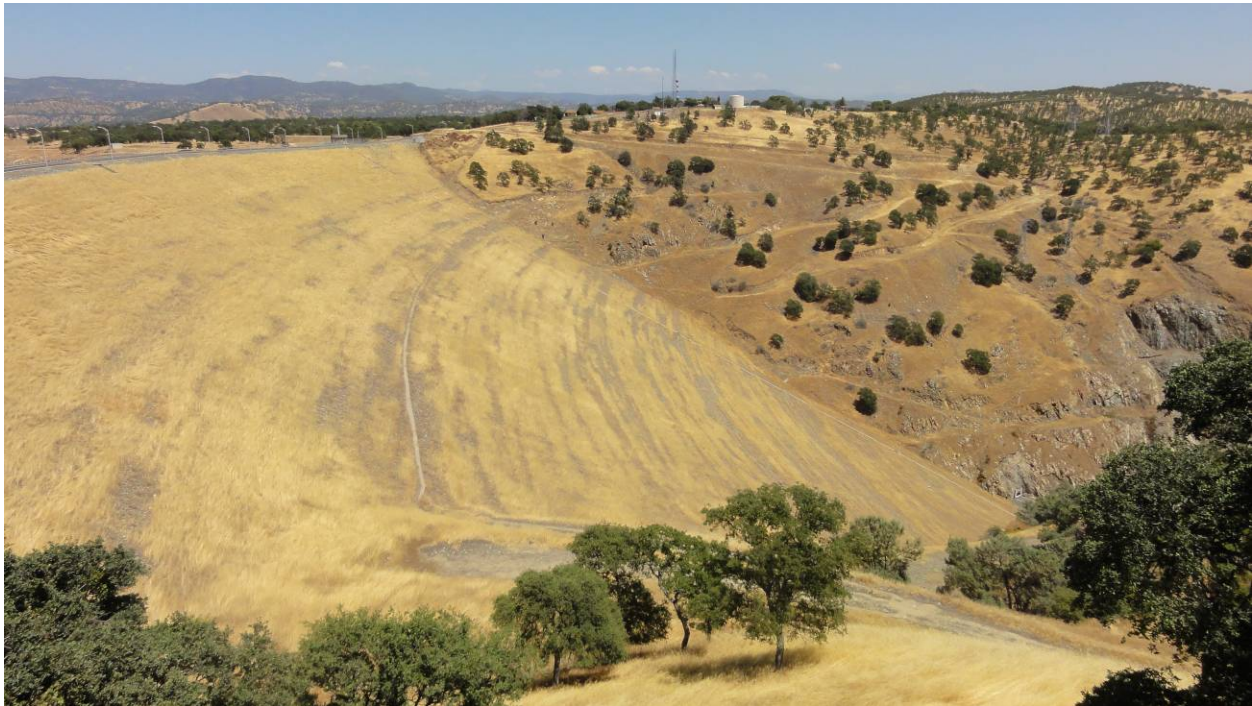
Figure 22. KOP 10. View east towards the Don Pedro Dam from Don Pedro Recreation Agency Headquarters and Visitors Center. (July 2012)

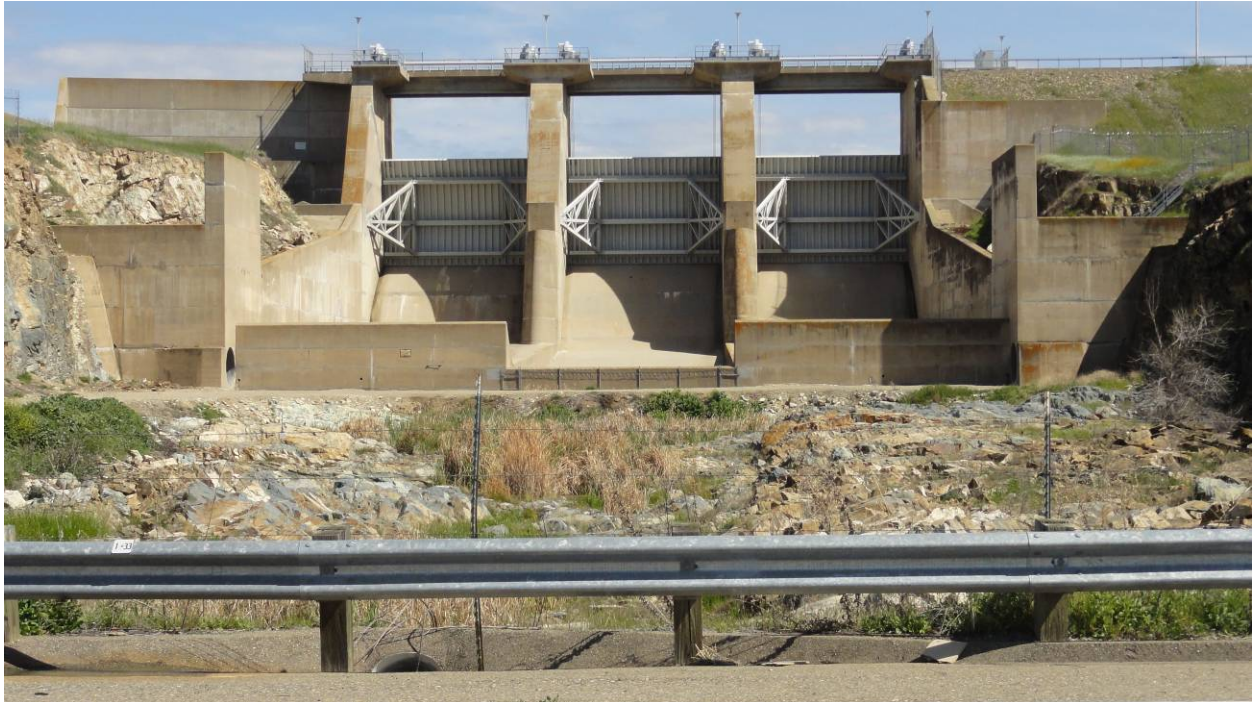
Figure 25. KOP 11. View east of Don Pedro Spillway from Bond Flats Road. (March 2012)

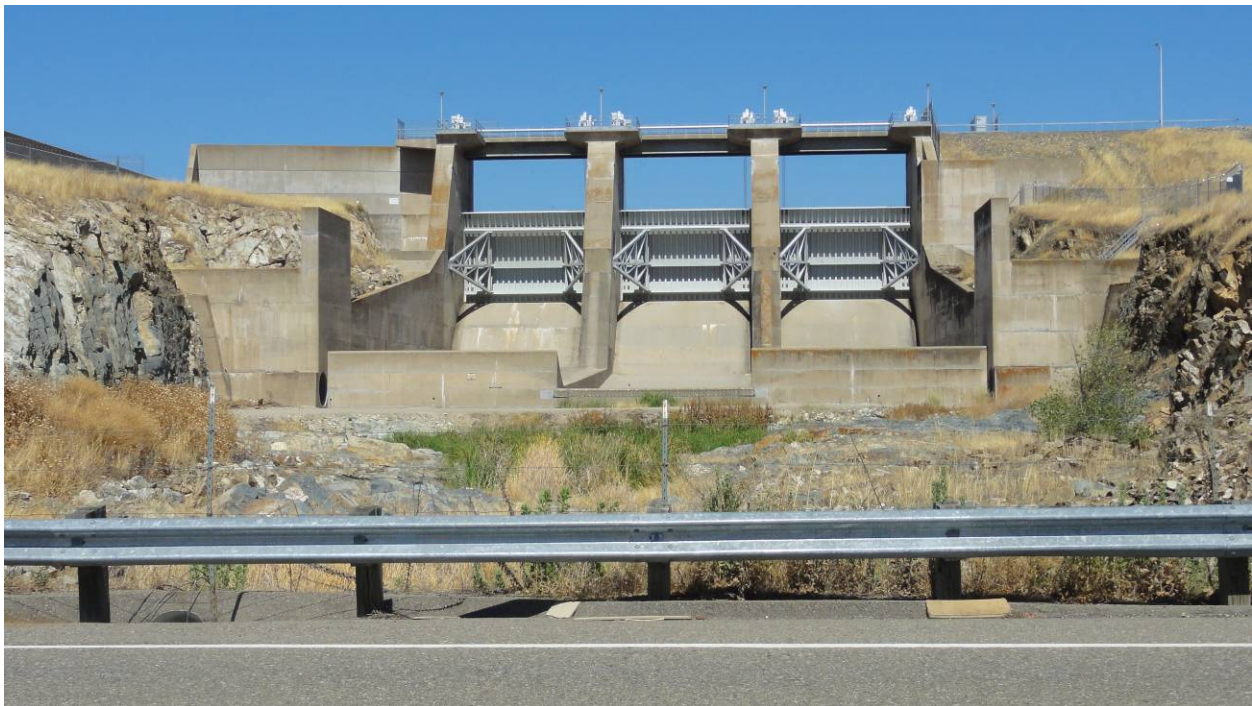
Figure 26. KOP 11. View east of Don Pedro Spillway from Bond Flats Road. (July 2012)

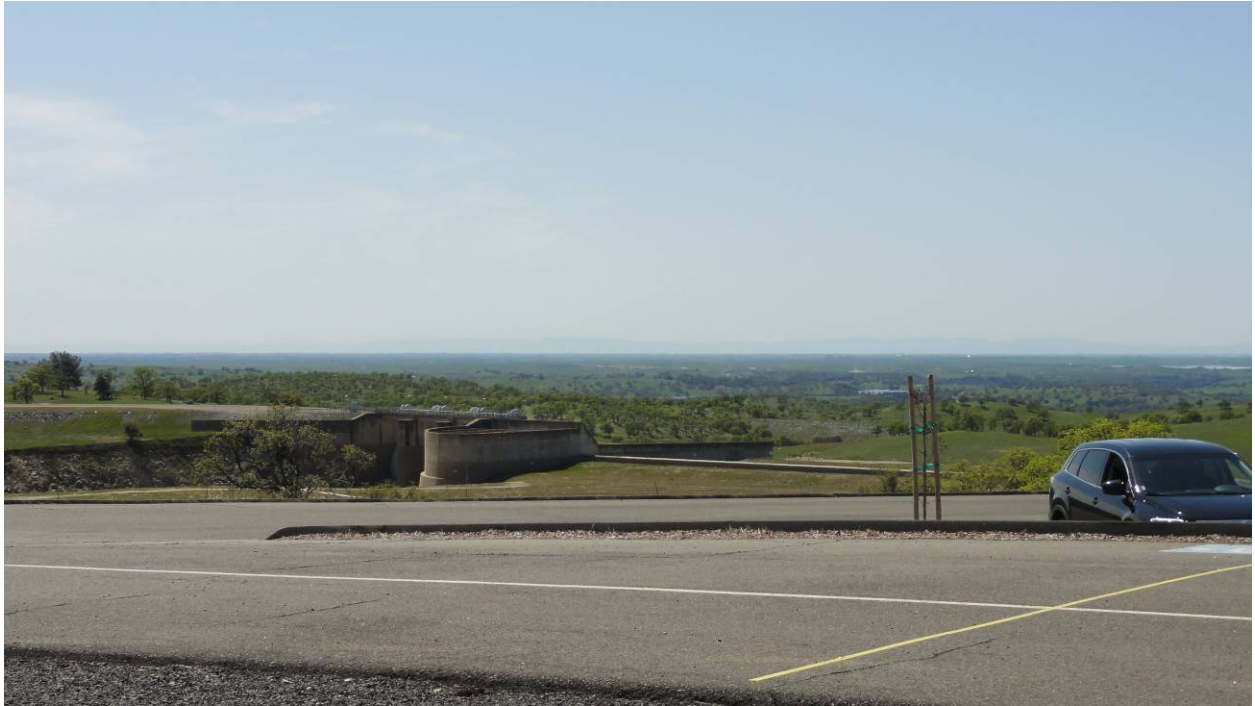
Figure 27. KOP 12. View southwest to the Don Pedro Spillway from Picnic Pavilion at Blue Oaks Recreation Area. (March 2012)

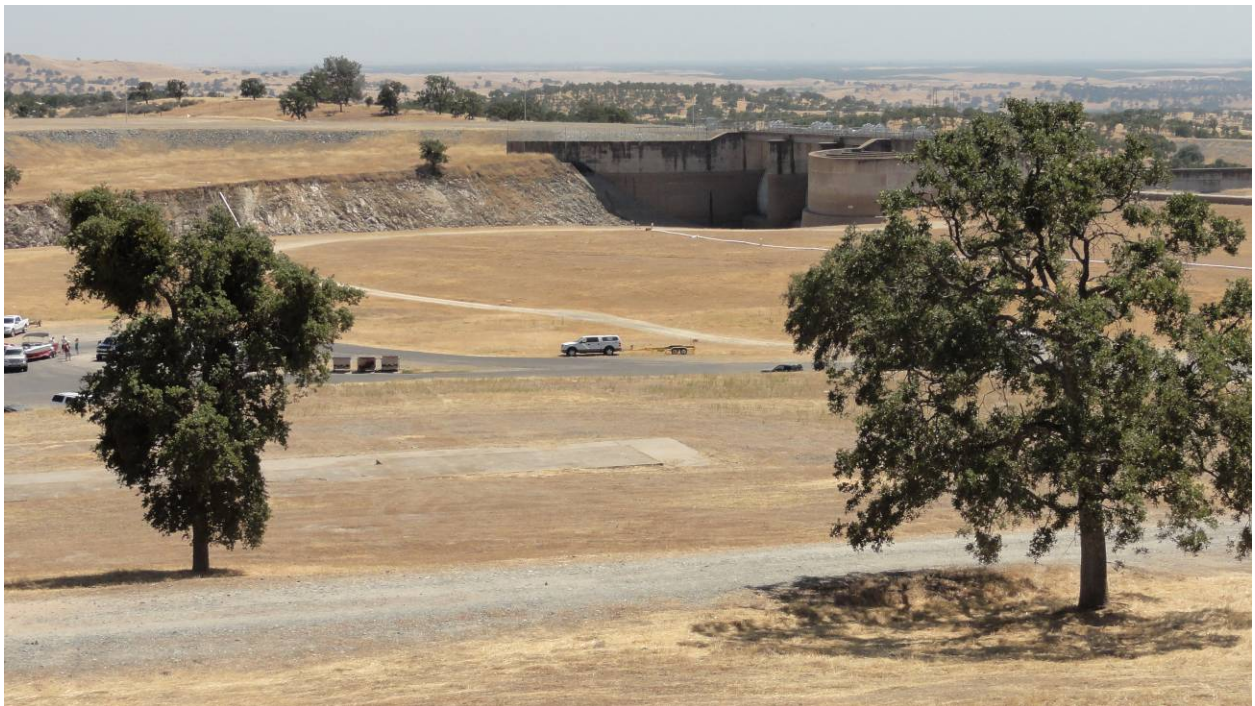
Figure 28. KOP 12. View southwest to the Don Pedro Spillway from Picnic Pavilion at Blue Oaks Recreation Area. (July 2012)

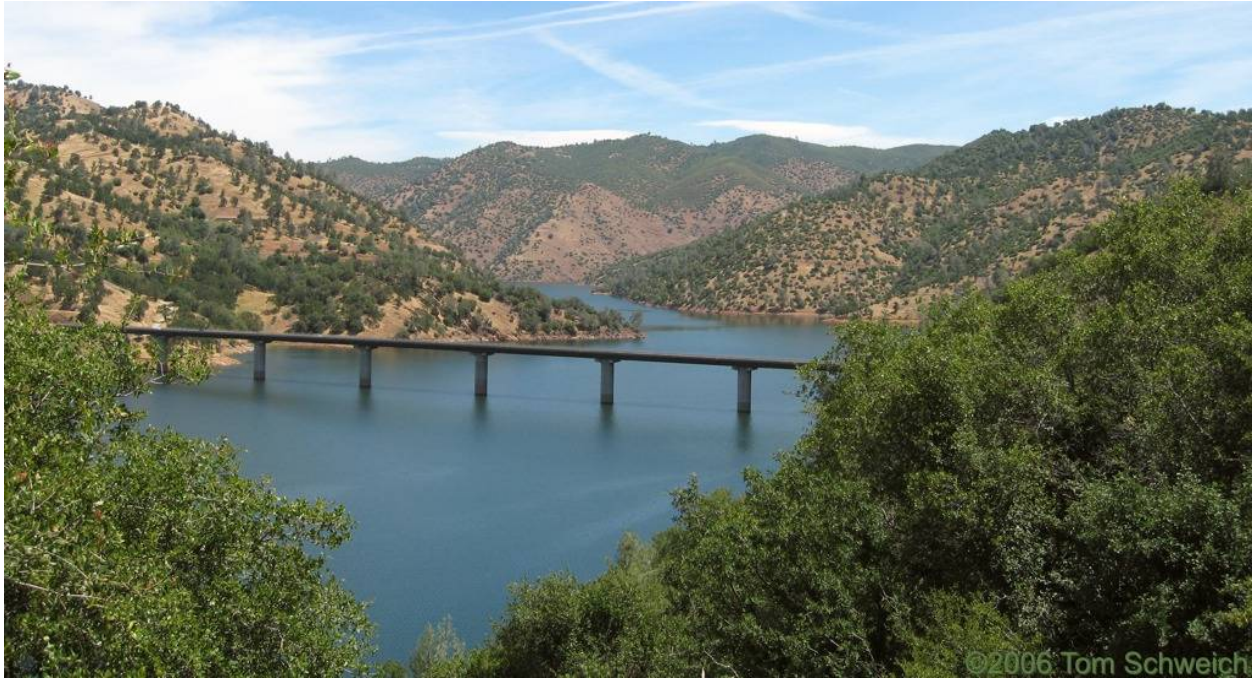
Figure 35. SPP 1. View depicting high reservoir elevation condition taken from the Highway 49/120 Vista Point looking east towards the Jacksonville Road Bridge. (Photograph provided by DPRA)

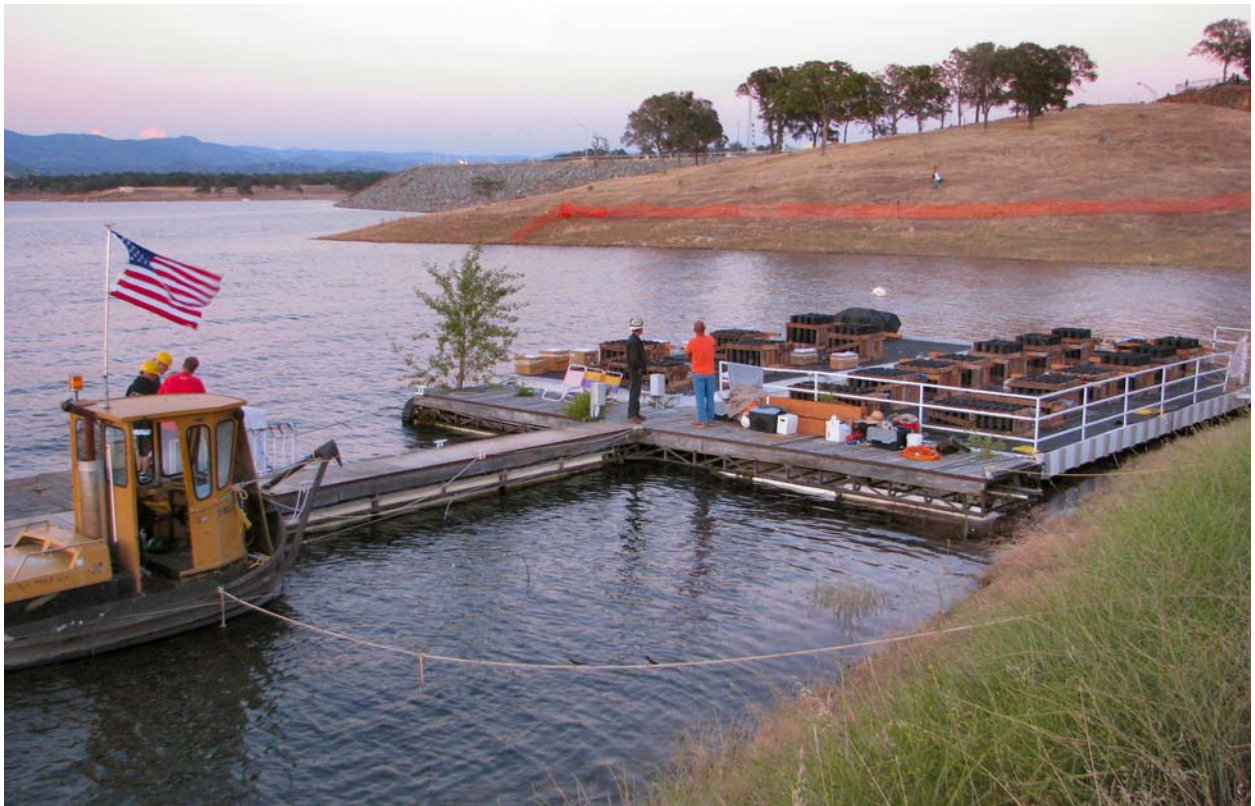
Figure 36. SPP 2. View at high reservoir elevation condition from a cove along the Don Pedro Reservoir shoreline looking east towards the dam. (Photograph provided by DPRA)

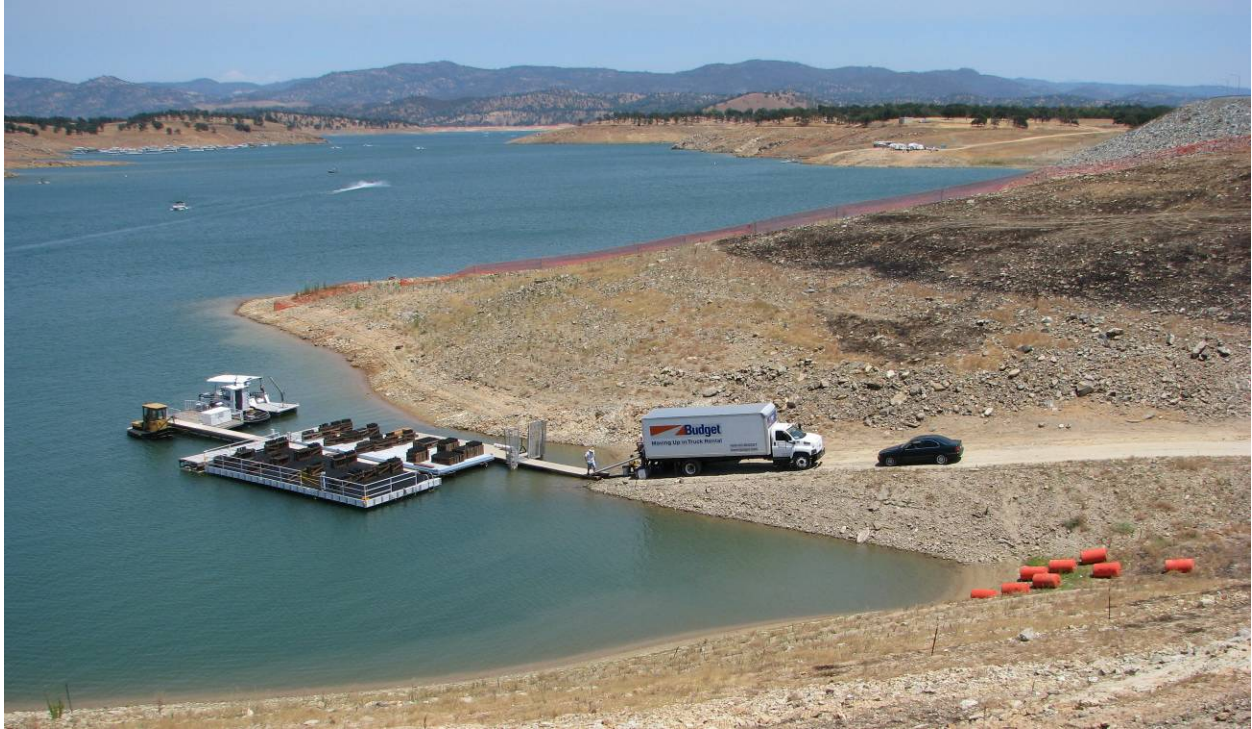
When the reservoir is below full pool elevation, the drawdown zone can be seen here and it was found to be moderate visual contrast during the study. Lower water levels will result in a stronger visual contrast.

Figure 37. SPP 3. View at low reservoir elevation condition from a cove along the Don Pedro Reservoir shoreline looking east towards the dam. (Photograph provided by DPRA)

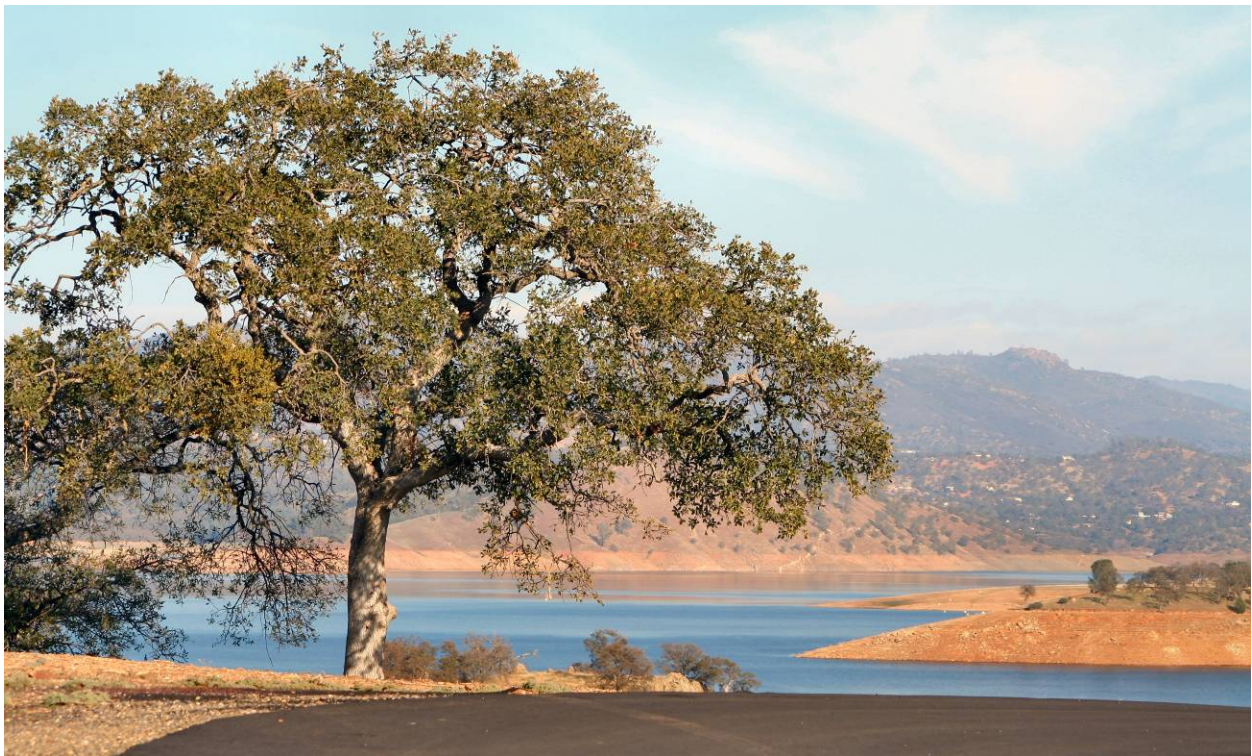
Figure 38. SPP 4. View depicting low reservoir elevation condition taken from the Blue Oaks Recreation Area looking east towards Don Pedro Reservoir. (Photograph provided by DPRA)
