**STUDY REPORT RR-02
WHITEWATER BOATING TAKE-OUT
IMPROVEMENT FEASIBILITY**

ATTACHMENT A

PHOTOGRAPHS OF THE WARD'S FERRY BRIDGE TAKE-OUT SITE

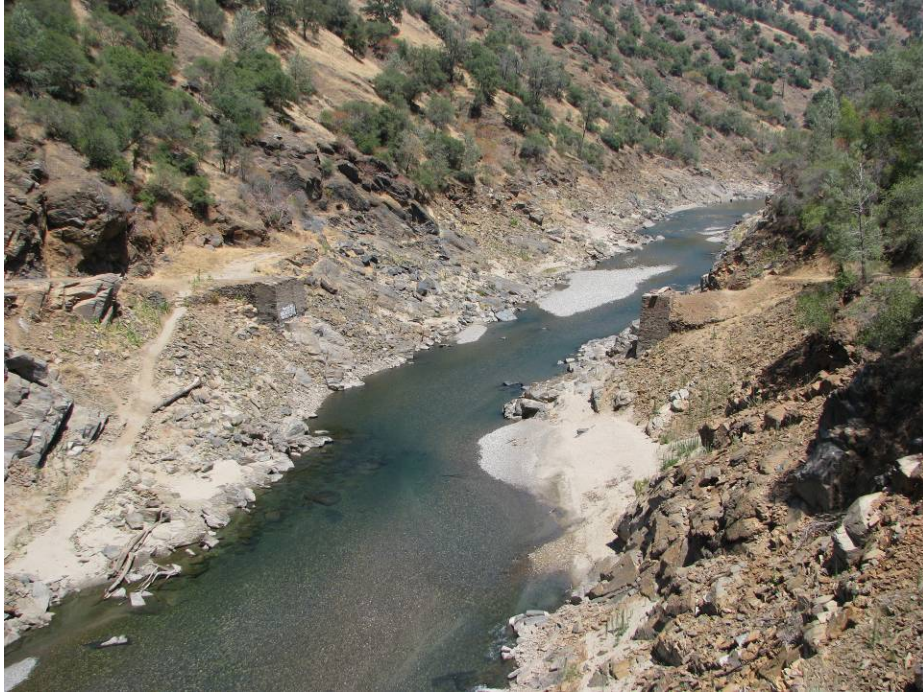
Photo 1. Ward's Ferry Bridge Take-Out Site, Looking Upstream from Existing Bridge. Note Old Bridge Abutments and User-Defined Access Trail. (Water Elevation 759 ft msl at Don Pedro Dam.)

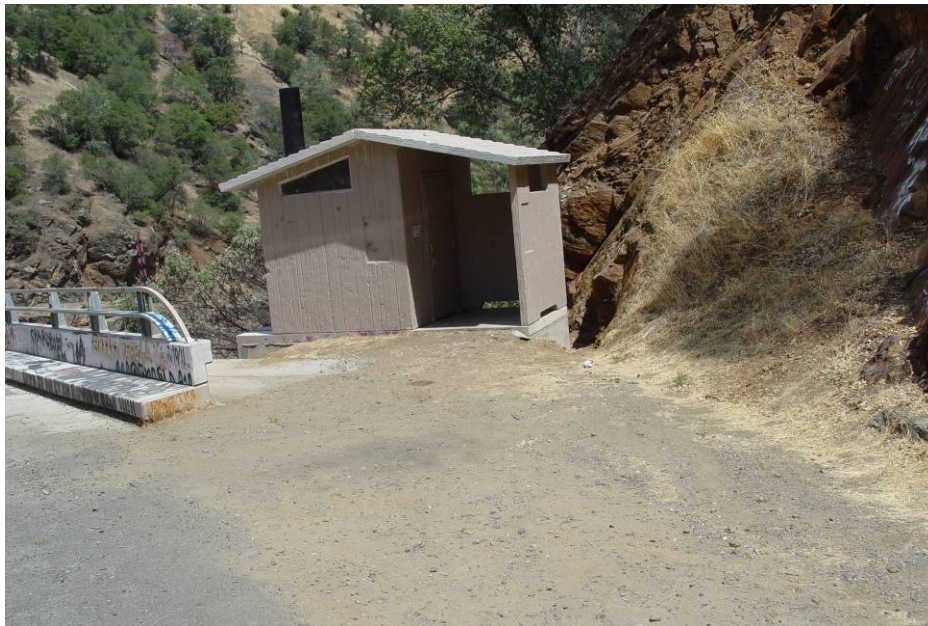
Photo 2. Ward's Ferry Bridge Take-Out Site, Vault Toilet on River Left at South End of the Existing Bridge.

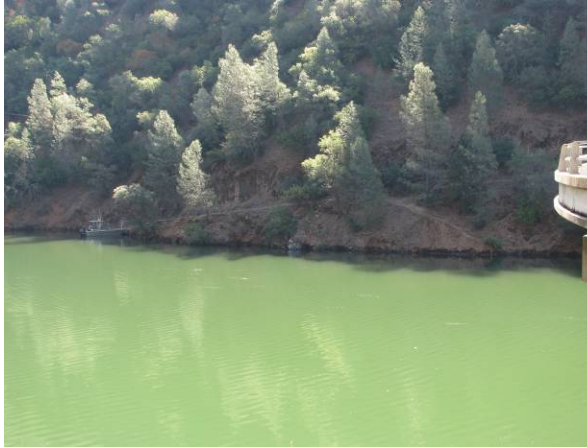
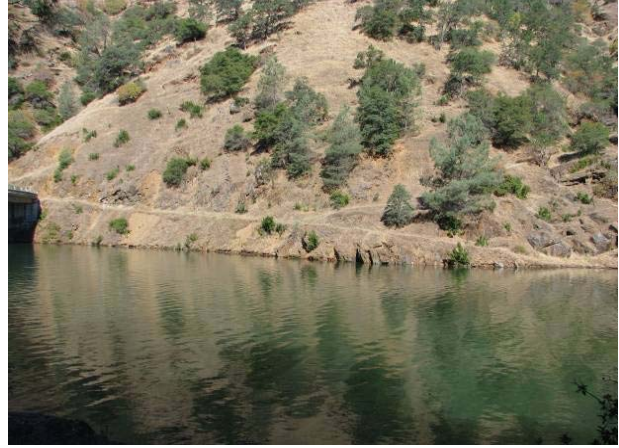
Photo 3. Ward's Ferry Bridge Take-Out Site River Left and River Right Under High Water Elevation Conditions. (Water Elevation 827 ft msl at Don Pedro Dam.)

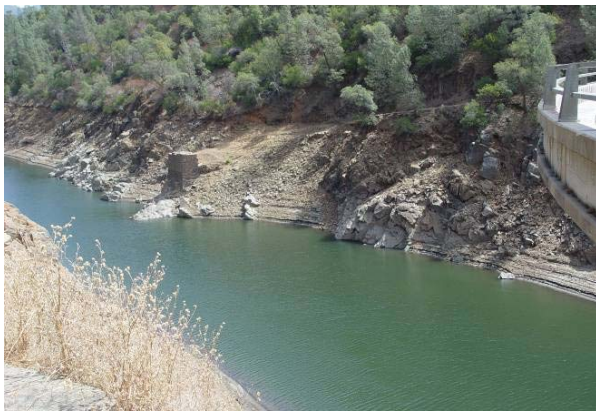
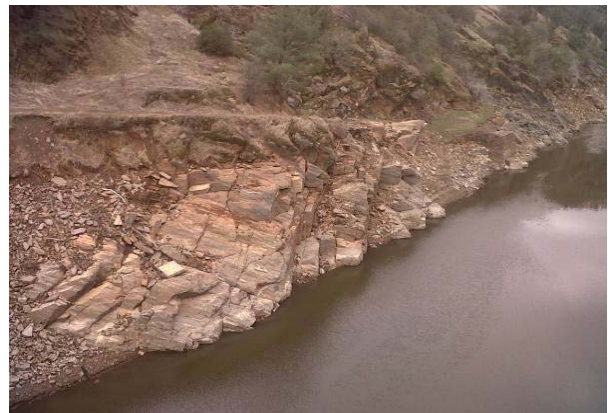
Photo 4. Ward's Ferry Bridge Take-Out Site Depicting Steep Banks, River Left and River Right.

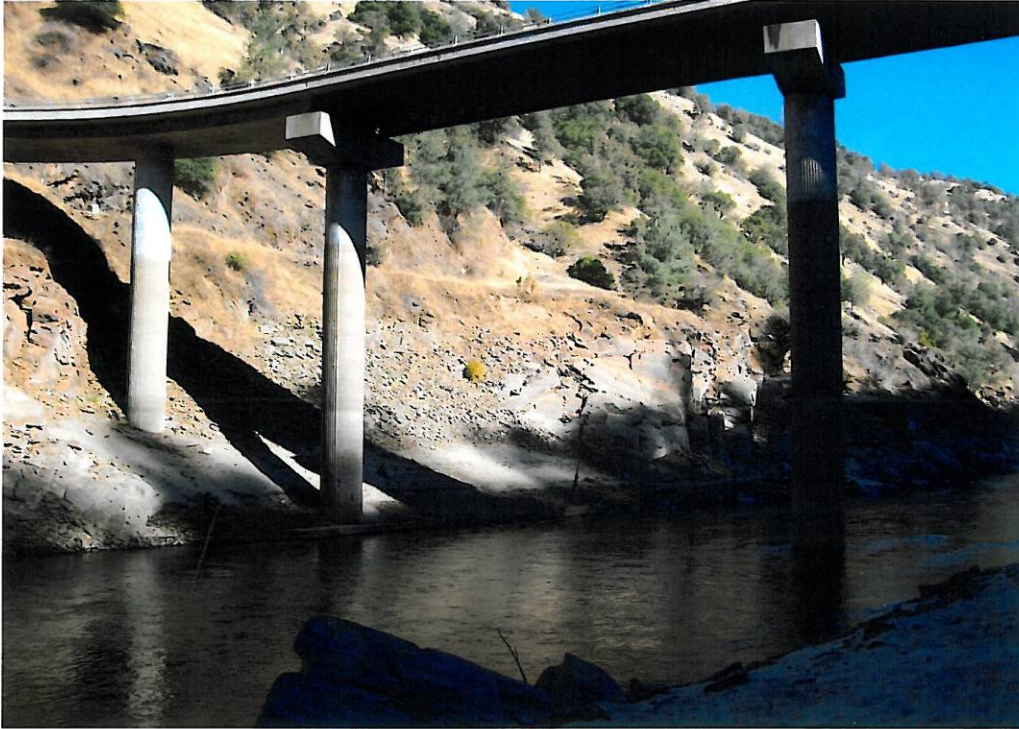
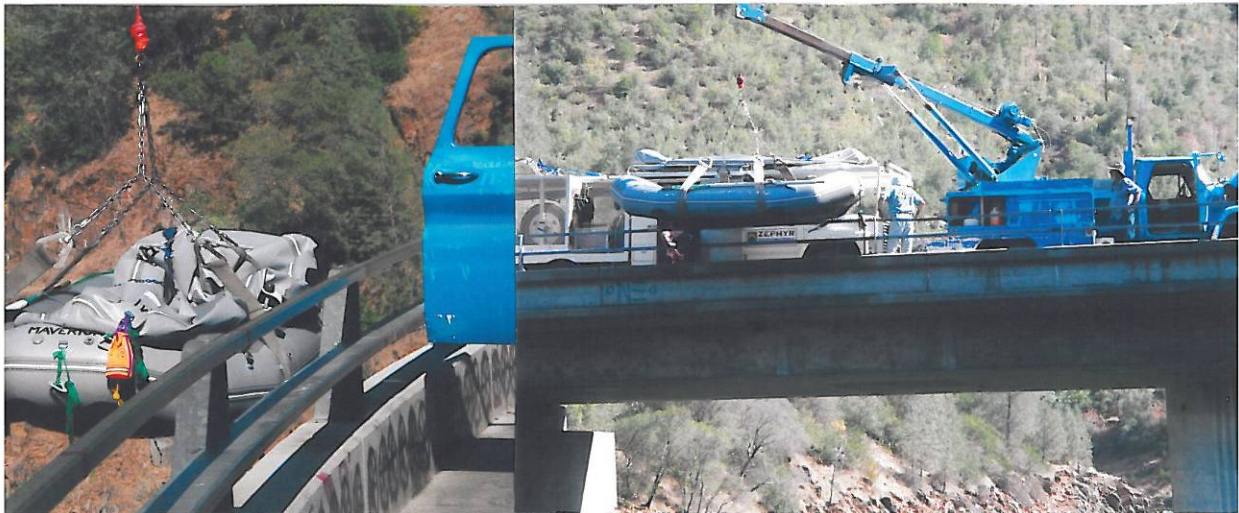
Photo 5. Ward's Ferry Bridge Take-Out Site, Showing Height from River to Bridge Deck and Outfitter Hoisting Rafts from River to Bridge Deck.
